# Cairngorms Mountain Heritage Project

## Upland Path Audit

Surveyors – Dougie Baird, Chris Goodman

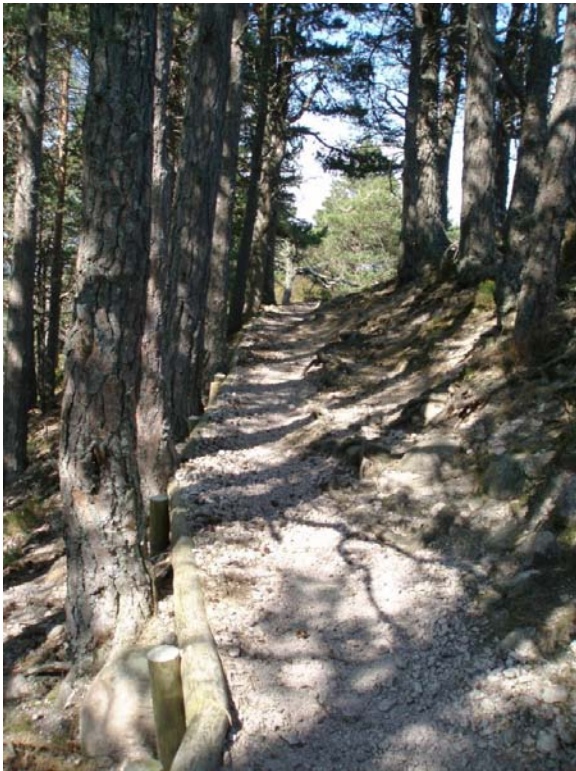
**Woodland section in good condition.**

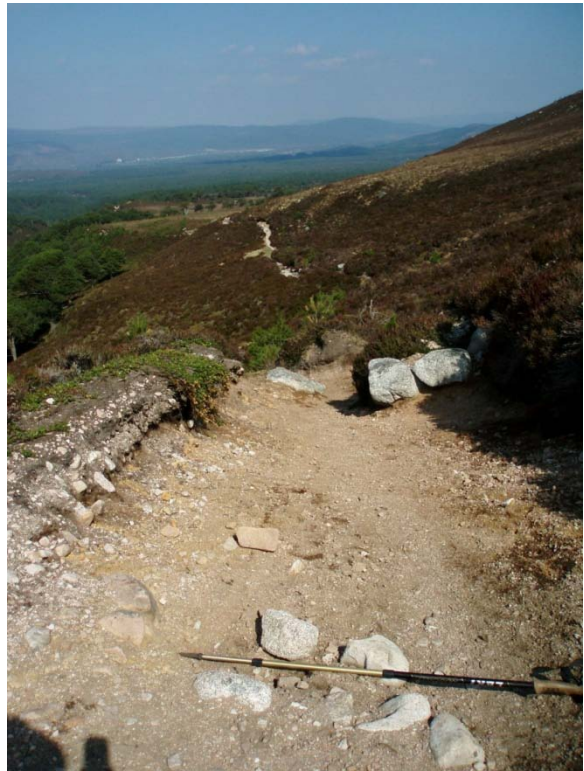
**Repairs and short rebuild required on the first few kms.**

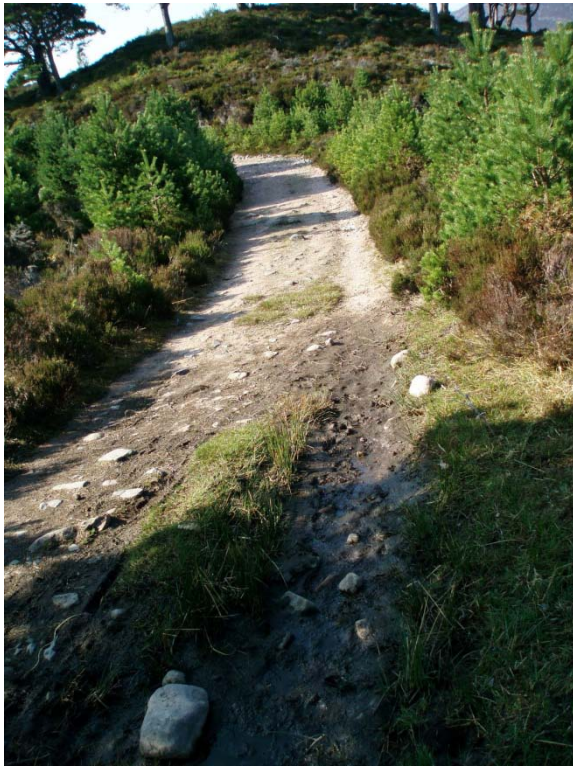
**Vehicle track requires no work.**

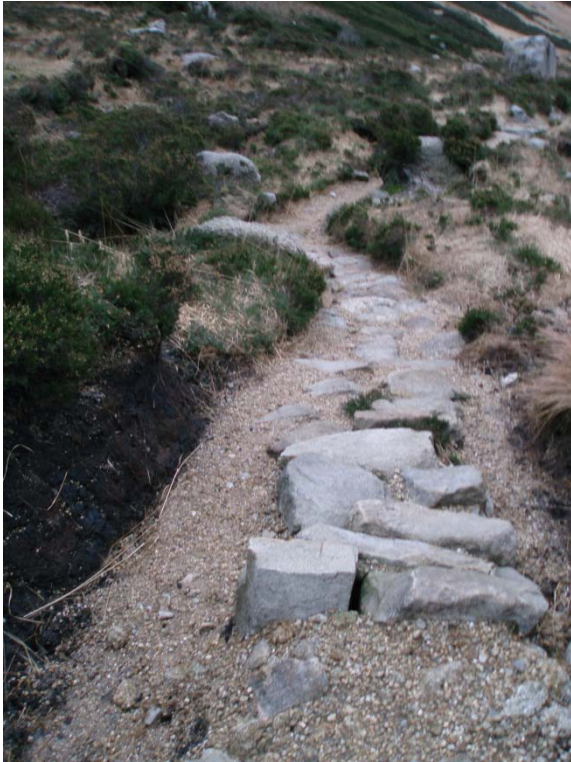
**Pitching not working**

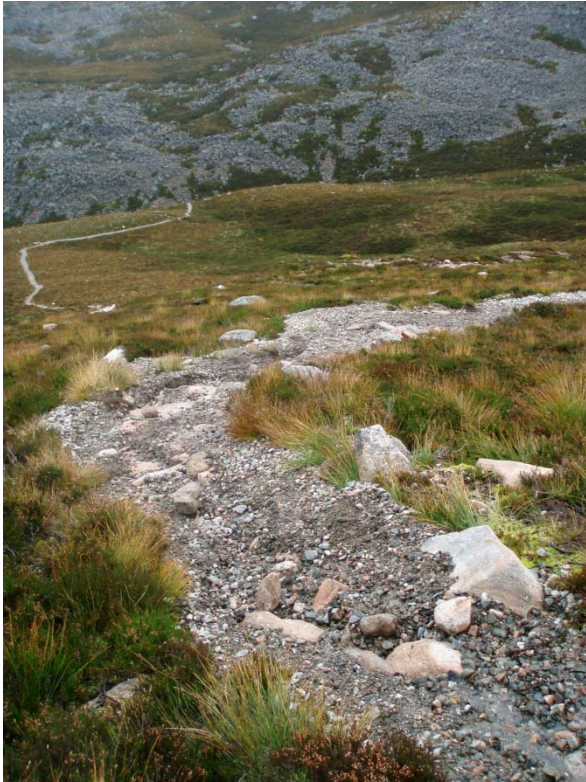
**Grey chips falling apart.**

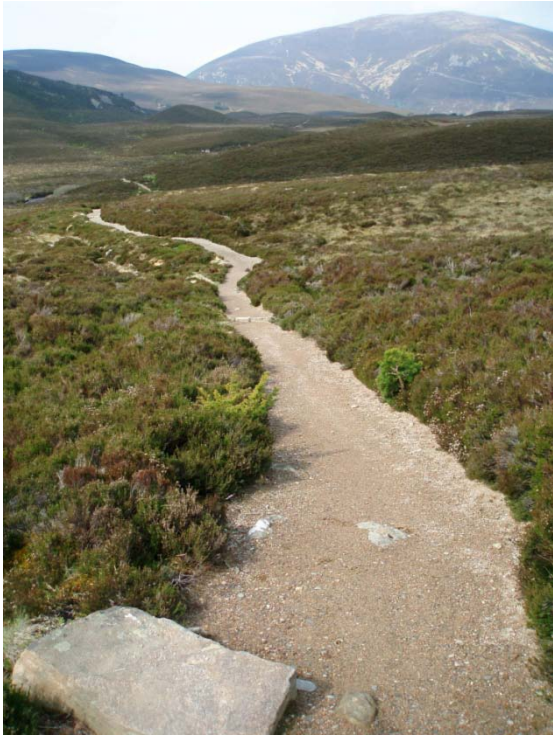
**Full build path, section 2**

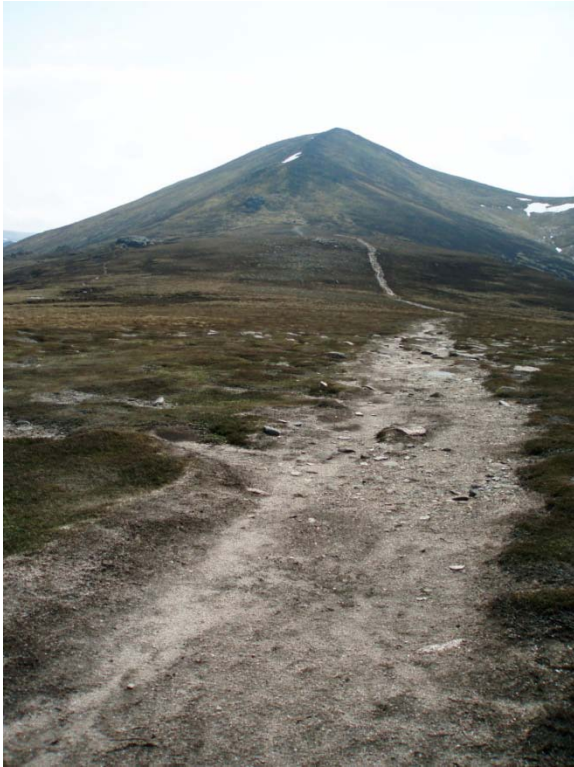
**Gradually spreading erosion on the lead in.**

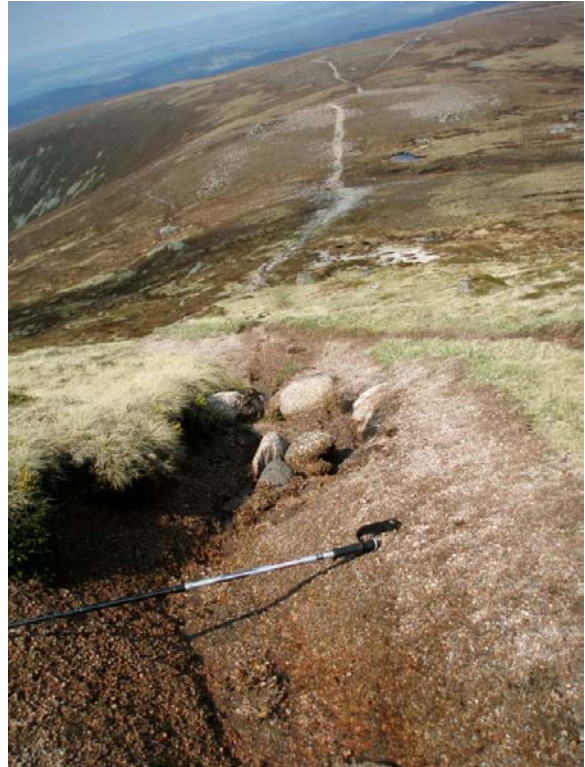
**Start of rapid erosion process.**

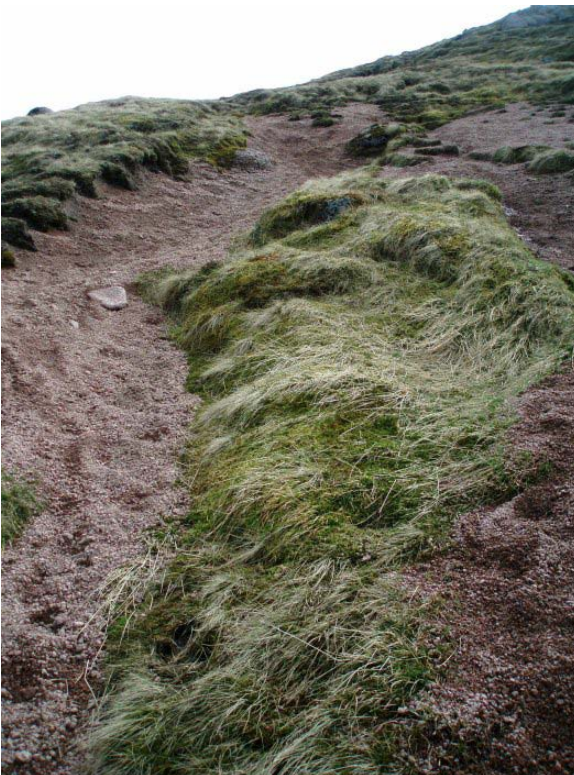
**Gullying of loose granite soils.**

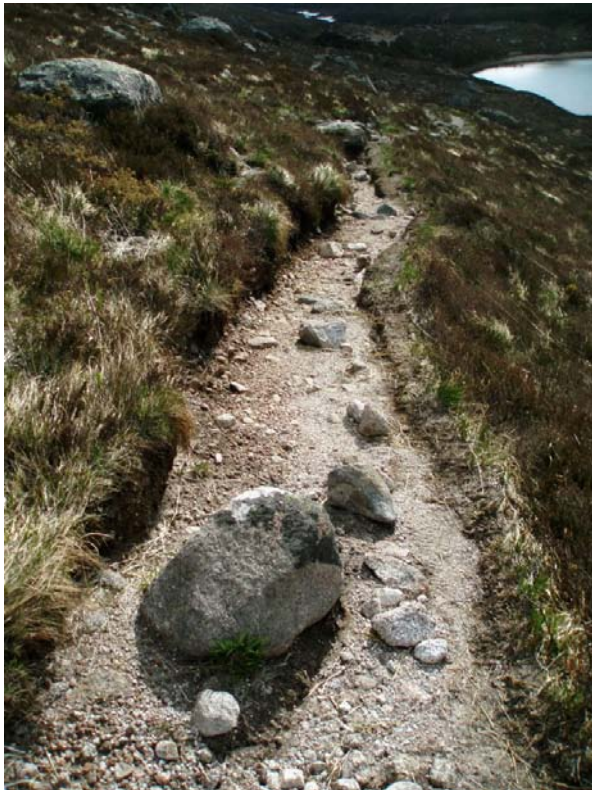
**Light touch work needed to protect surface,  
section 1**

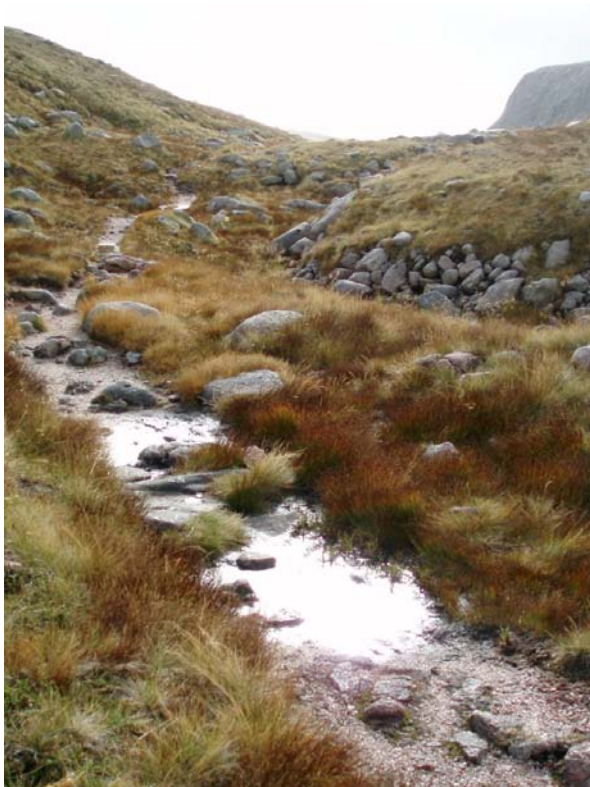
**Evolved line down Coire Domhain**

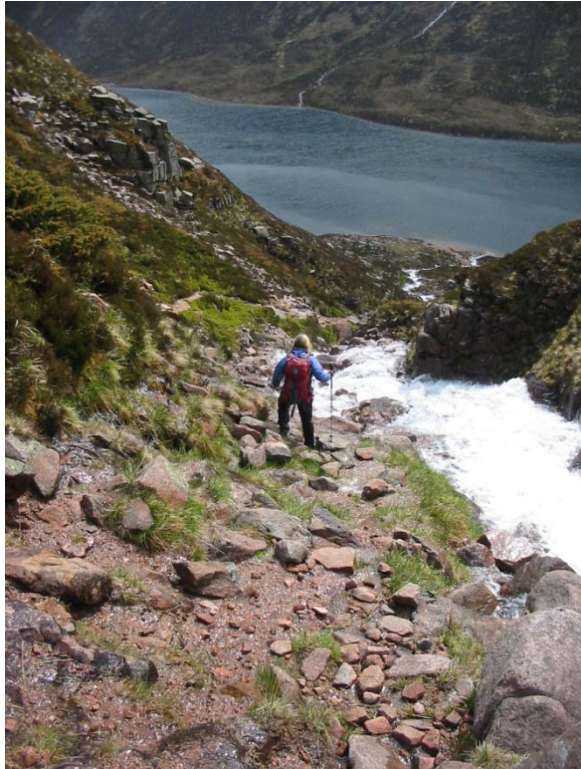
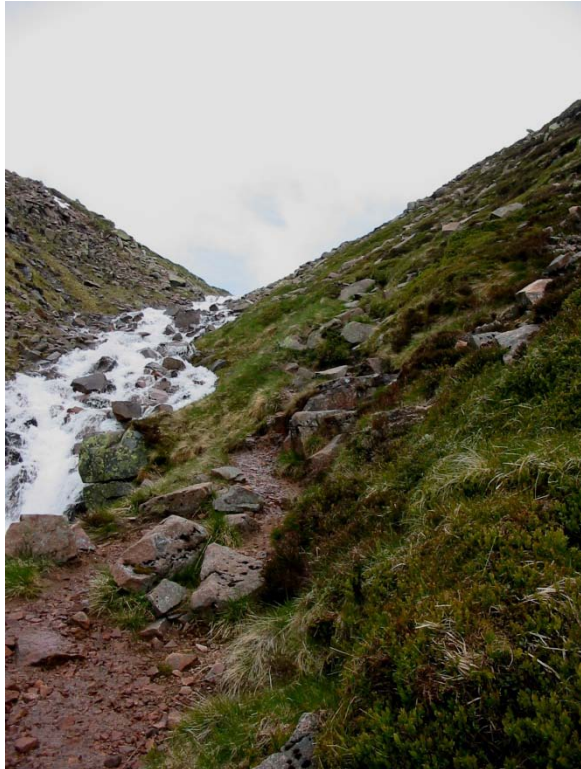
<b>Recommendations:</b> <ul style="list-style-type: none"><li>Sections above and below bedrock step need quite intensive work to repair.</li><li>Lower sections will need light touch repairs.</li></ul>			
<b>Maintenance:</b> Route will need some ongoing ‘light touch’ and pre-emptive repairs.			
<b>Repairs needed on steeper sections</b>		<b>Light touch work needed</b>

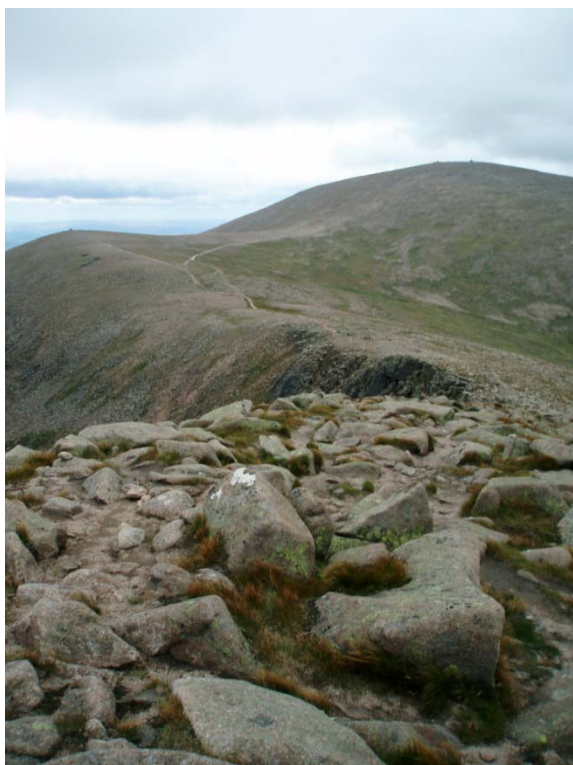
**Broad erosion damage up to Cairngorm.**

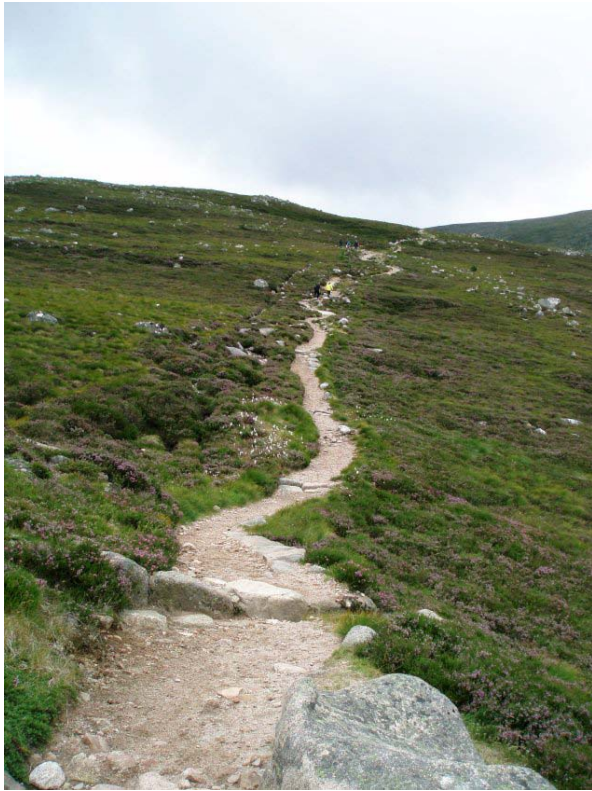
**High Build path on the first few kms.**

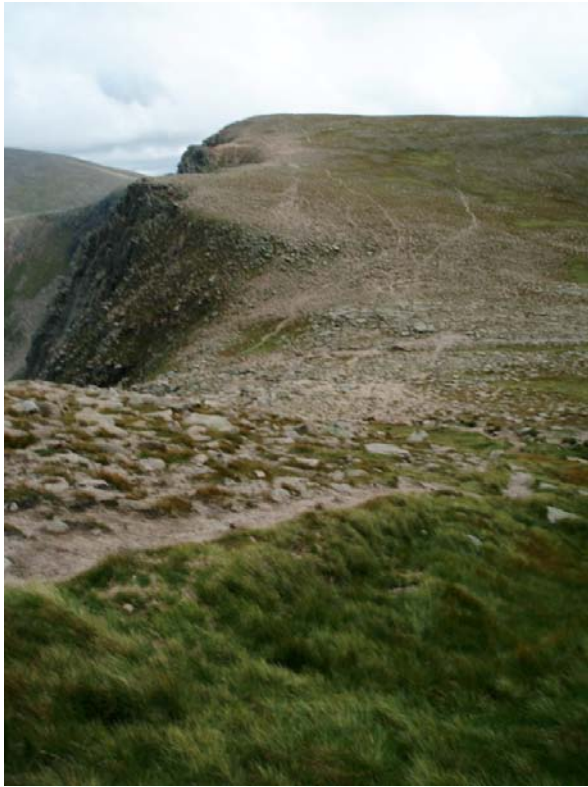
**Broad trample zone with braids**

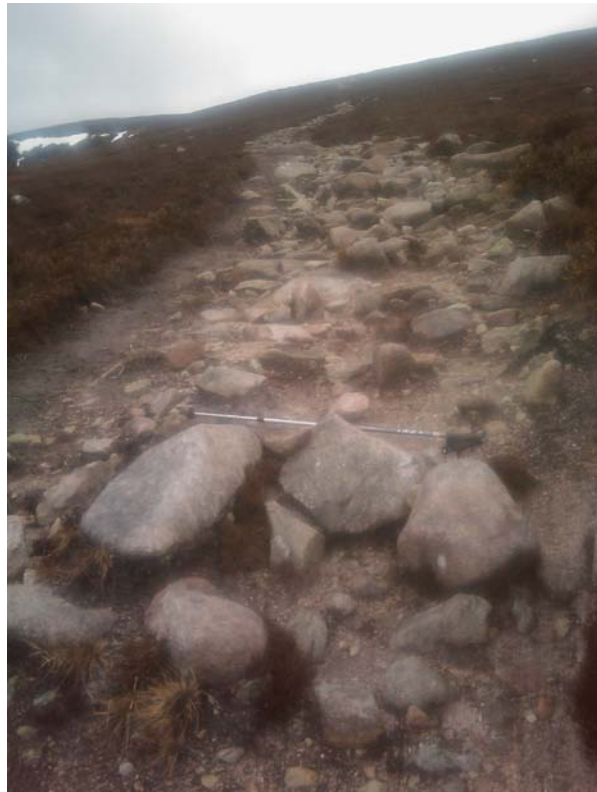
<b>Rougher surface on section 2</b>

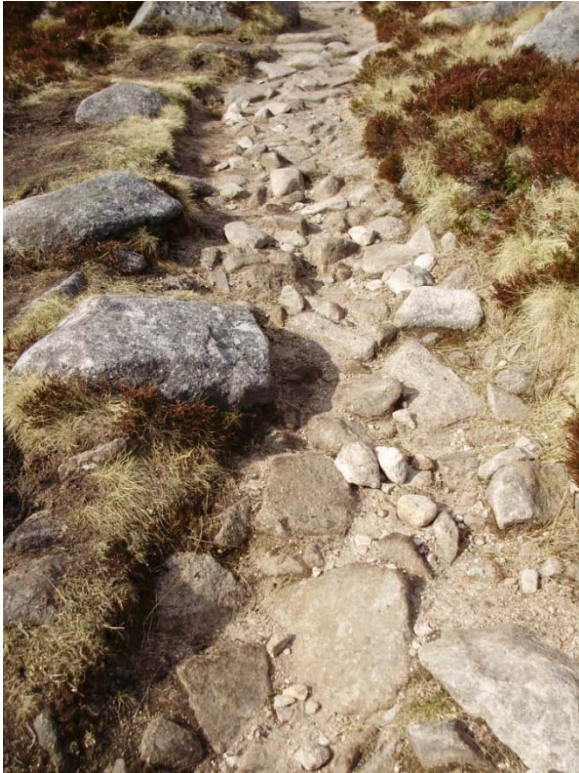
**Resurfacing needed, section 1.**

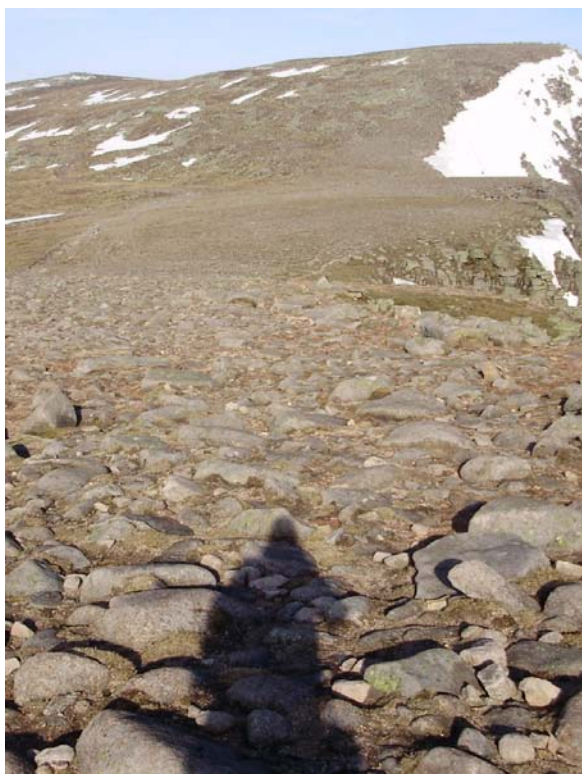
**Broad trample zone across plateau.**

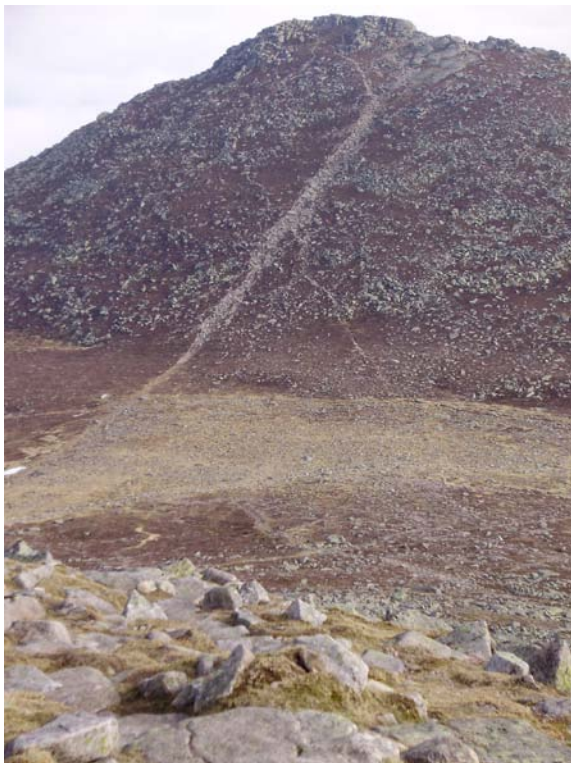
**Some erosion and loss of vegetation very visible.**

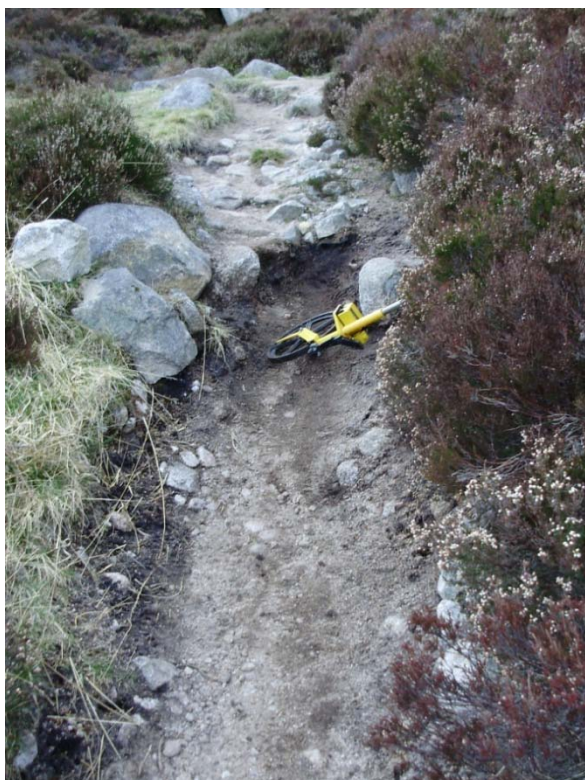
**Section 2 in need of repairs and resurfacing.**

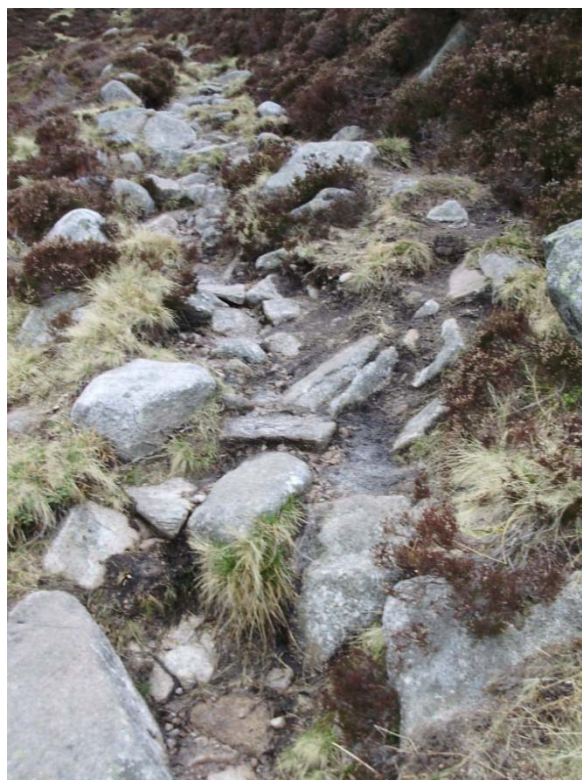
**Section 3 very rough.**

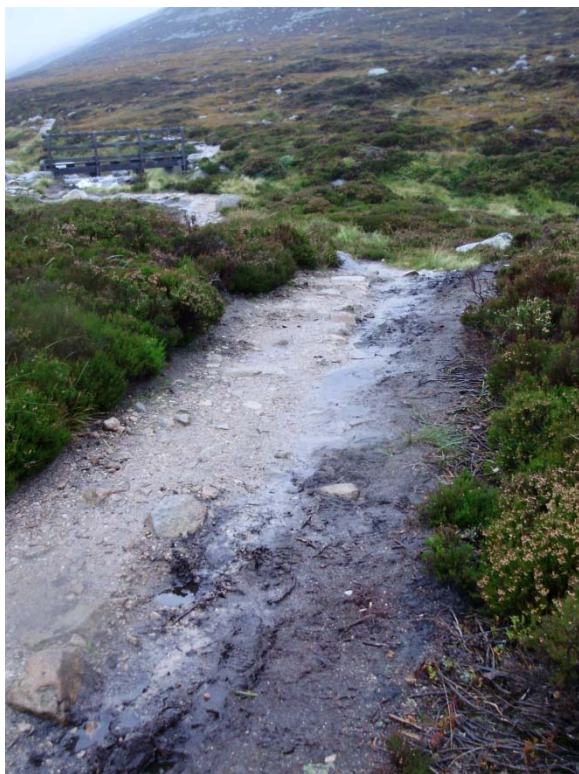
**Some repairs needed, section 5.**

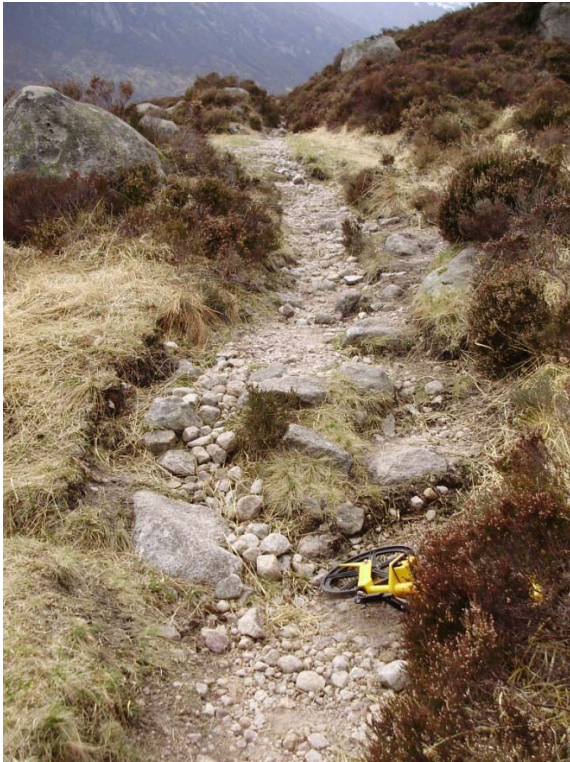
**Section 3 needs side ditch and resurfaced.**

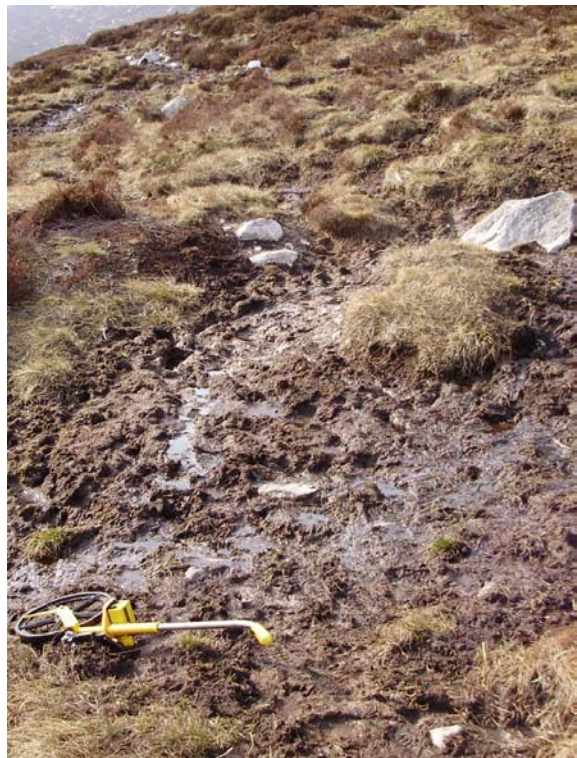
**Section 6 very wet.**

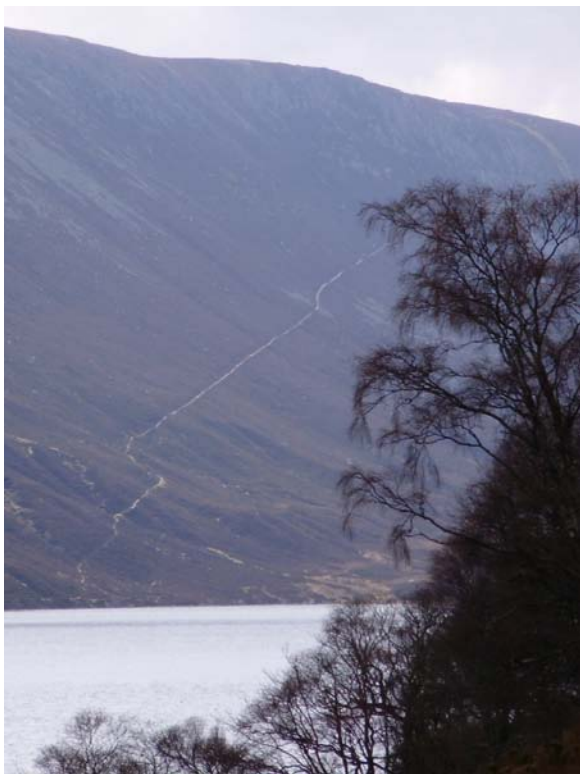
**Coirre Chash path in good condition.**

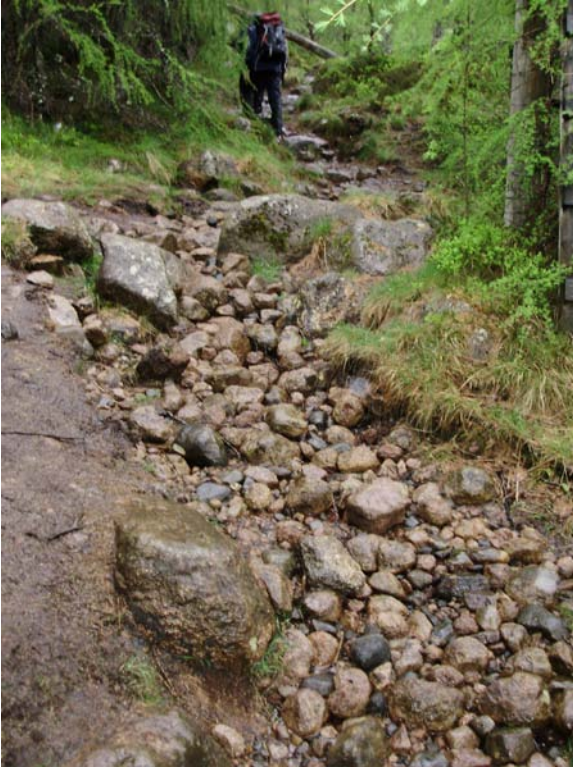
**Short section at start requires more intensive build.**

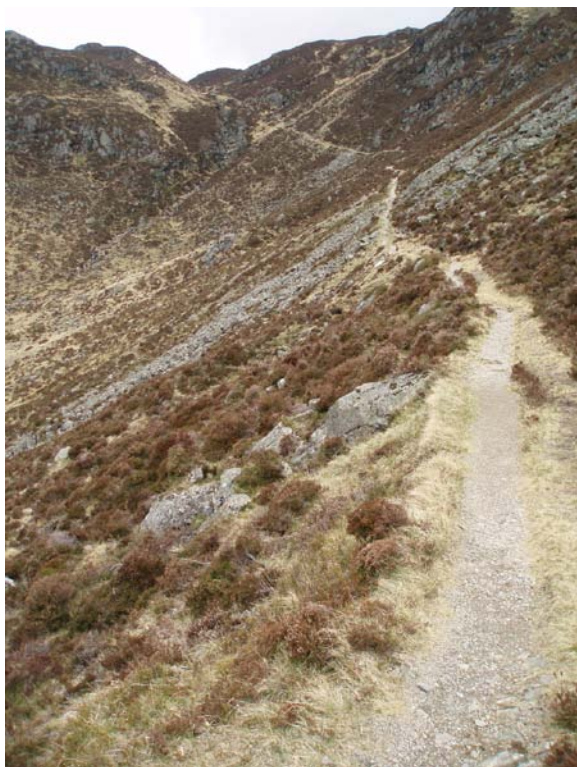
**Lower sections in good condition.**

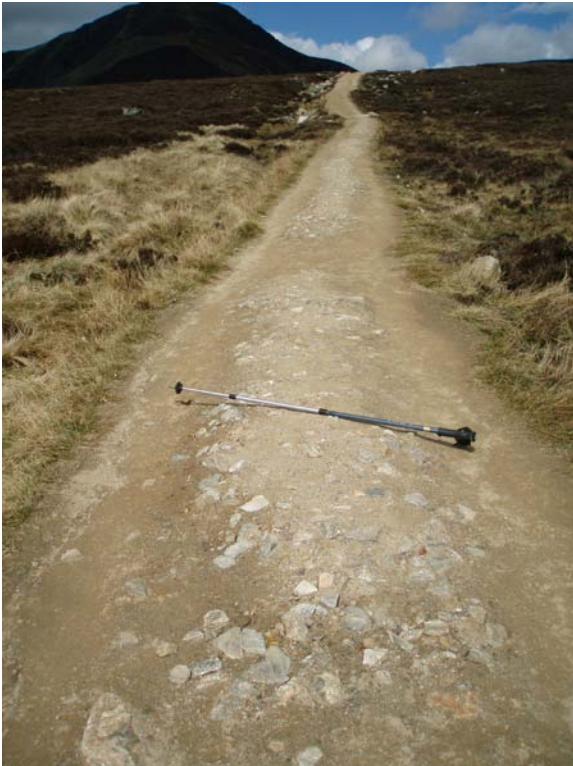
**Heavy build path in need of maintenance.**

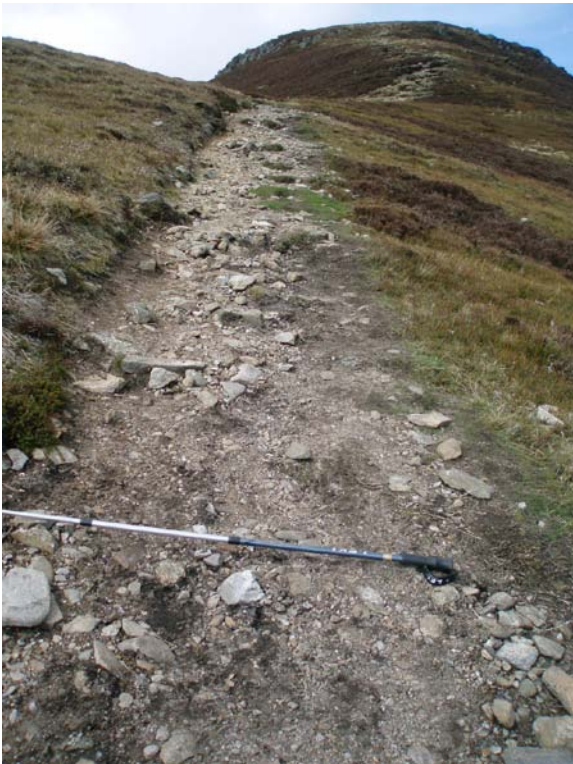
**Erosion spreading up the Snub.**

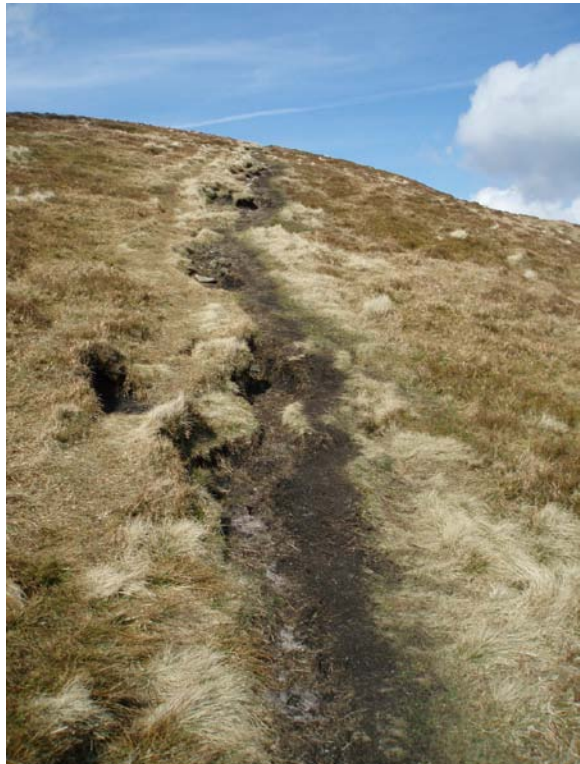
**Less trample damage at very top.**

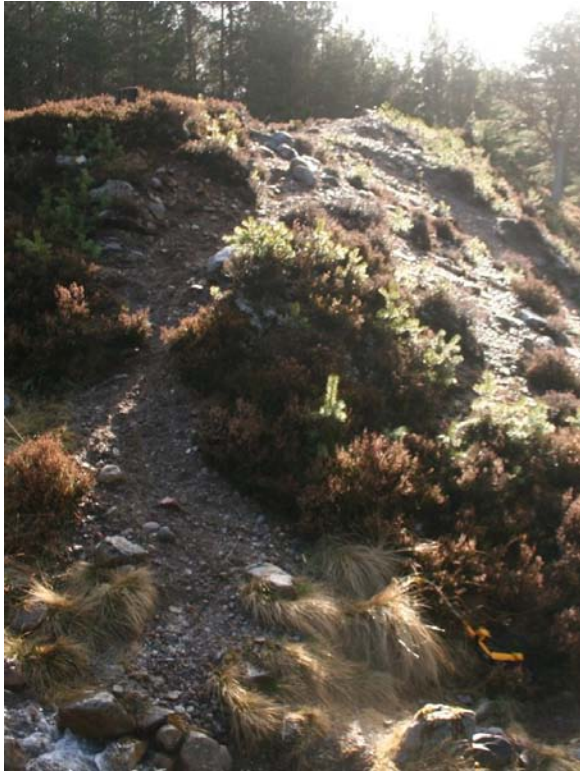
**Short section of pitching needed to protect path up moraine and define route more, section 5.**

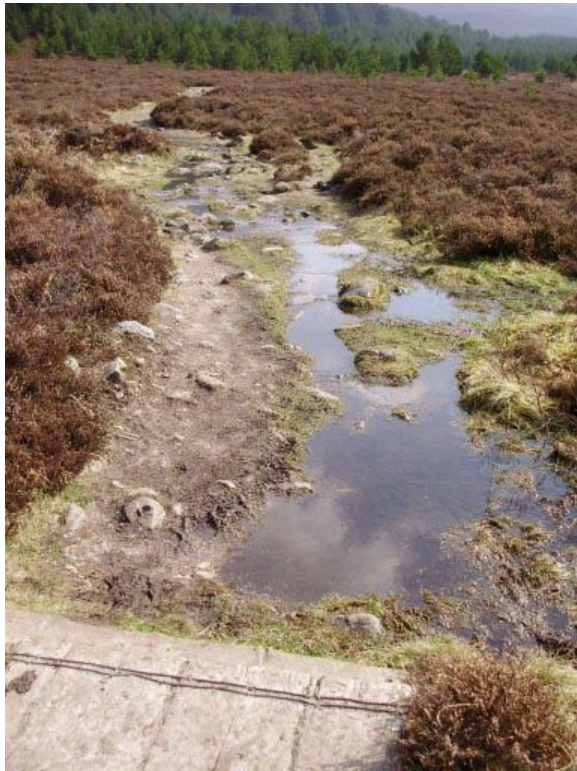
**20m stretch on section 1 needs building up.**

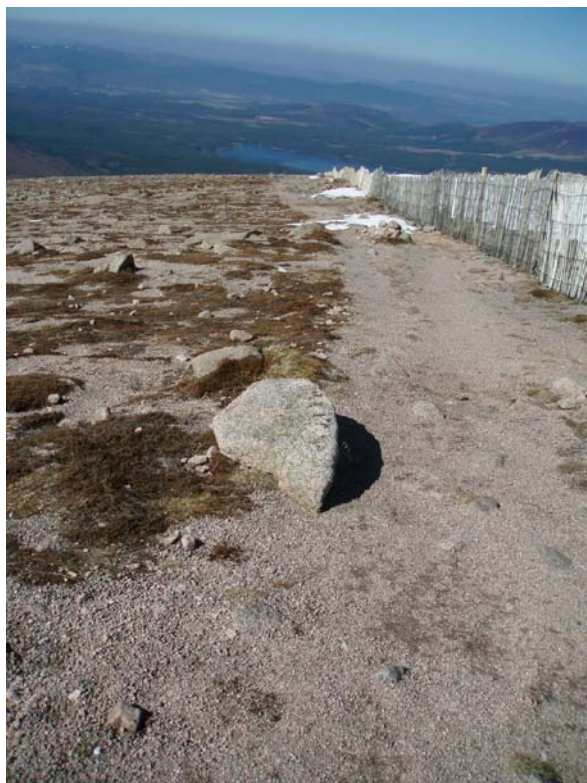
**Path spread on easier gradient.**

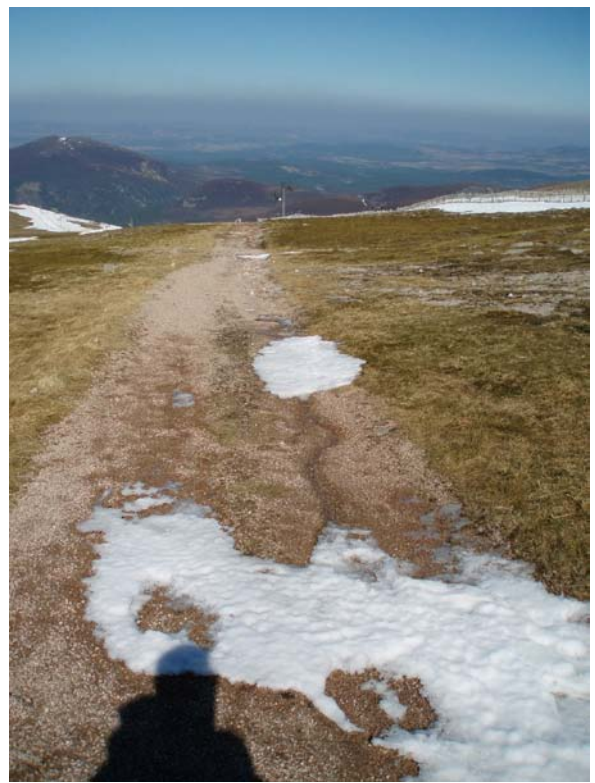
**Some rilling of loosely bound materials.**

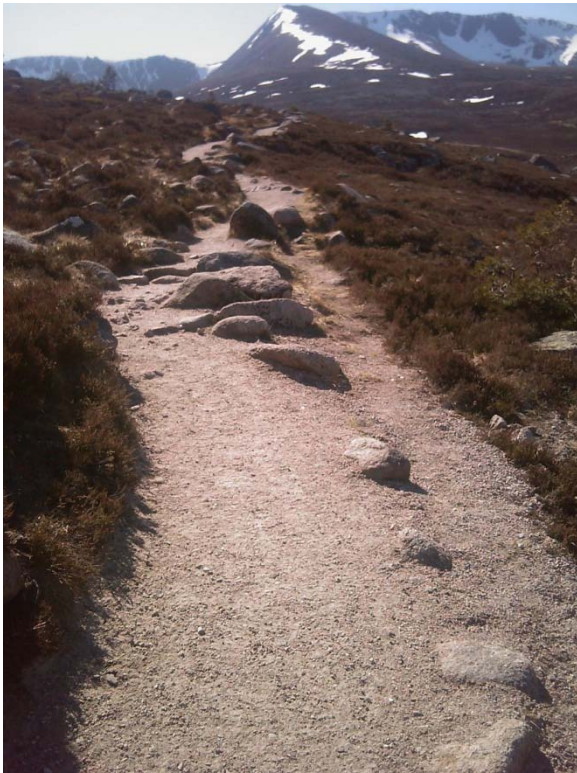
**Some maintenance of built path required.**

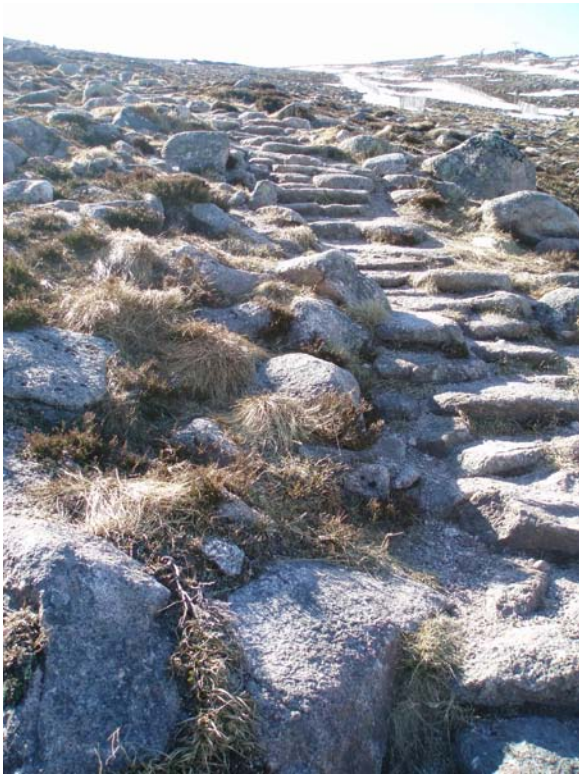
**Pitching.**

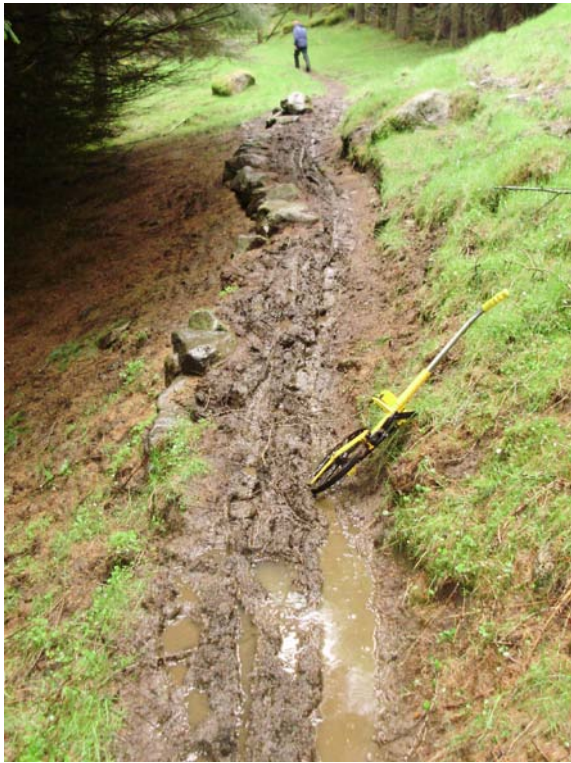
**Wet ground.**
