MacGillycuddy's Reeks Upland Path Audit 2015

Upland Path Audit, Remedial Plan and Indicative Costings

MacGillycuddy's Reeks
Mountain Path Audit 2015

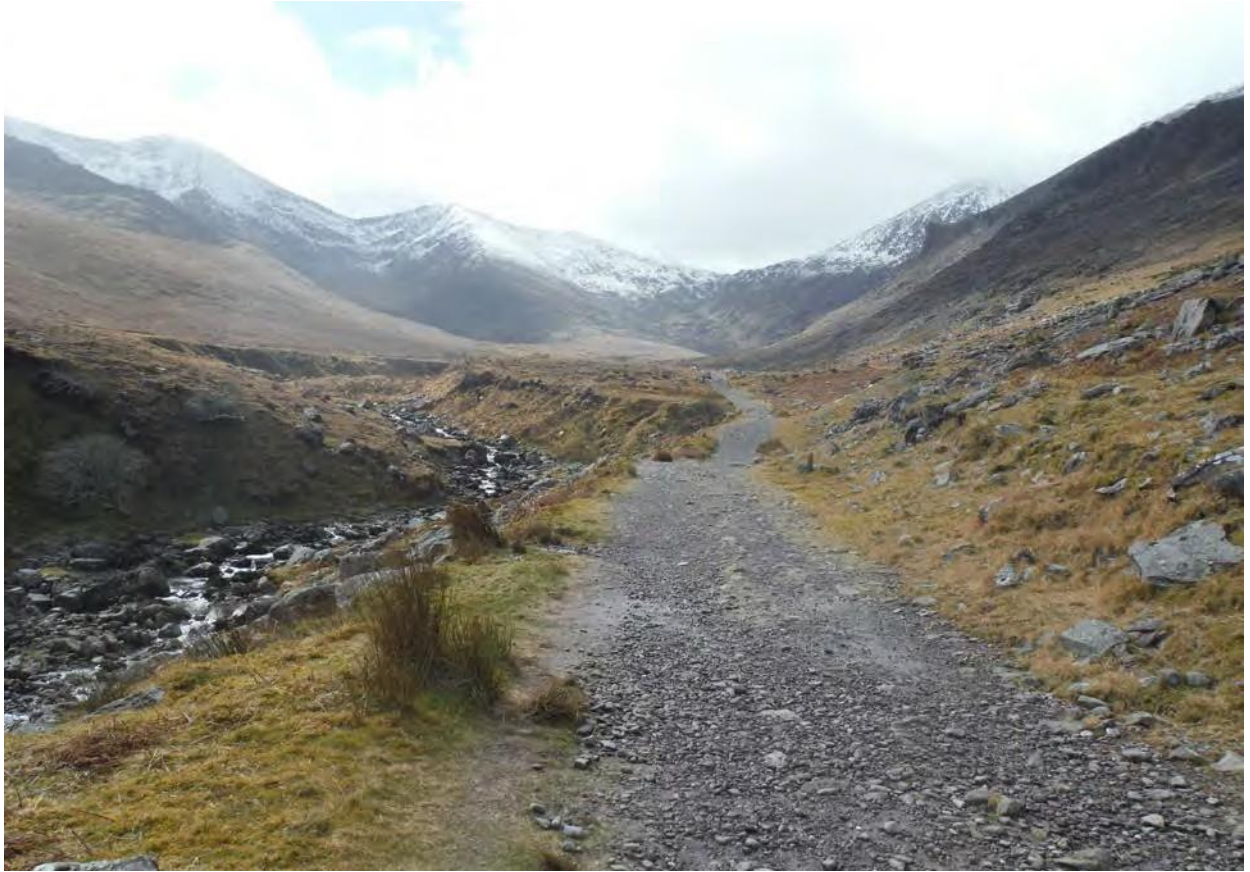
Figure 1 Lisleibane Track looking up Hags Glen

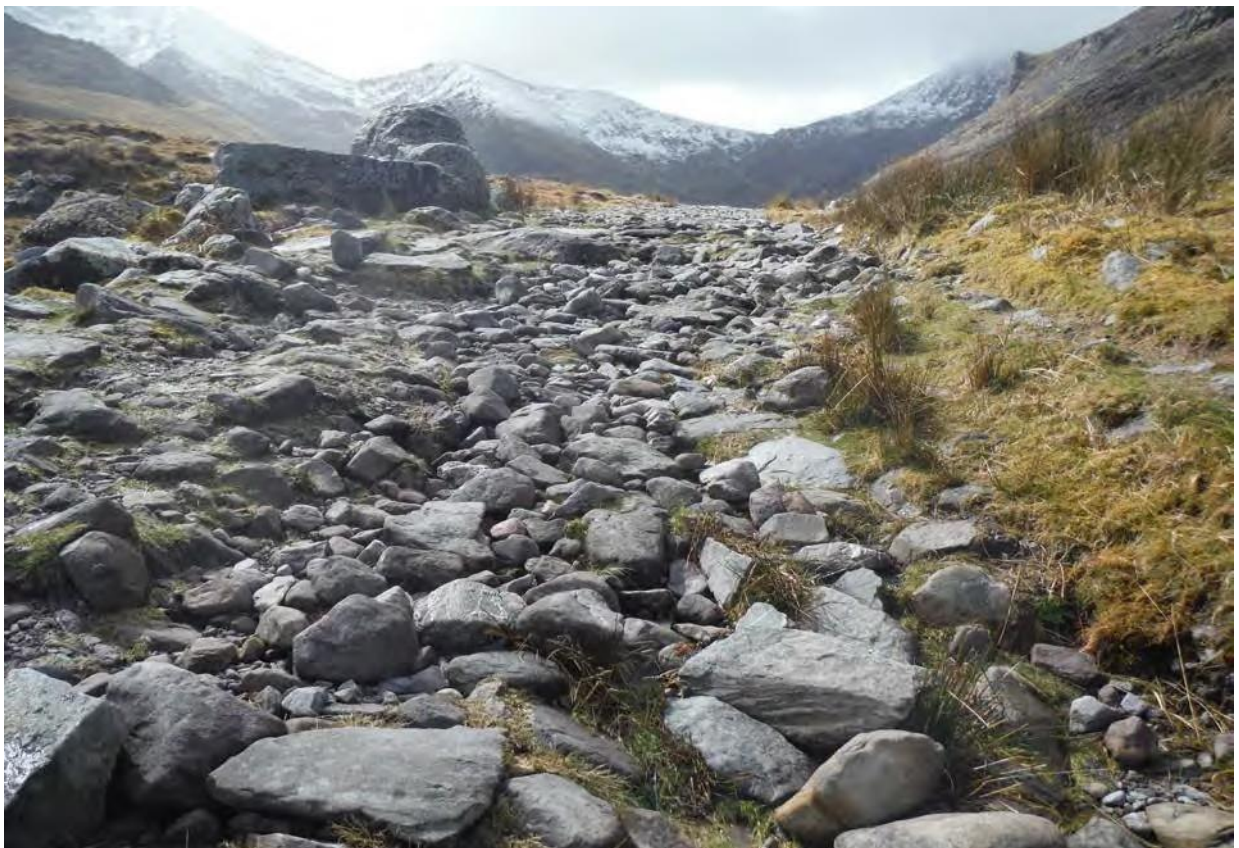
Figure 2 - Surface Loss and Drainage Problems

Track has serious drainage issues in places with integrity of surface broken and needs resurfacing and lateral drainage, plus conduits

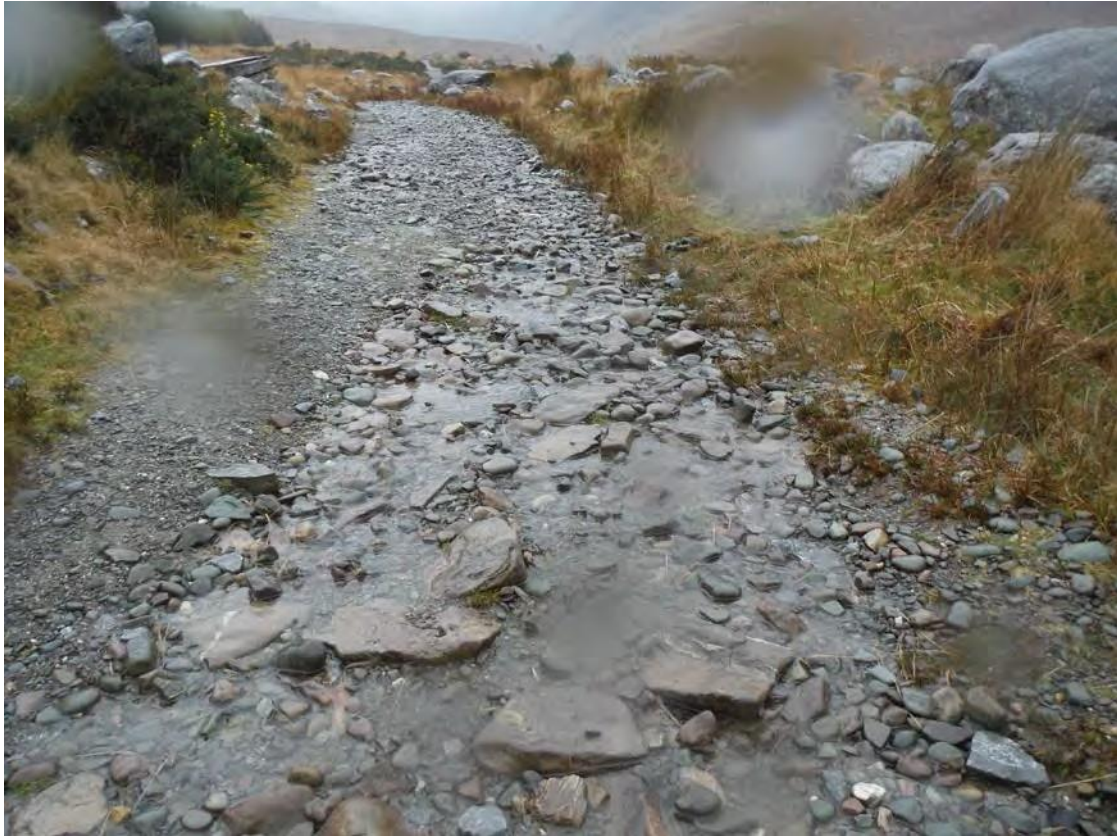
Fig 1 – Lateral Drainage required on section 1

The Path from Cronins Yard has been laid with loose burn wash. It is not very eroded but really needs lateral drainage along most of the length to protect it - machine work

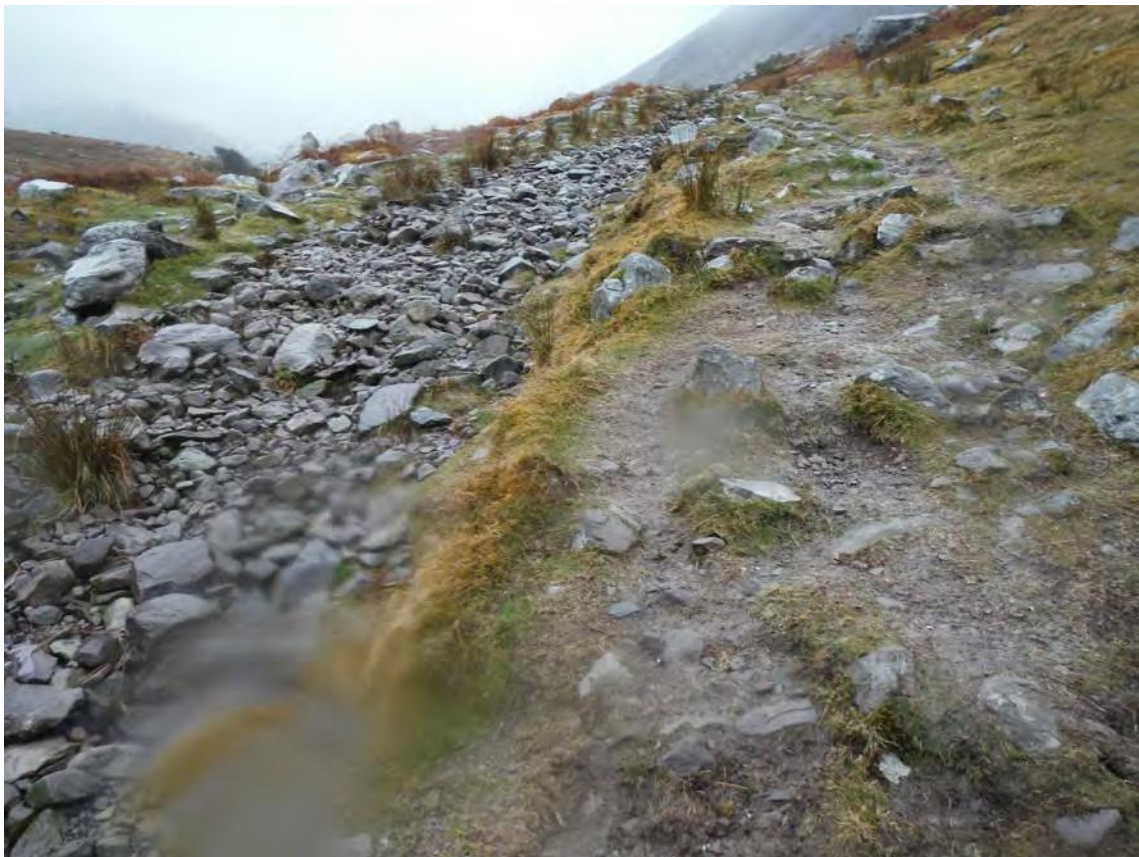
Figure 2 – Badly eroded path at Section 3

The path from Cronins is mostly built using loose pebble aggregate. Sections 1 and 2 could really do with lateral ditching for most of the way to protect what is there Section 3 is badly eroded and needs built completely by hand

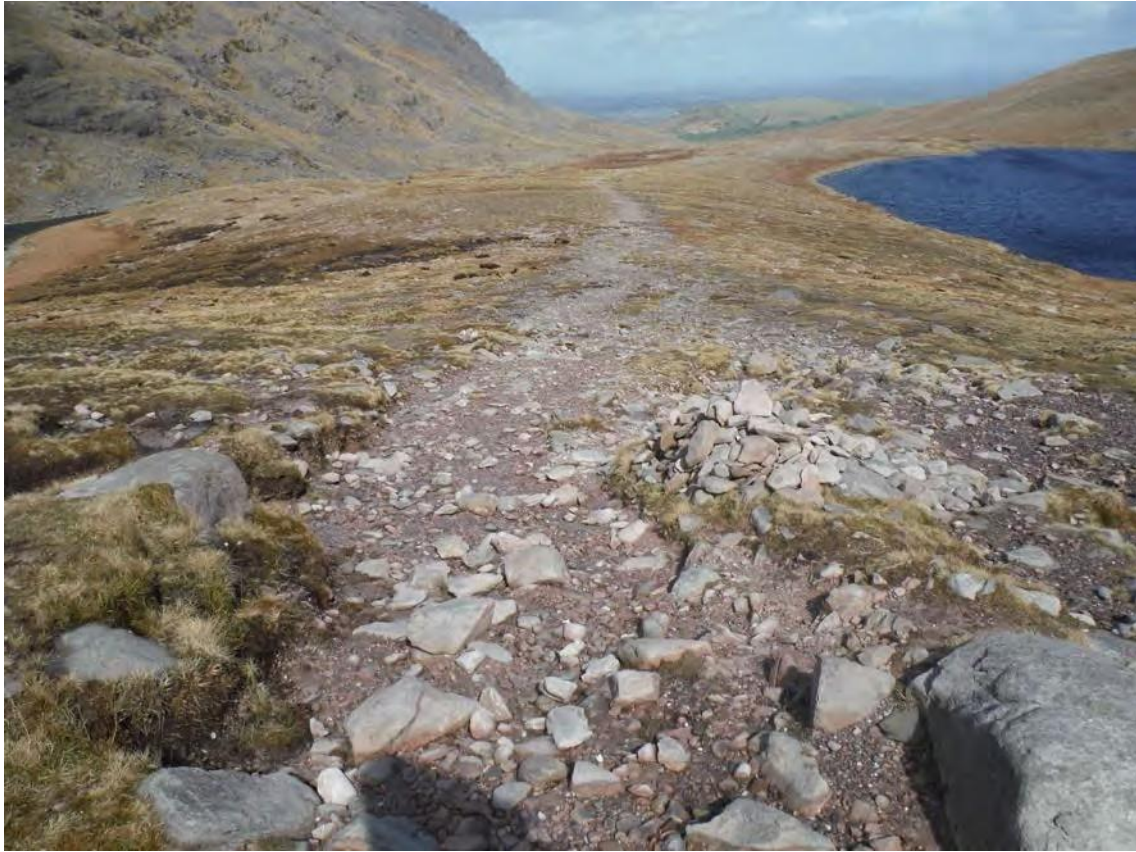
<p>Path Condition:</p> <ul style="list-style-type: none">• The Track is badly eroded, with damage to habitat spread up to 20 meters wide, as people try to avoid the roughest and wettest parts• Whilst most of the erosion is due to ‘path spread’ on what is mostly a robust environment, there is a short steep section in the middle with severe gullyng.• The upper section is more robust on the whole with an intact contained path going through boulder fields, with peat erosion in between.				
<p>Recommendations:</p> <ul style="list-style-type: none">• Most of the site is accessible by machine, and if used sensitively a ‘high and dry’ machine built solution would make a huge difference, with recovery of the habitat on the desired line likely to be quite rapid at that elevation in comparison with higher up the hill.• The upper sections would need to be done by hand, and would consist of light touch definition works, with some path building and drainage works in the wet peaty sections

Fig 1 – Path Spread on section 1

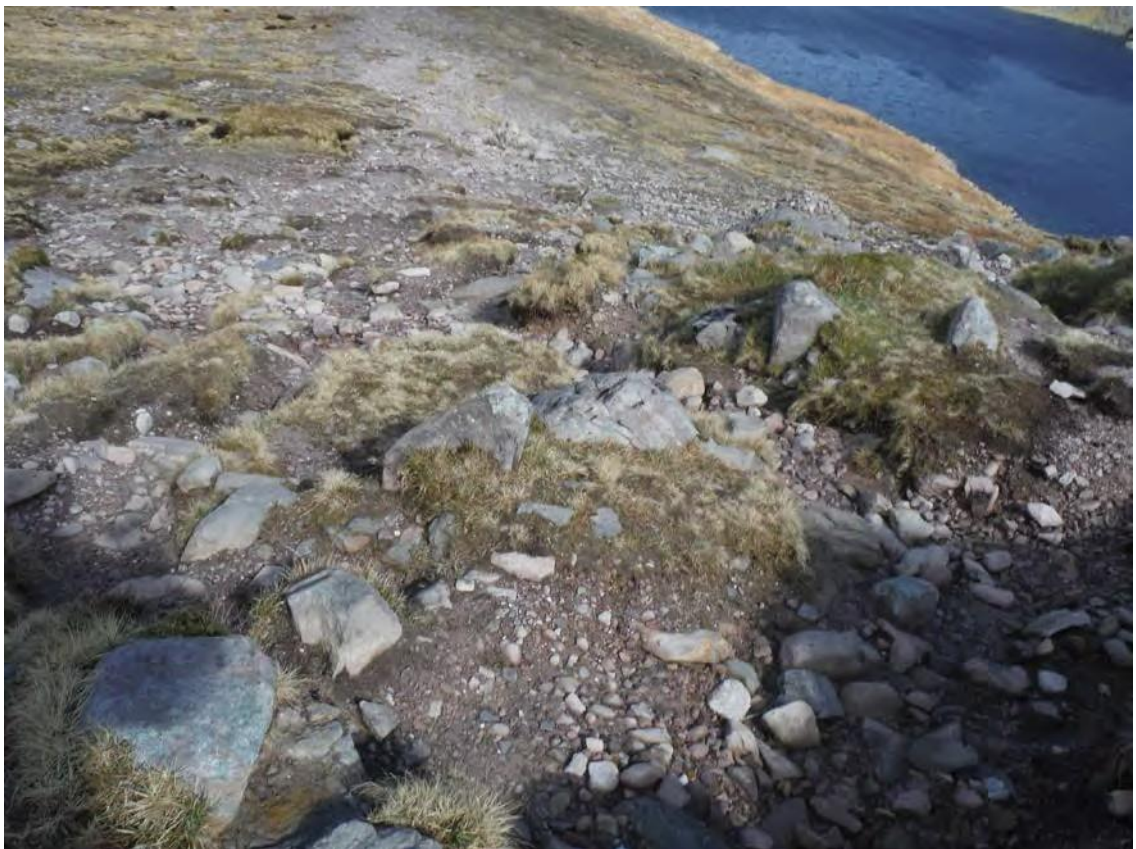
Figure 2 – Gullied Section

Wide erosion on steepening slope, with some severe gully in places
Needs full Hand Build to repair - good availability of materials

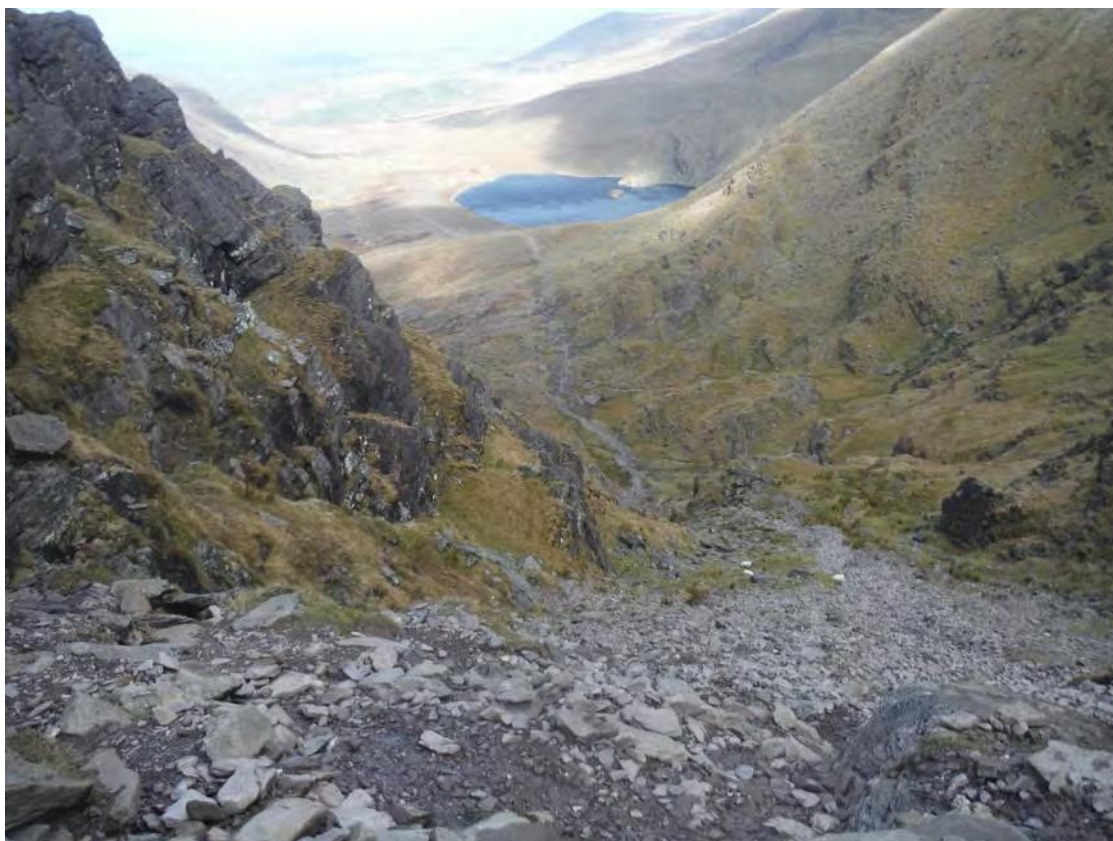
Fig 1 – Looking down the damaged path to Hag's Glen

Boulder scree with multiple routes and a lot of erosion and gullyng
Full Build hand build repairs required, pitching revetment and alignment

<p>Recommendations:</p> <ul style="list-style-type: none">• The path can be repaired borrowing techniques tried and tested in the Highlands of Scotland. A mixture of careful definition, substantial revetment and mixed pitched and aggregate path would provide a sustainable route to the summit ridge that was in keeping with the surrounding environment• The site is extremely challenging, with works likely to be based on similar styles achieved (over time) in Glencoe and Torridon in the Scottish Highlands. This is work for people with expertise in this technical upland path work only, and should not be attempted by workers without a good deal of experience, technical ability and a proven track record on handling health and safety in such a contained and steep site! If a local work force had built up experience on other paths in the area first then after a year or two they may be ready to tackle it

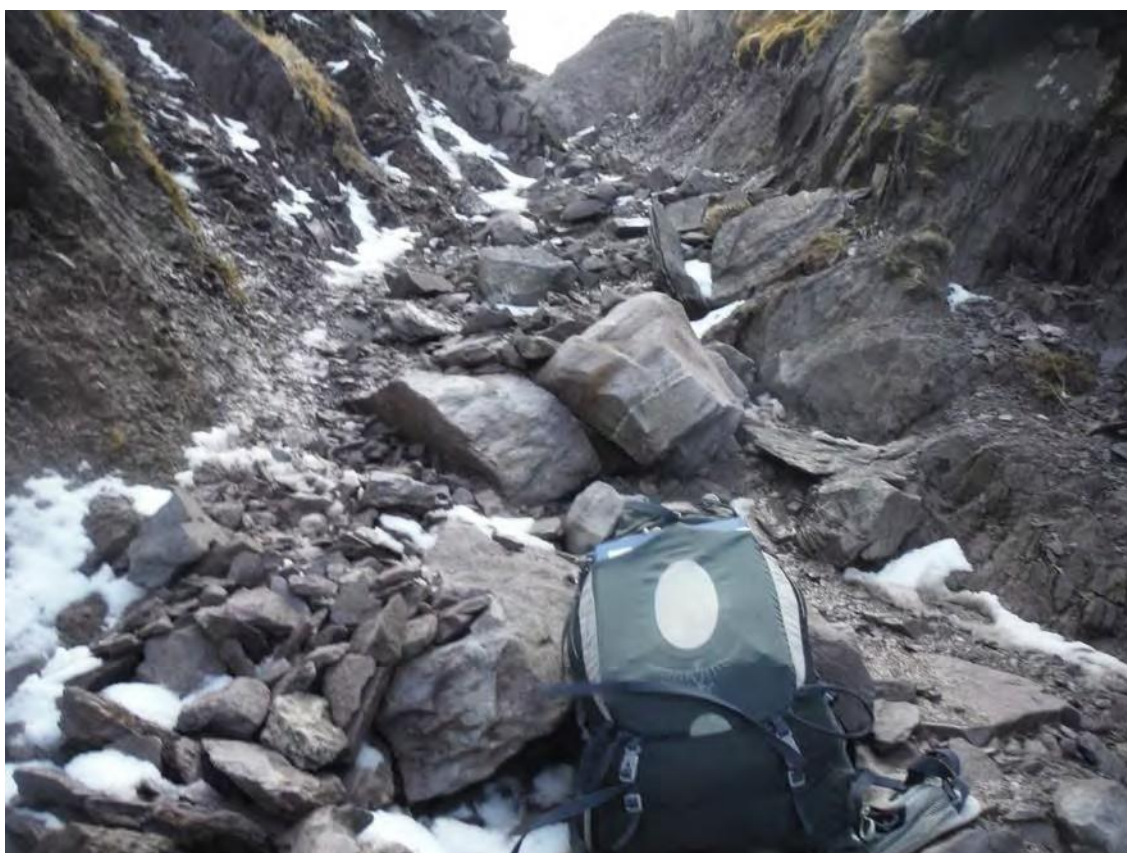
Figure 2 – Severe Gullying beneath the Summit Ridge

Badly gullied steep approach to the ridge with multiple paths,
loose debris and deep gullyng. Full Build hand-build path required

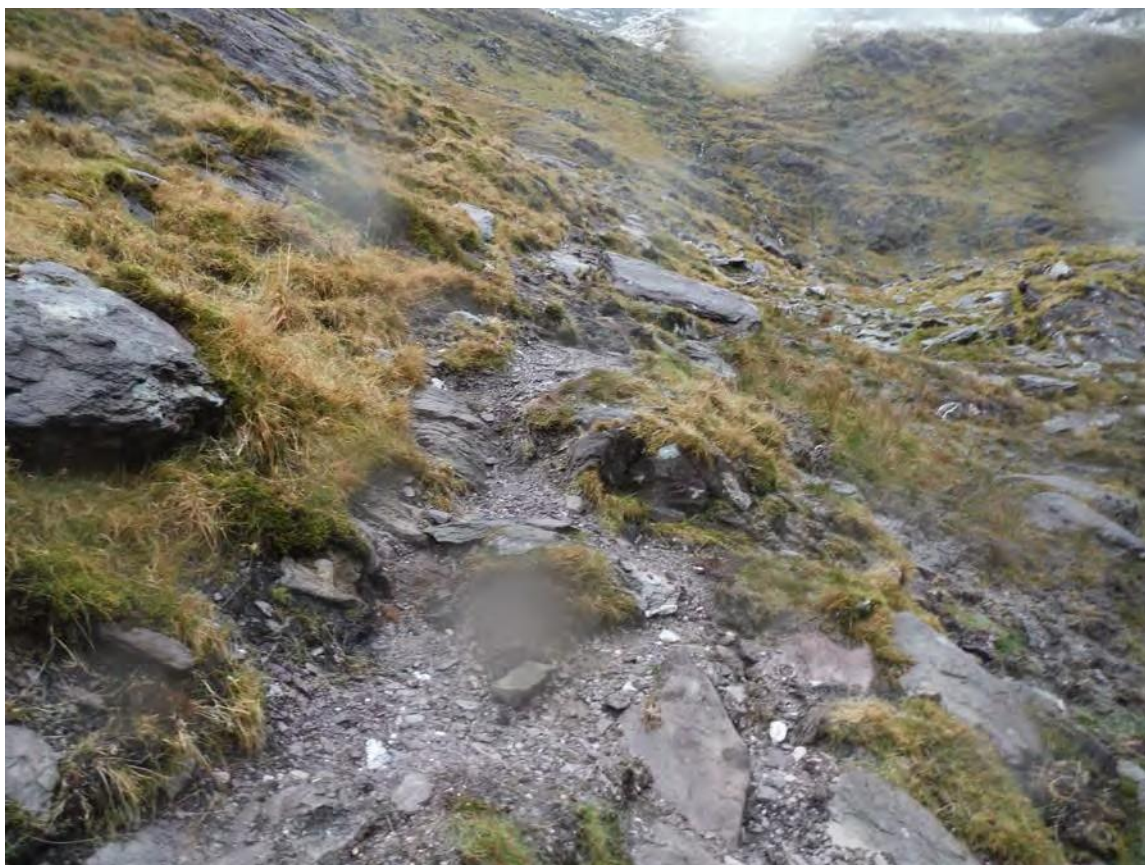
Fig 1 – Erosion on Section 1

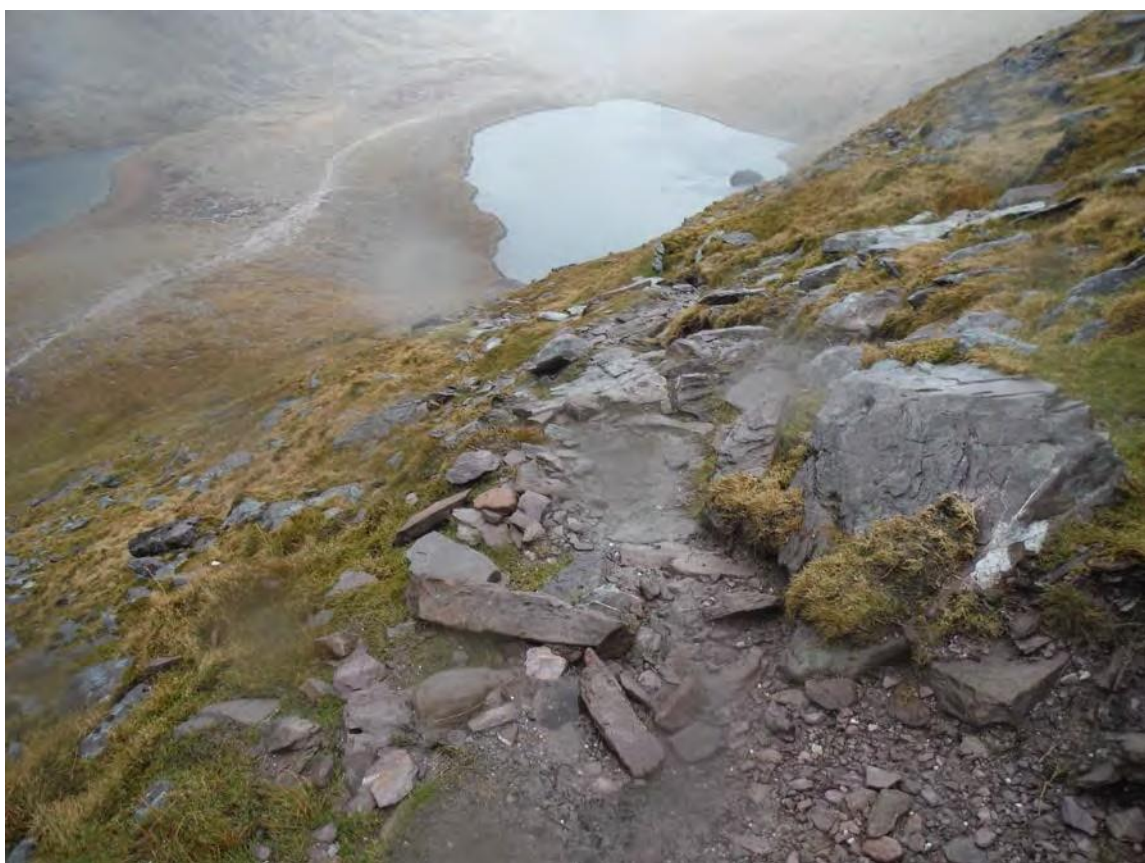
Figure 2 – Narrow path traversing the slope

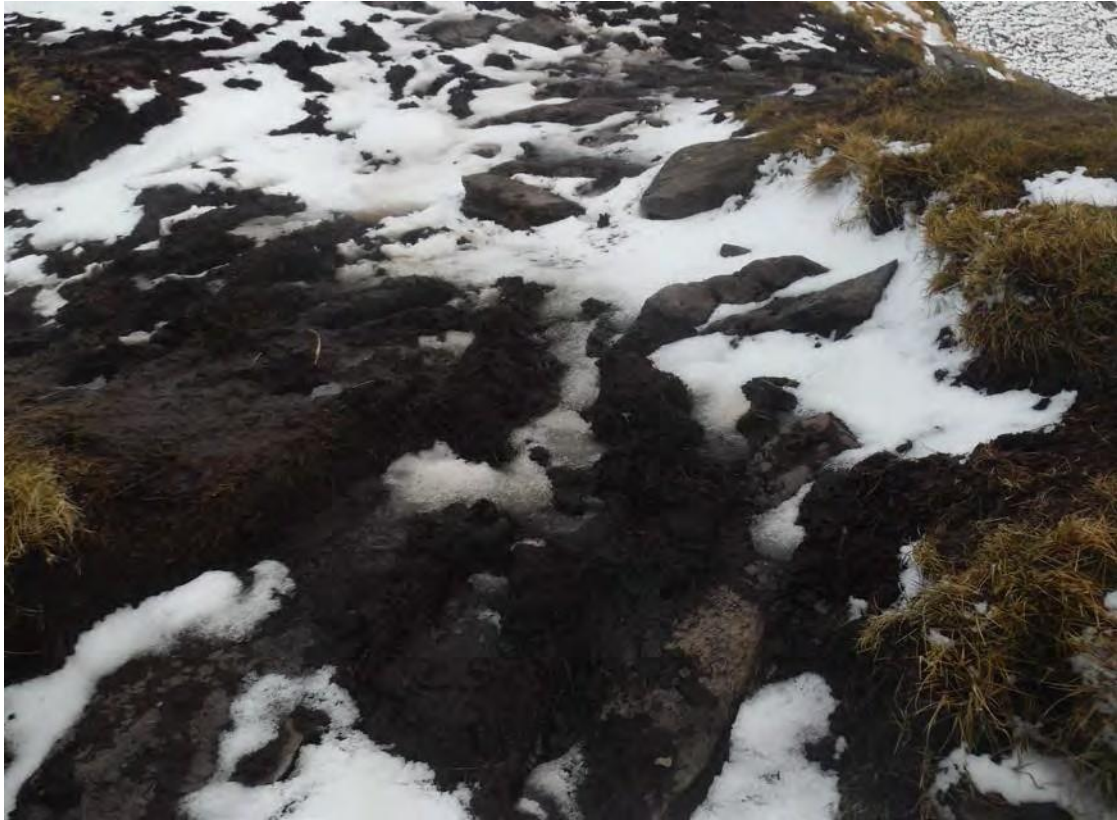
Fig 1 – Peat erosion on the ridge at Section 1

Peaty wet track from top of Zig Zag to top of Devils Ladder. Light touch and pre-emptive works would prevent further deterioration without any intensive works

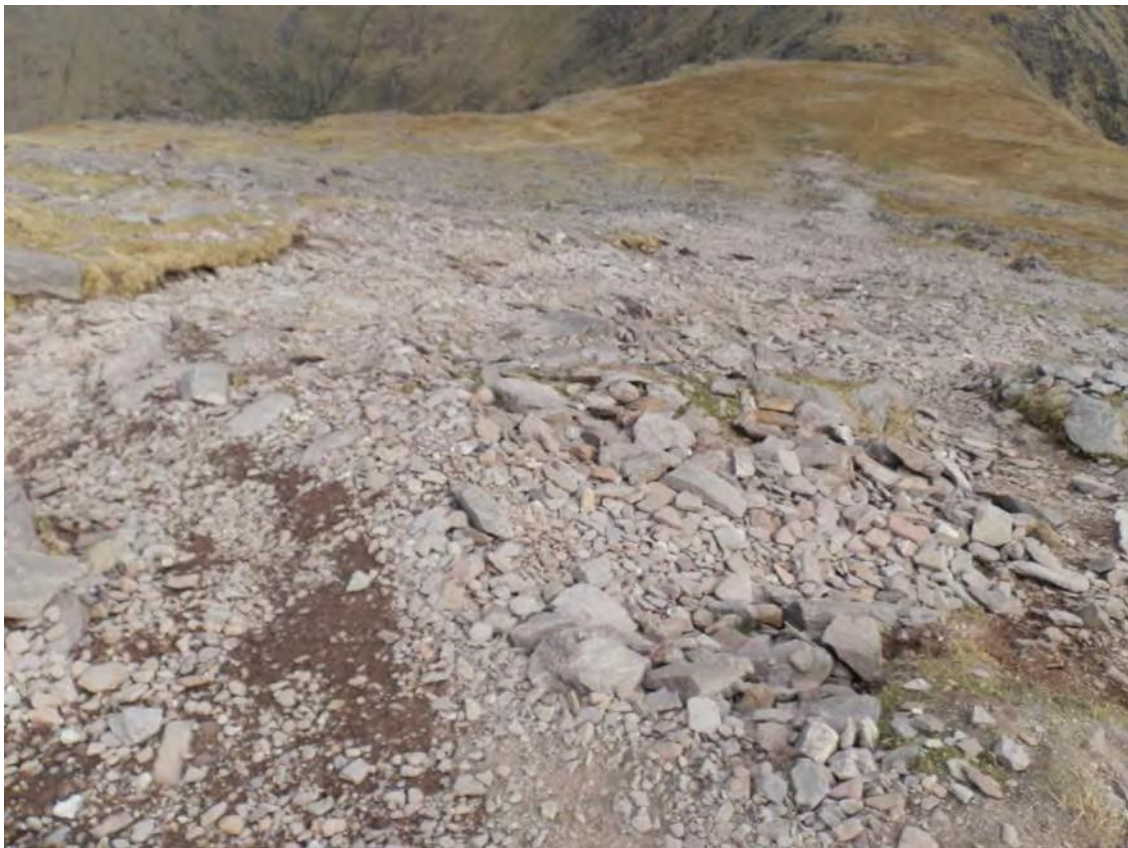
Figure 2 – The approach to Carrauntoohil is becoming spread out with a number of paths and braids

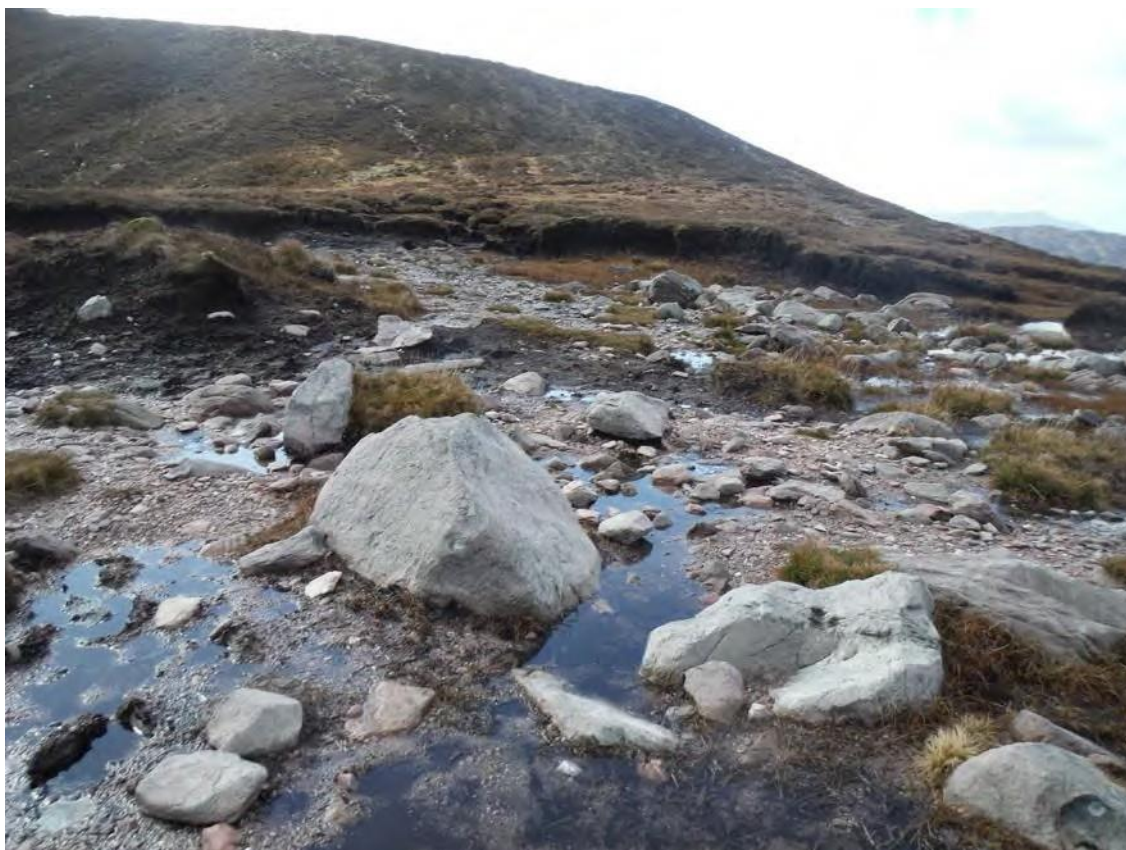
Fig 1 – One of the numerous paths through the peat hags at Section 1

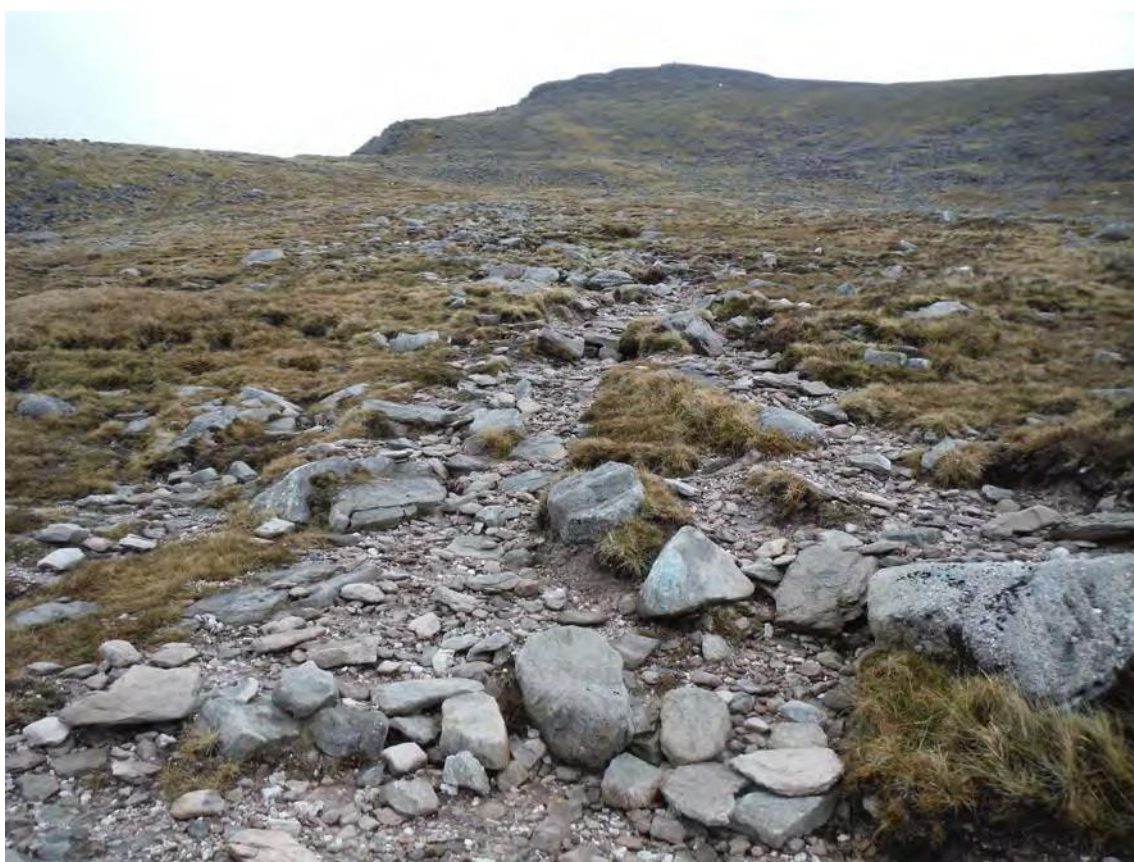
Figure 2 – Small scale path erosion and spread on the summit approach

summit approach on steepening ground worn and spreading
some light touch work here would save a lot of work in future years

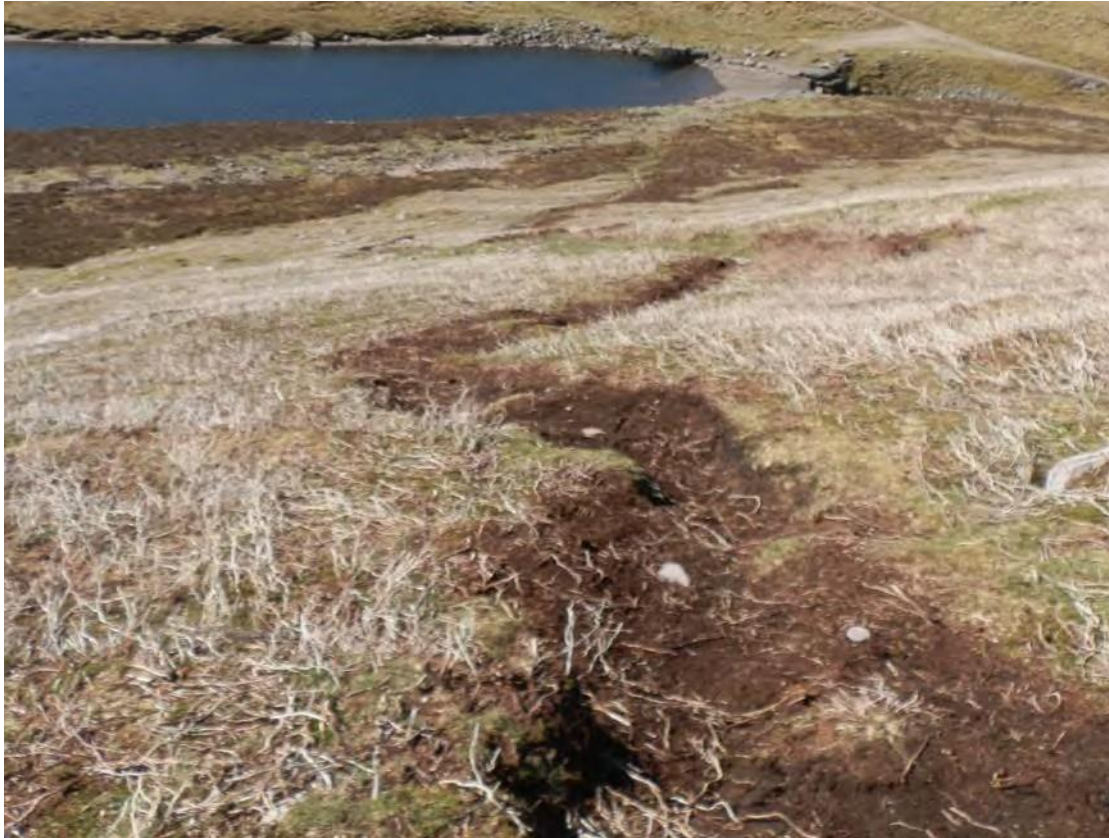
Fig 1 – Narrow peaty path at section 1

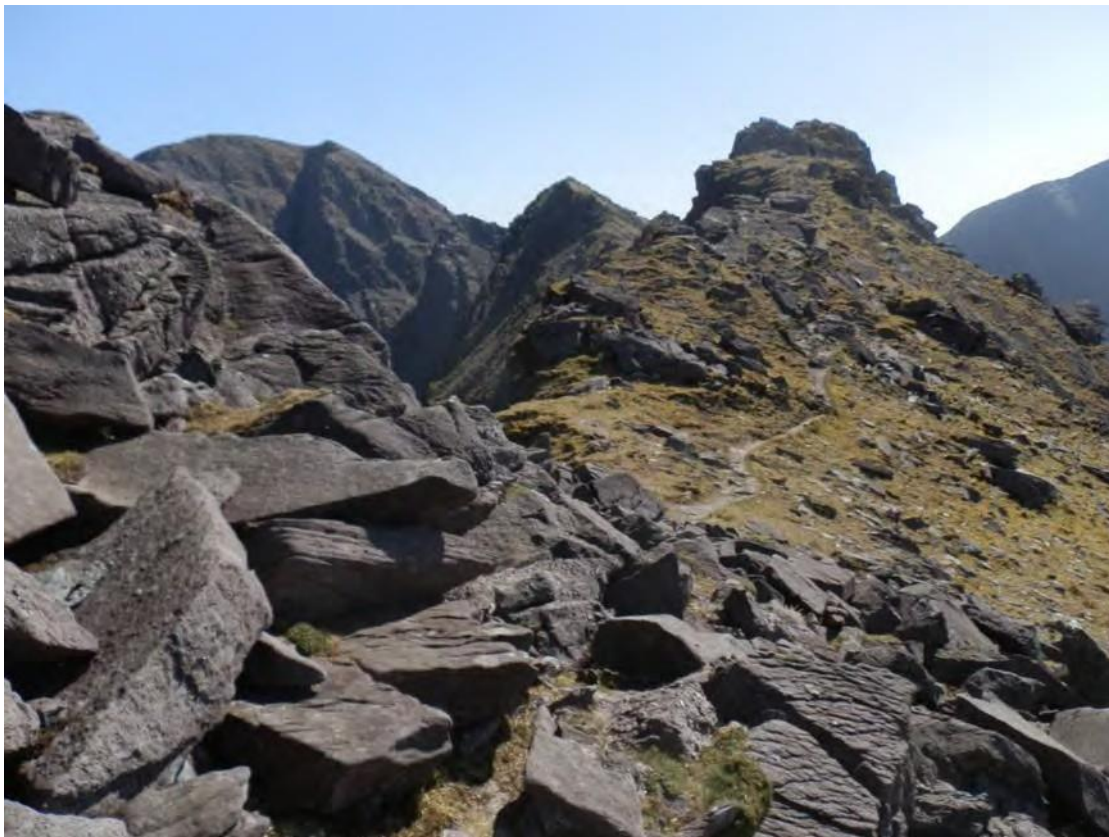
Figure 2 – Narrow and robust approach Ridge path

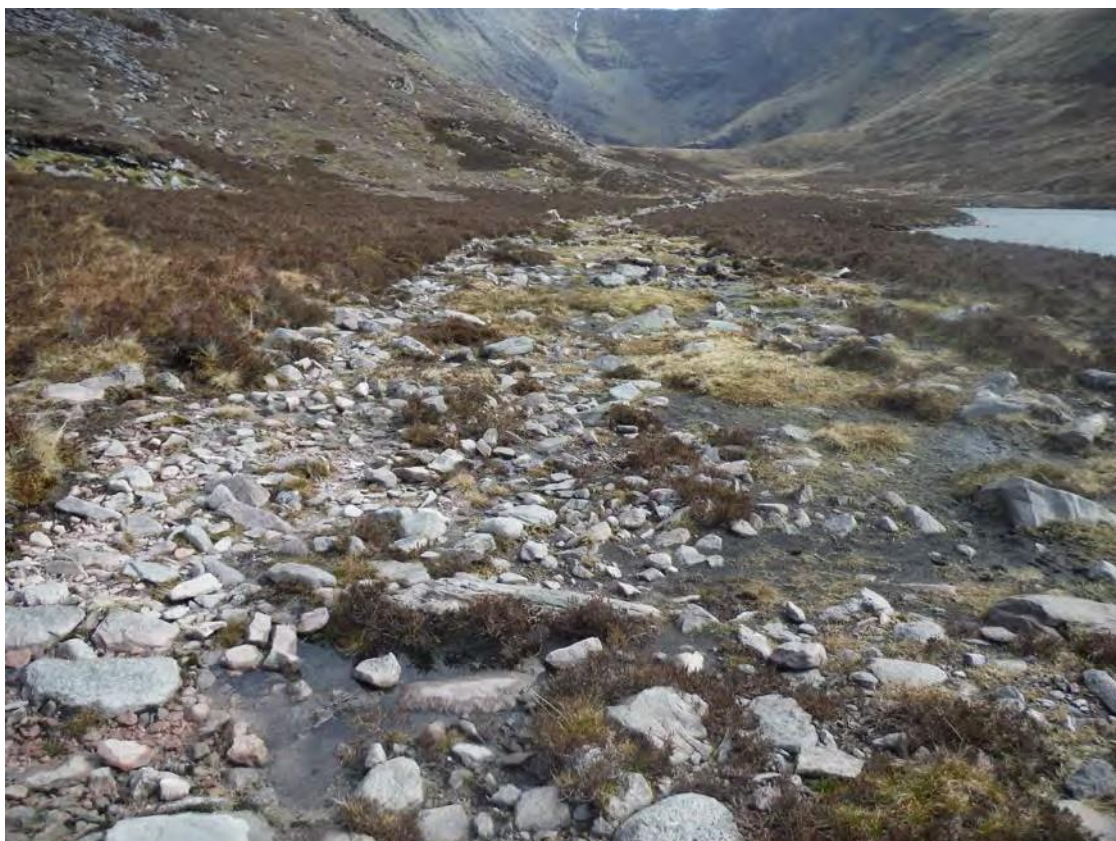
Fig 1 – Worn spread out path on section 1

Worn and spreading path from dam, robust but very wet in places and widening
Full Build machine constructed path, raised Hi and Dry with soil inversion

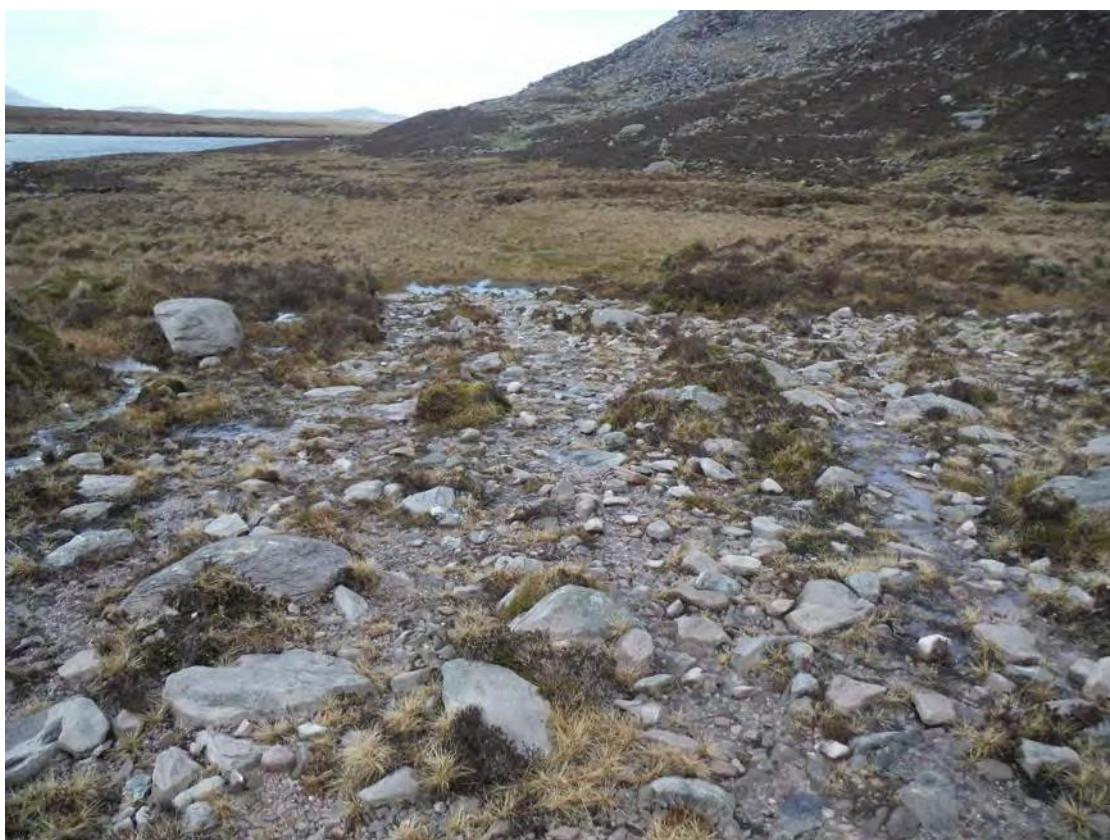
Figure 2 – Spread erosion approaching the Lough

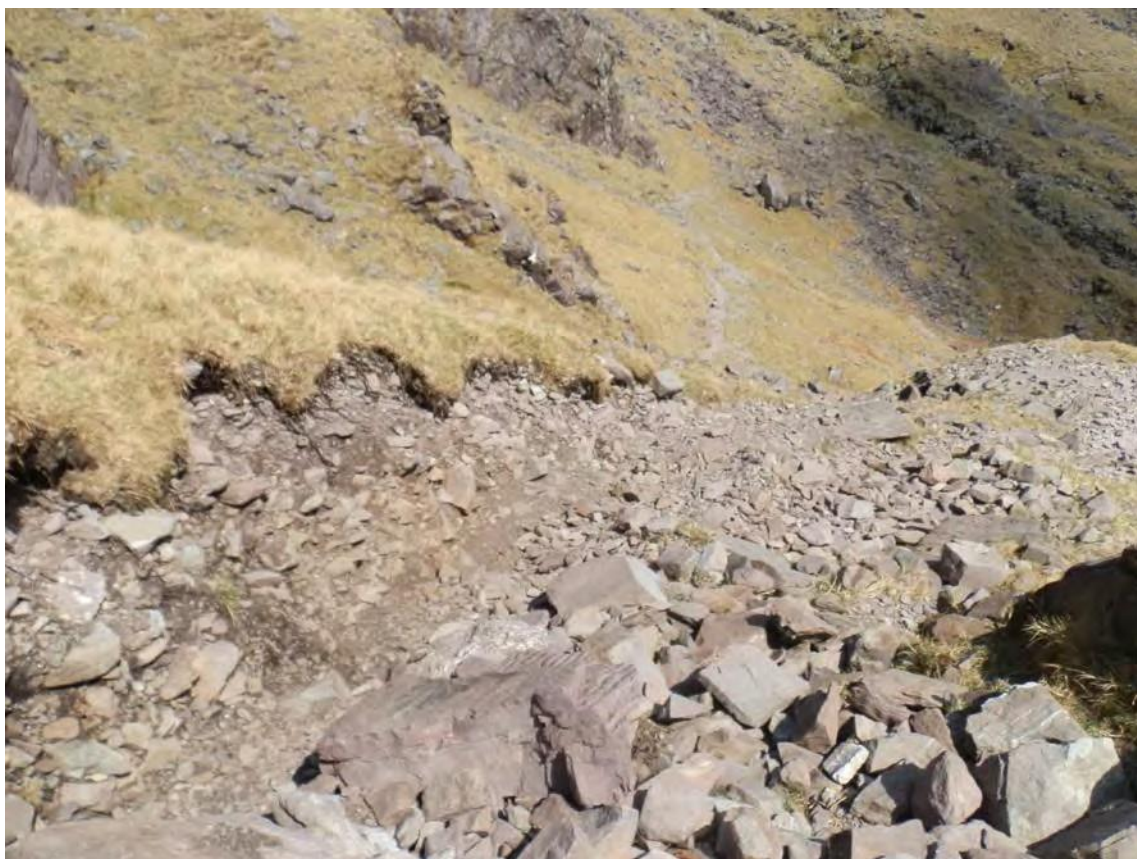
Fig 1 – Localised erosion approaching the first bedrock 'step'

<p>Recommendations:</p> <ul style="list-style-type: none">The path can be repaired with short sections of upgrade at the few places where the path is vulnerable and eroding. Light touch and pre-emptive techniques could be utilised well on this site to address immediate erosion and prevent the further deterioration that seems inevitable.				
<p>Maintenance:</p> <p>The path will require a few days pre-emptive and maintenance work to prevent future deterioration on an annual basis.</p>

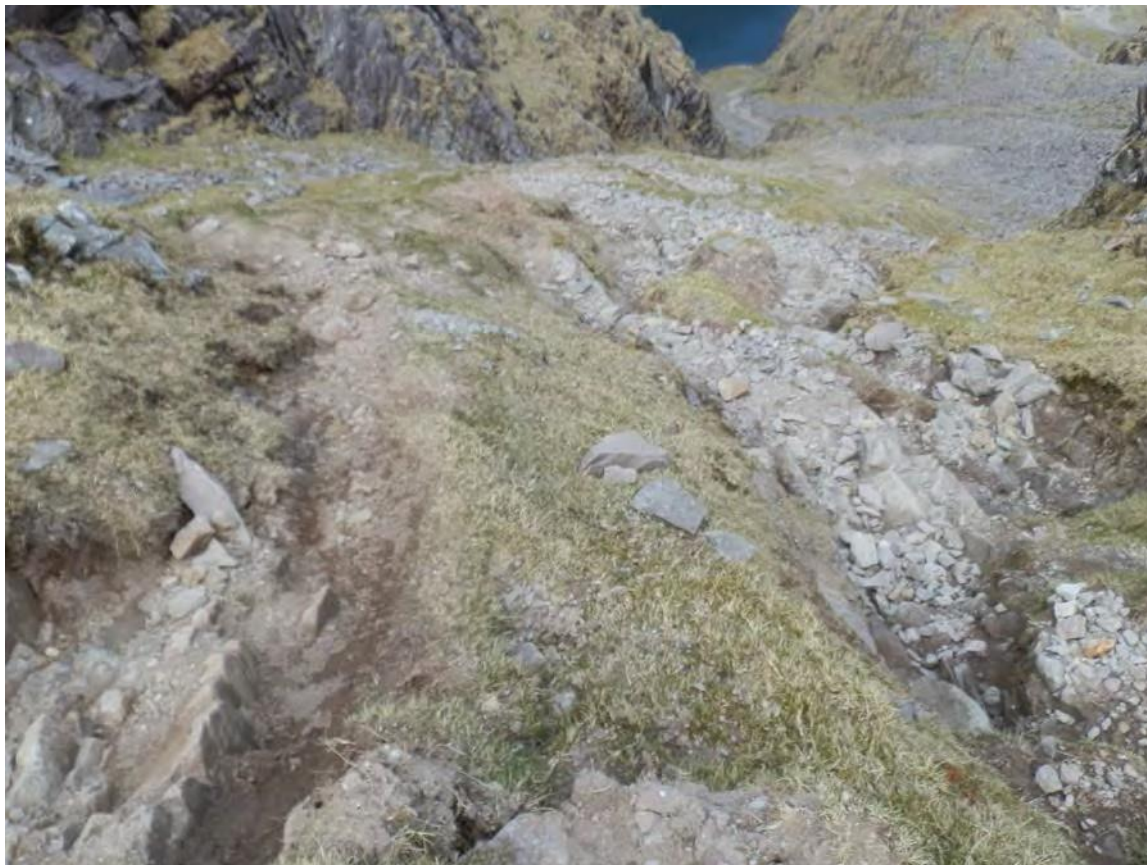
Figure 2 – Gullying on the vulnerable final approach to the summit ridge

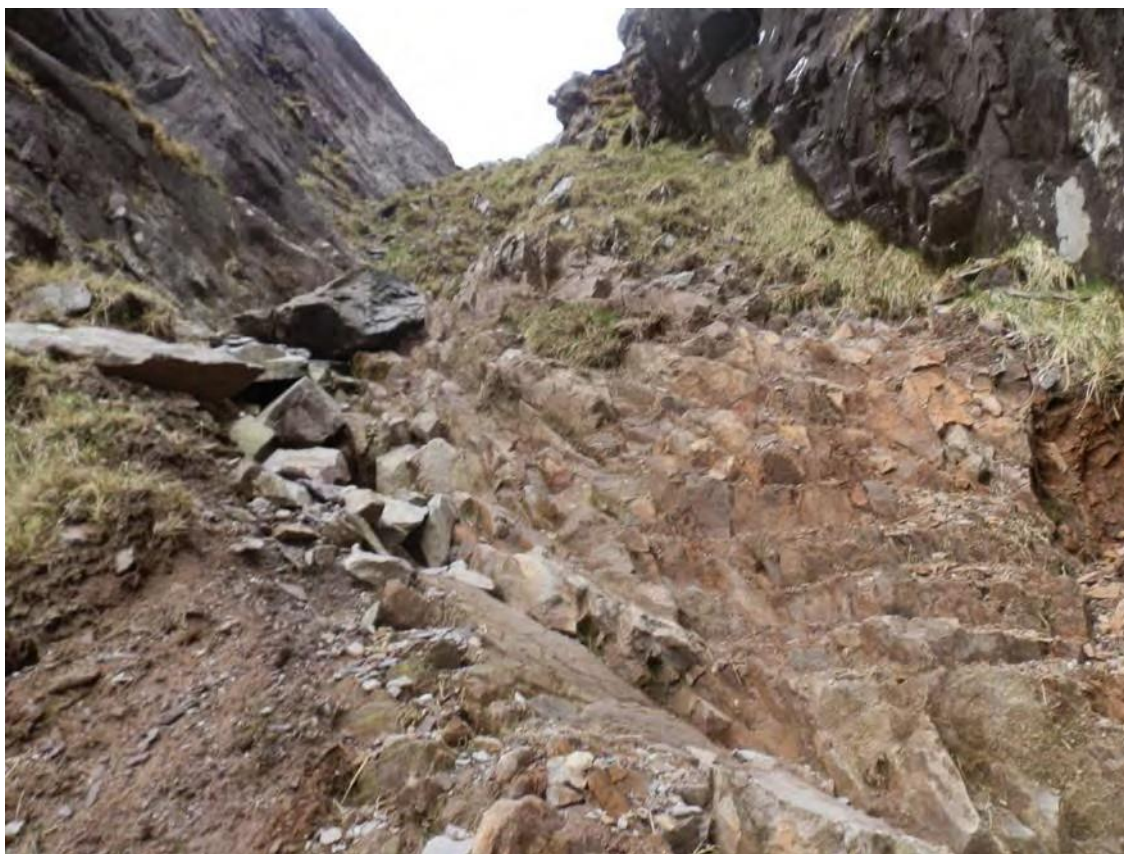
Fig 1 – Localised erosion around the bedrock 'step'

<p>Recommendations:</p> <ul style="list-style-type: none">The path can be repaired with short sections of upgrade at the few places where the path is vulnerable and eroding. Light touch and pre-emptive techniques could be utilised well on this site to address immediate erosion and prevent the further deterioration that might require heavier intervention in the future.				
<p>Maintenance:</p> <p>The path will require a few days pre-emptive and maintenance work to prevent future deterioration on an annual basis.</p>

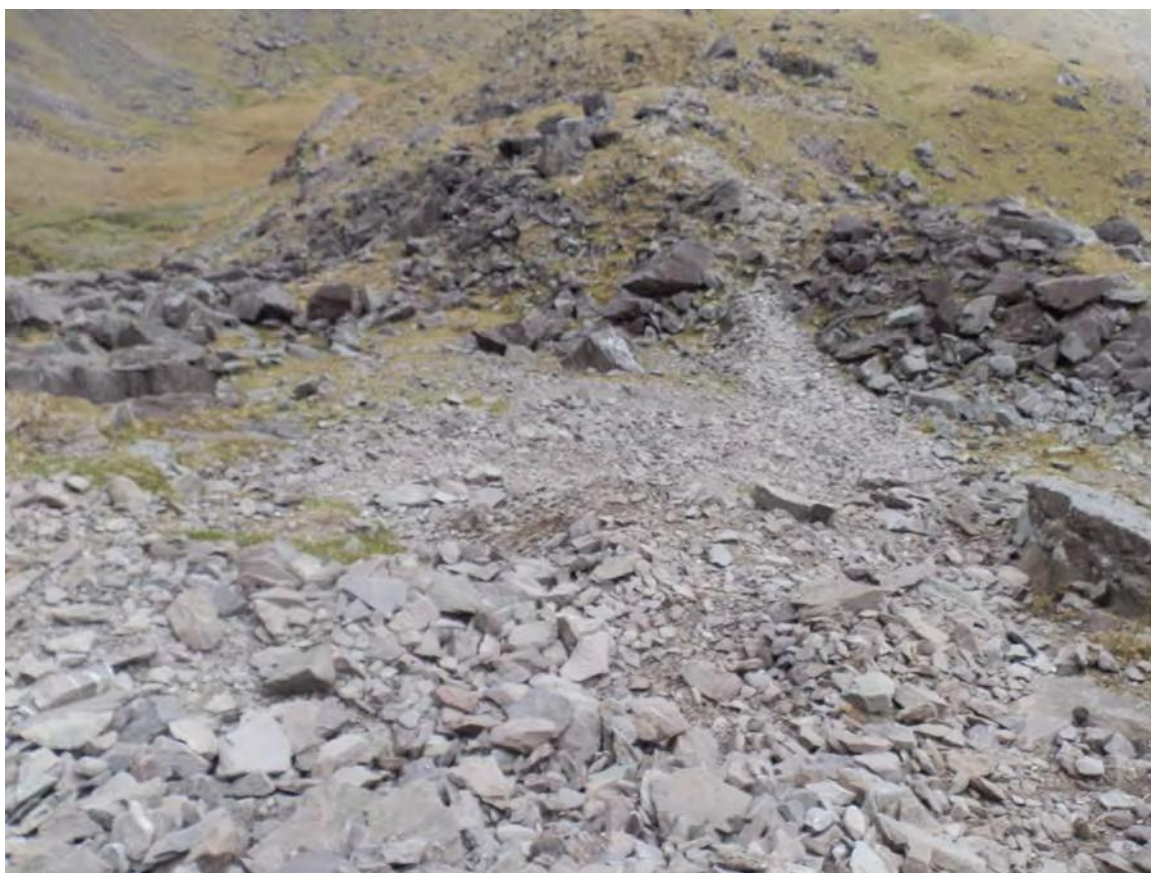
Figure 2 – Scree chute at section 3
