MacGillycuddy's Reeks Upland Path Audit 2015

Upland Path Audit, Remedial Plan and Indicative Costings

MacGillycuddy's Reeks
Mountain Path Audit 2015

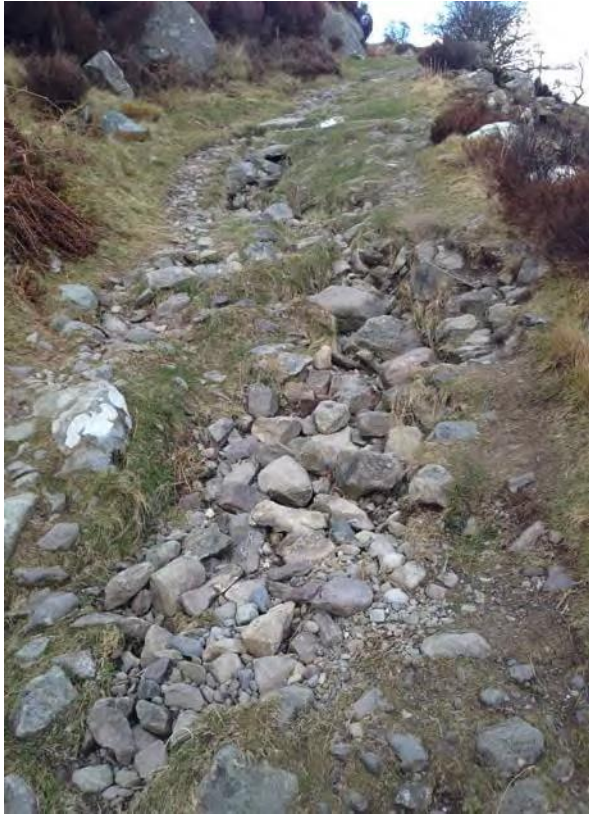
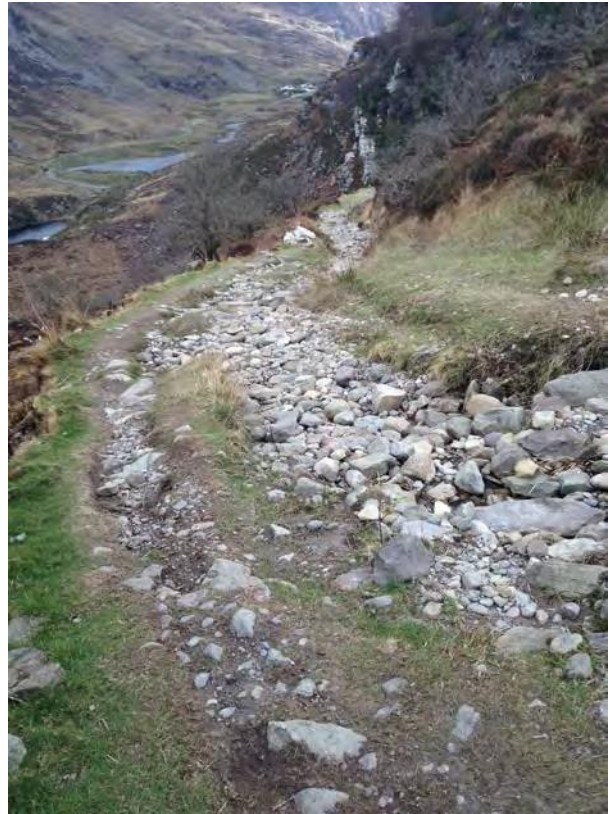
Figure 1 and 2 – Built surface breaking down on zig zags due to collapse of drainage systems

<p>Recommendations:</p> <ul style="list-style-type: none">• Drainage repair to the existing track, including excavation of lateral drains, construction of cross drains and water bars would largely preserve the track for future use. Lost surfacing could then be replaced.• Extension of the path to the viewpoint would narrow erosion on the developing path, and provide a very good alternative walk for people who do not necessarily wish to climb Carrauntoohil but with to experience the mountains and the area, especially if promoted.				
<p>Maintenance:</p> <p>Regular maintenance will be required once work has been completed.</p>

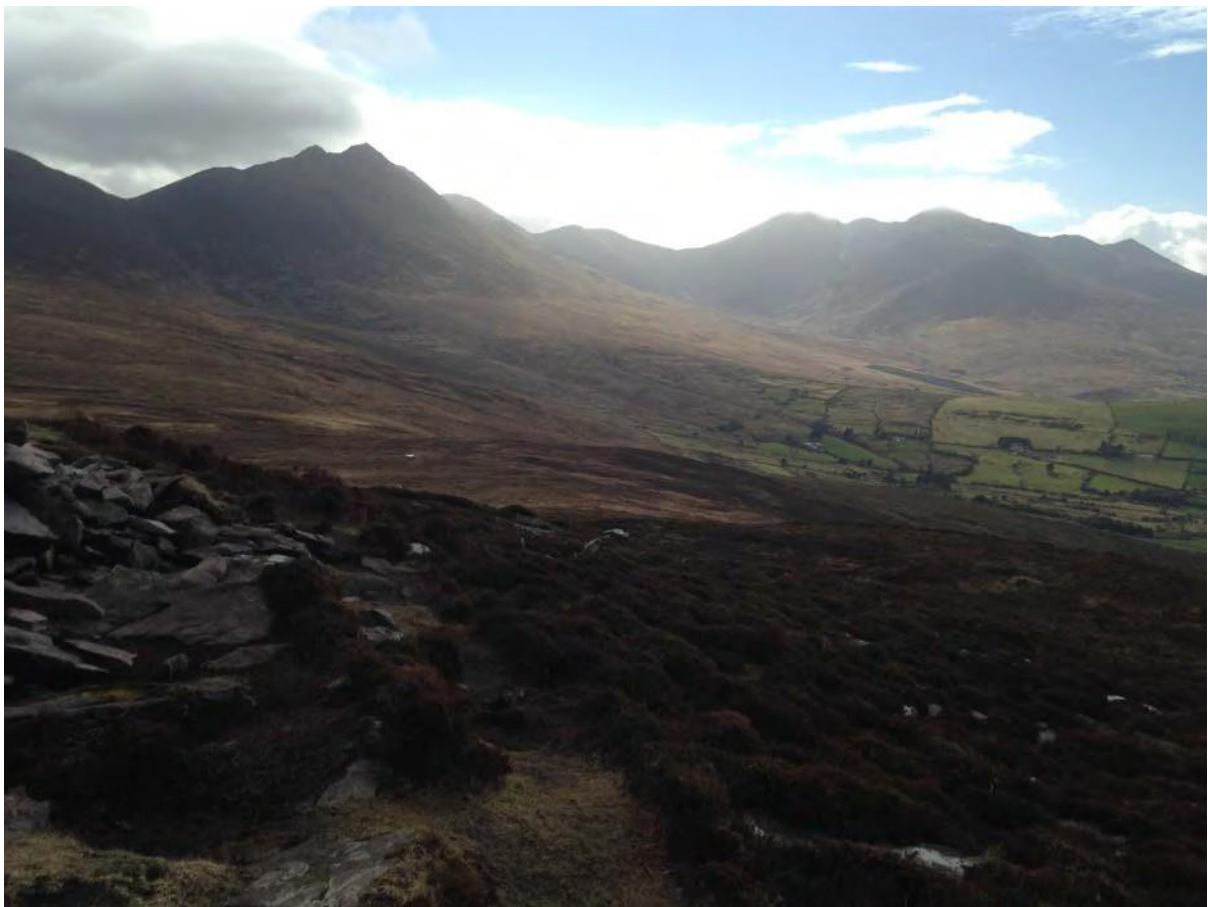
Figure 3 – Viewpoint for the Reeks
