Pentland Hills Regional Park

Upland Path Audit 2016

Upland Path Audit, Priorities and Indicative Costings

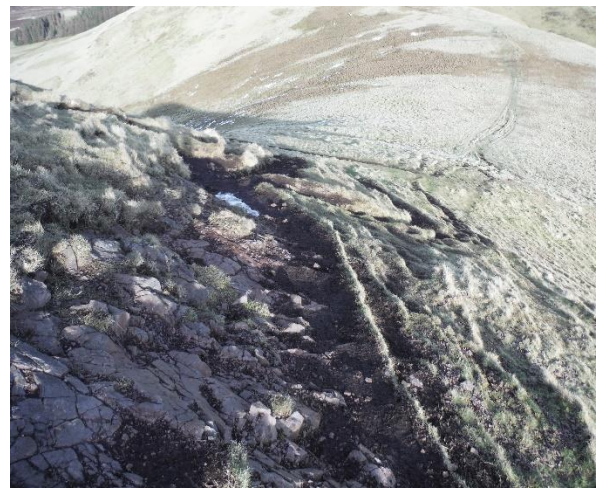
Steeper eroded slopes requiring hand build only due to steepness of the terrain

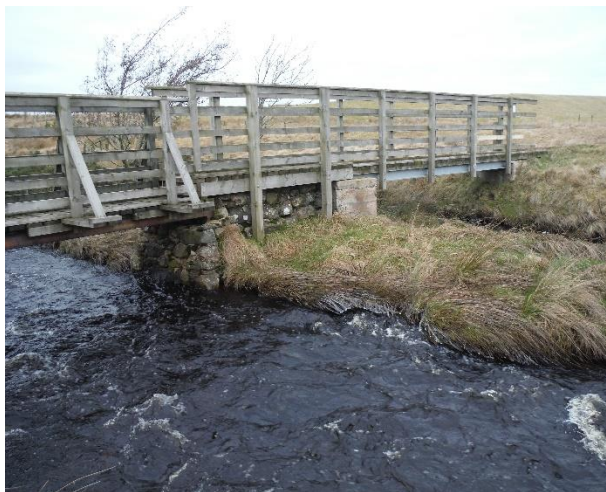
Questionable bridge work at PRP1 Cauldstane Slap.

- For similar reasons the bridges should be surveyed and reviewed by a qualified engineer, as they both look to be constructed to non standard designs, and the 'old' half of the double bridge looks to be in poor condition.

- A raised machine built aggregate path is recommended from top to bottom.
- The bridges should be surveyed by a qualified engineer and look like, at least in part, that they should be replaced

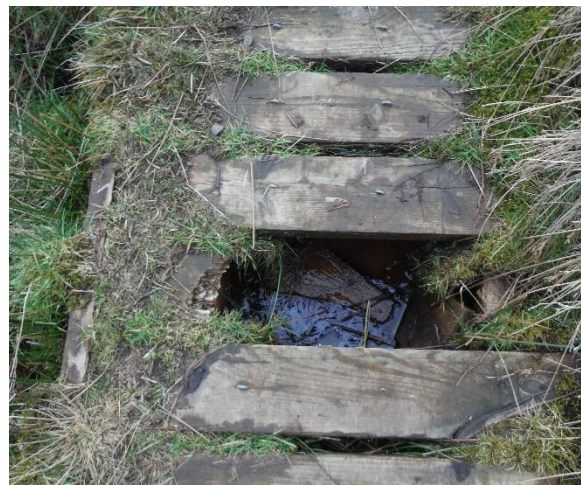
Damaged boardwalk at PRP1 Cauldstane Slap

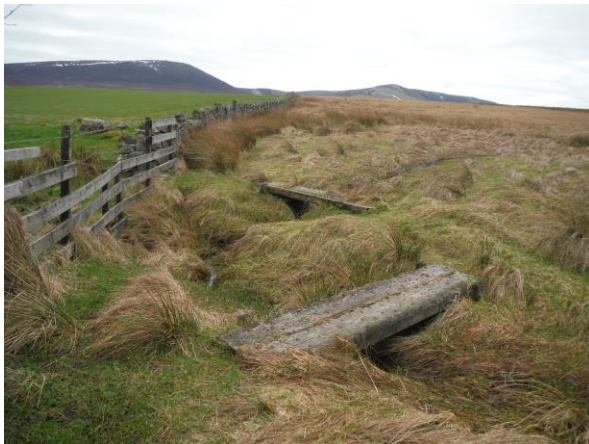
**Indicative Photographs of Path Condition
Section 1.**

Path Condition:

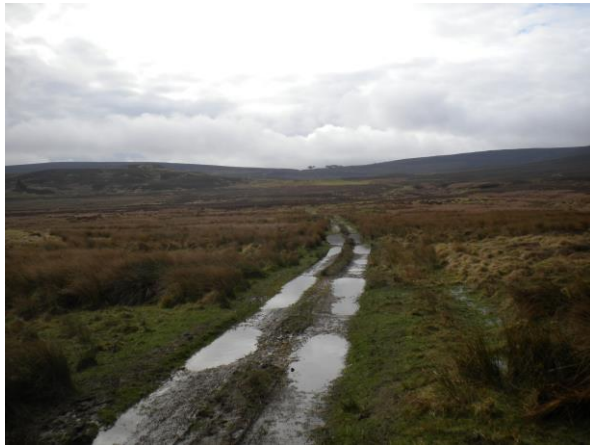
Indicative Photographs of Path Condition
Section 1.

Path Condition: <ul style="list-style-type: none">Section 2 is very wetSection 3 has had no previous work

- A raised machine built aggregate path is recommended for Section 3
- There is no work required on sections 1 and 2, where there is an existing vehicle track

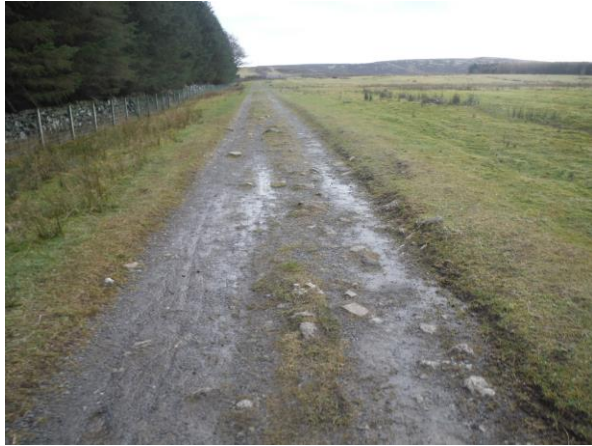
Indicative Photographs of Path Condition
Section 1.

Path Condition: <ul style="list-style-type: none">The ditches are slumping and the drainage system is breaking down. The surface itself has also slumped in places, and is generally overlain with a layer of soft muddy material

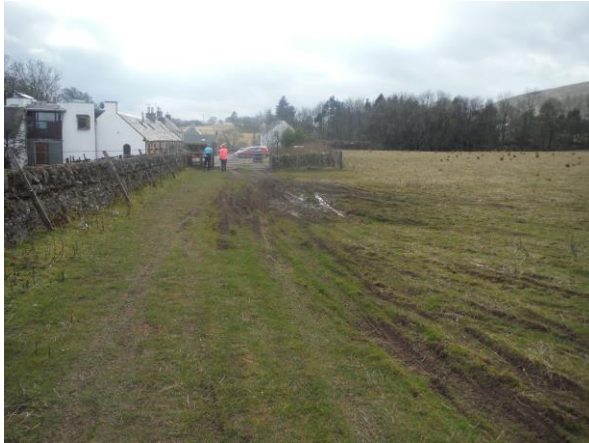
Indicative Photographs of Path Condition
Section 1.

Path Condition: <ul style="list-style-type: none">The path is a trod for its entirety, and is soft and beginning to break downUpgrading the track would prevent further deterioration and make it more attractive for a wider range of users
