Scotland's National Parks - Upland Path Project

South and East Cairngorms

Upland Path Audit 2013

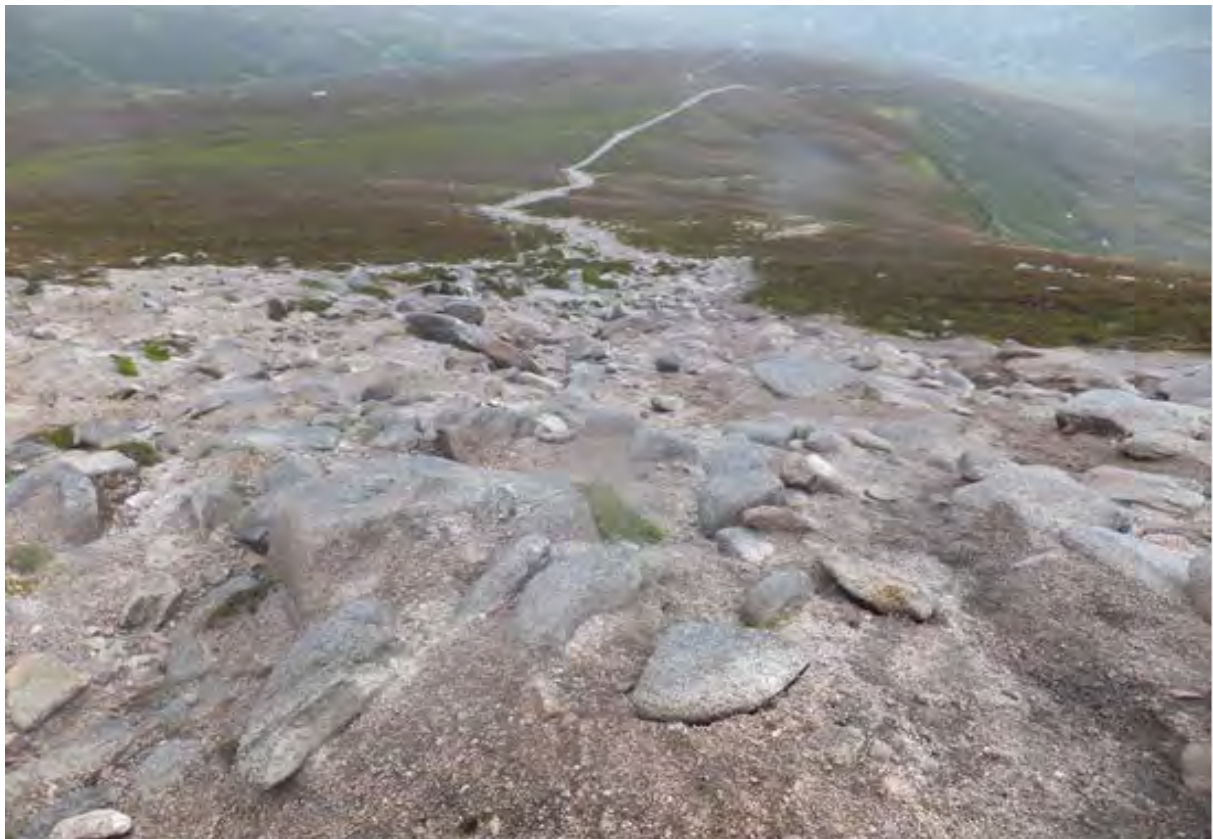
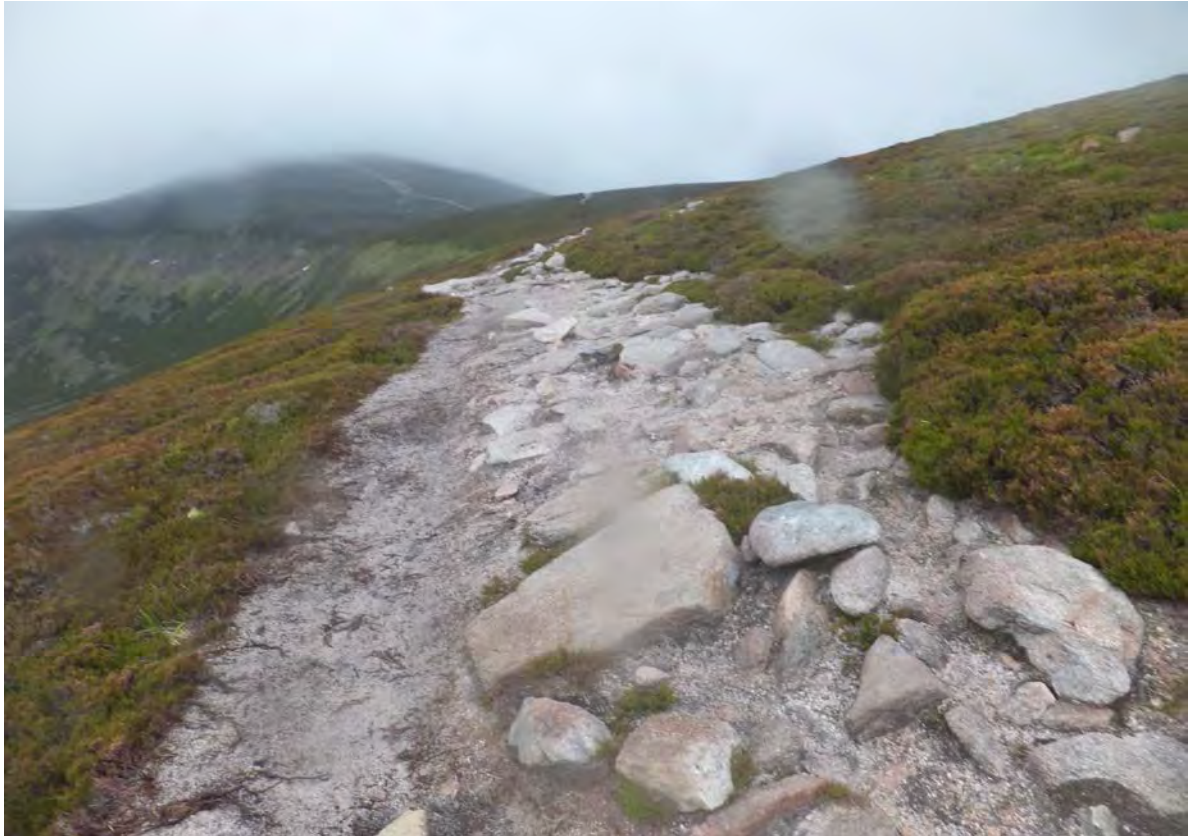
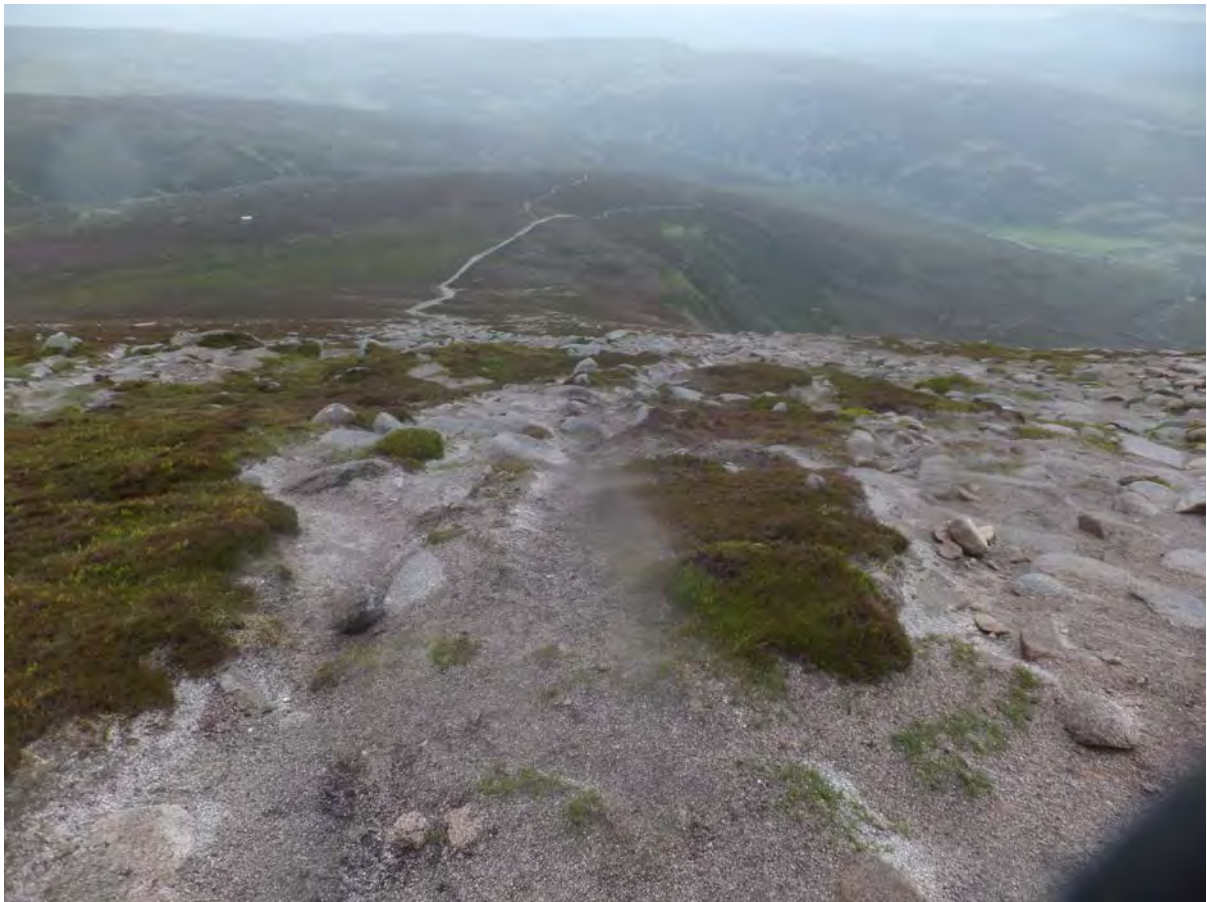
**Upland Path Summary Sheet
UL13 – Mount Keen**

Section taverses to shoulder to short plateau, heavy damage at top. Full build required with heavy landscaping at top.

Recommendations: <ul style="list-style-type: none">• Requires full build path with extensive landscaping and careful alignment for all but the very top section approaching the summit• Scope to share initial section with the Mounth (Mount Keen) with careful alignment			
Maintenance: Once built the path will need relatively high maintenance with on-going pre-emptive repairs.

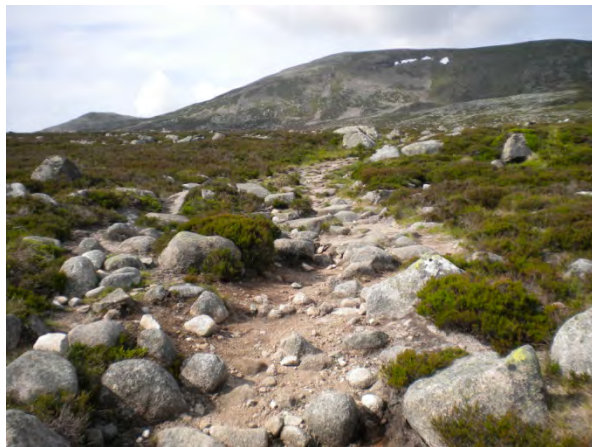
Start of main Lochnagar path to saddle. Very solid footpath but path surface rough in places resulting in brading. Recommend resurface entire section with additional anchor bars

Section 1 is very rough in places causing path spread. Entire section should be resurfaces with additional anchor bars in places and blocking of braids. Machine job possible

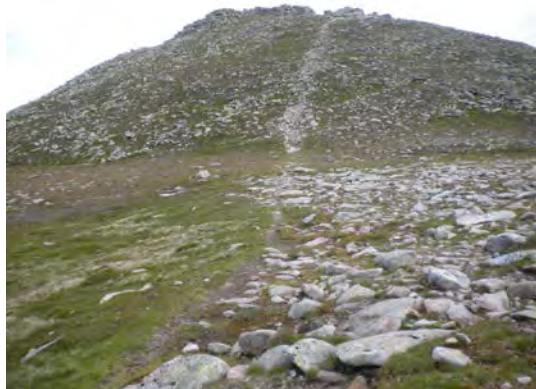
Section 1

Steep section straight up face

No built path up Meikle Pap. Scar very visible. Steep route would need defining and some wbs and anchor bars using local materials with 'light touch' approach.

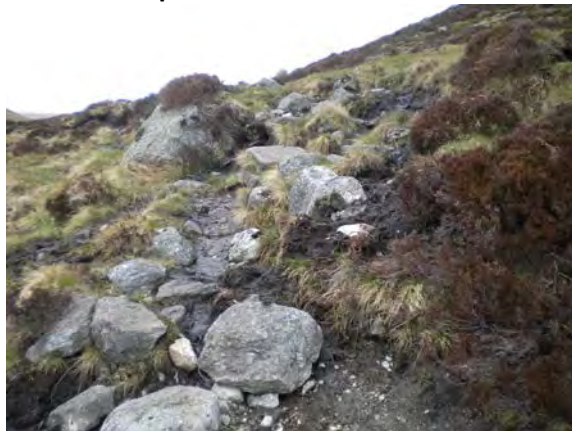
Looking back on section 4

Full build required at start of section 4.

No capital works required up to end of S3. Low maintenance path. High build recommended on section 4 and possible light touch works higher up.

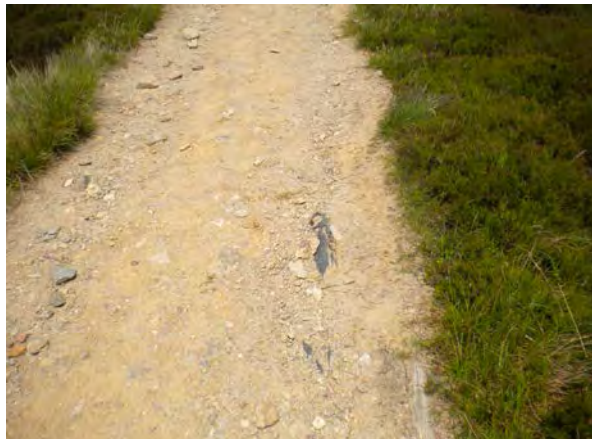
Full build required up Snub – Section 5

Steep and rapidly eroding path to summit. Full build recommended
Pitching stone will need to be bagged and helicoptered.
