Scotland's National Parks - Upland Path Project

The Mountains and The People

Loch Lomond and the Trossachs

Upland Path Audit 2013

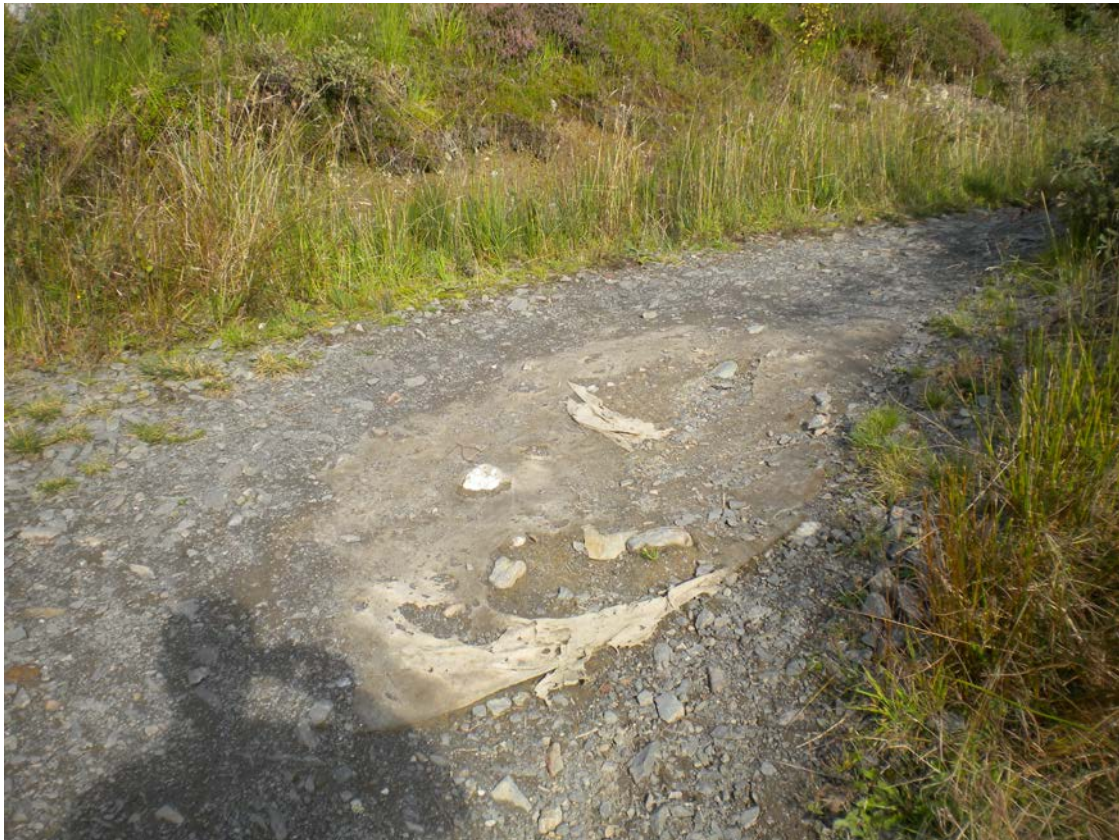
Section 1.

Path Number: LL1	Path Name: The Cobbler	Distance: 5.292km	Location: NN29422704850 to NN2596905851
Landowner: FCS	Designations: NPC	Land Management Priorities: Forestry/Sporting/stewardship	
Use: Popular route used by hillwalkers to access the Cobbler and other surrounding hills			
Previous Path Management: Sections 1 – 4 have previously been machine built. No work has been undertaken on sections 5 and 6. There is no evidence of any on-going maintenance work.			
Path Management Constraints: <ul style="list-style-type: none"> Any work on sections 5 and 6 should be only considered during the summer months. 			
Path Condition: <ul style="list-style-type: none"> Lack of drainage features on the lower path has resulted in a lot of the surfacing washing off and exposing geotextiles. Lack of maintenance on section 3 is producing the same result. No work has been undertaken on section 5 or 6. 			
Recommendations: <ul style="list-style-type: none"> Sections 1 and 2 – resurface and additional drainage features. Section 3 – rebuild or extend some waterbars and cross drains Section 5 – Full build required Section 6 -light touch work to prevent further erosion.

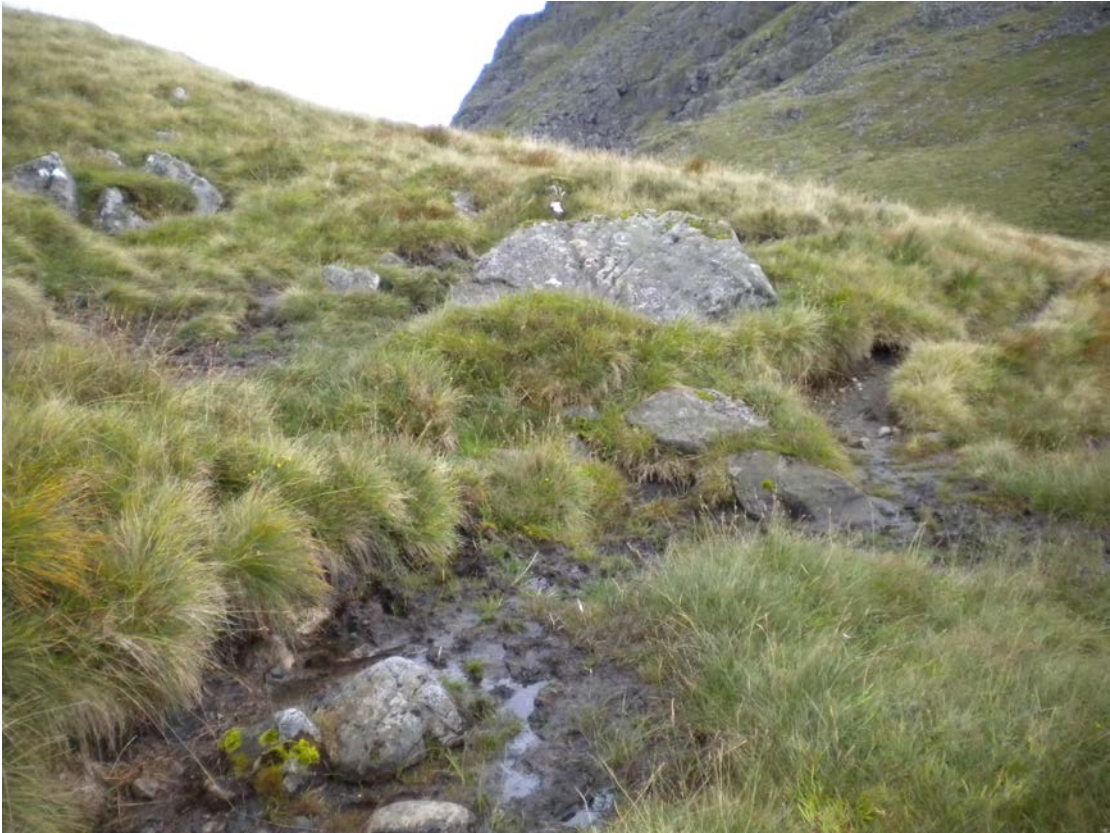
Section 1.

Path Number: LL3	Path Name: Ben Ime	Distance: 2.360km	Location: NN2613706574 to NN2550208475
Landowner: t.b.c	Designations: NPC	Land Management Priorities: Sporting/stewardship	
Use: Main route for accessing Ben Ime			
Previous Path Management: No evidence of previous path management			
Path Management Constraints: <ul style="list-style-type: none"> • Due to the distances involved in getting to the site remote accommodation systems may be needed if work is to be undertaken in the future. 			
Path Condition: <ul style="list-style-type: none"> • Poor drainage on lower sections of the path has produced an obvious erosion scar • Sections 4 and 5 are better drained 			
Recommendations: <ul style="list-style-type: none"> • Section one to three – full build required. • Section 4 – light touch works • Section 5 – no work required at present. 			
Maintenance: Once built the path will need an on-going maintenance program.

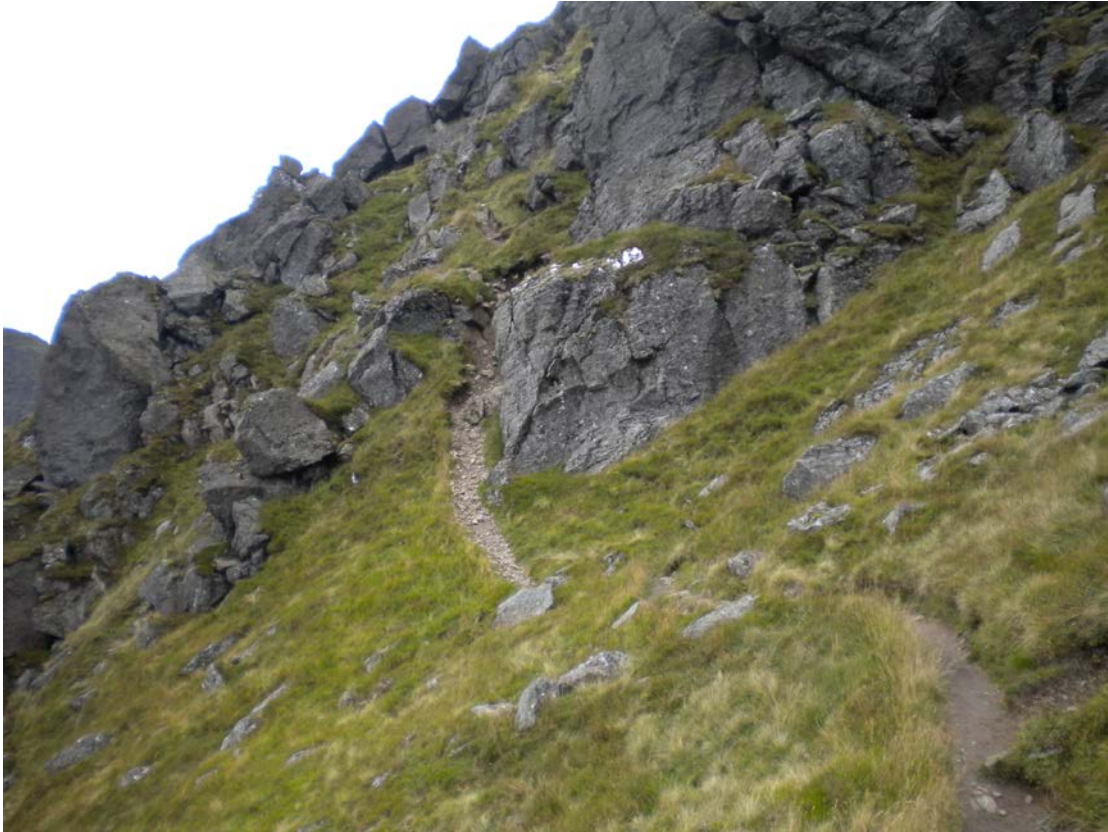
Path Number: LL4	Path Name: Ben Narnain	Distance: 3.576km	Location: NN2717006645 to NN2937104823
Landowner: t.b.c	Designations: NP	Land Management Priorities: Sporting/stewardship	
Use: Direct route up South East ridge of Ben Narnain. More popular as a descent route.			
Previous Path Management: No previous Path management.			
Path Management Constraints: <ul style="list-style-type: none"> Any work will carried out will be 'hand-built' due to steepness of ground and bedrock 			
Path Condition: <ul style="list-style-type: none"> Sections 1 & 2 from the summit involve some scrambling and are well contained Section 3 has a more prominent erosion scar and is poorly drained. Sections 4 & 5 are poorly drained but well contained by the tree line. 			
Recommendations: <ul style="list-style-type: none"> Section one and two – No work Section 3 – Full build required. Section 4 & 5 – Possiblr re-route onto the Cobbler –main path.

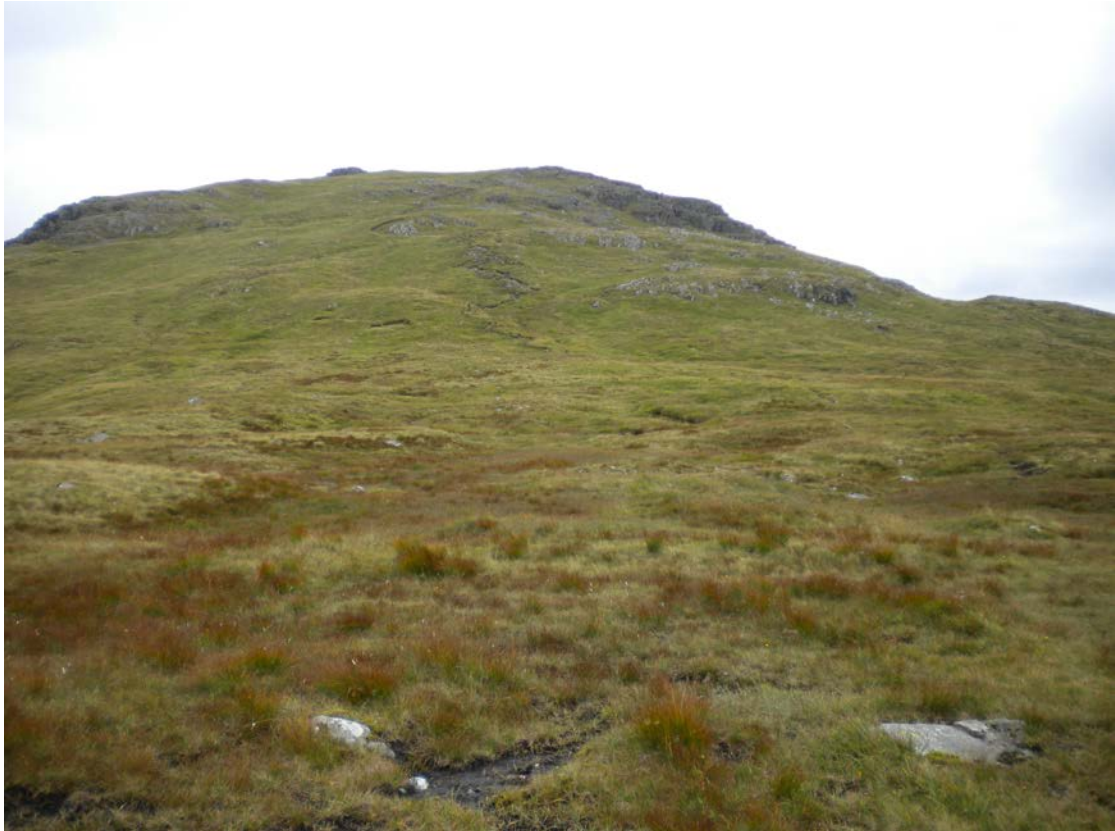
Path Number: LL5	Path Name: Ben Narnain from Bealach a Mhaim	Distance: 1.183km	Location: NN2624407009 to NN2717106647
Landowner: t.b.c	Designations: NP	Land Management Priorities: Sporting/stewardship	
Use: Popular route to the summit of Ben Narnain from Ben Ime and the Cobbler			
Previous Path Management: No previous path management			
Path Management Constraints: <ul style="list-style-type: none"> Distance and walk-in time could potentially see a remote accommodation system being used. 			
Path Condition: <ul style="list-style-type: none"> Section 1 – crosses very wet ground Section 2 – very visible erosion scar becoming worse with path spreading either side Section 3 – evolved line over dry ground and well contained. 			
Recommendations: <ul style="list-style-type: none"> Section 1 – full build required Section 2 – Full build required. Section 3 – No work required at present. 			
Maintenance: Once built the path will require a maintenance program.

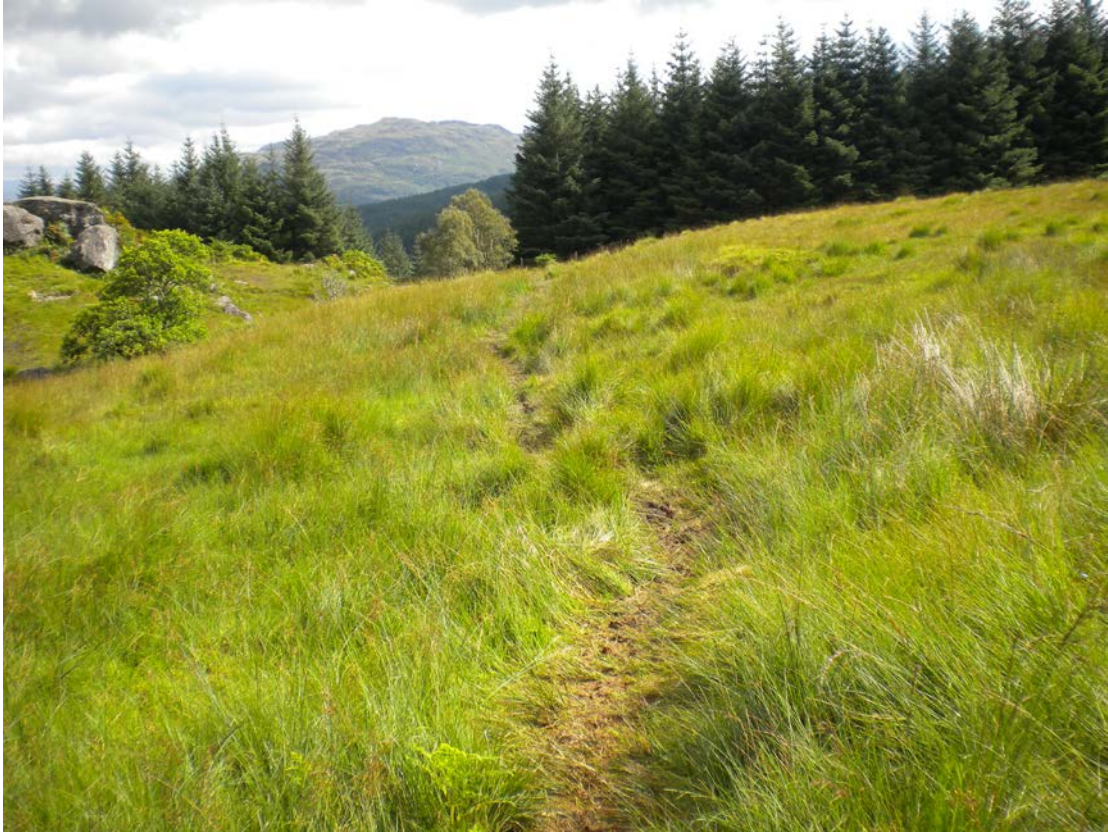
Path Number: LL6	Path Name: Ben Vane	Distance: 2.767km	Location: NN2950809201 to NN2775109841
Landowner: t.b.c	Designations: NP	Land Management Priorities: Sporting/stewardship	
Use: Popular route with hill walkers / Munro baggers directly up the South east ridge of Ben Vane			
Previous Path Management: No previous path management.			
Path Management Constraints: <ul style="list-style-type: none"> • Gradient of the path line will rule out a machine built path 			
Path Condition: <ul style="list-style-type: none"> • Due to it being such a direct line there is bad gullying in places and an obvious erosion scar from the Sloy road. 			
Recommendations: <ul style="list-style-type: none"> • Full build required on sections 1 - 4 • Section 5 – No work required at present 			
Maintenance: Once a path has been built a maintenance program should be put in place.			
Section 1.

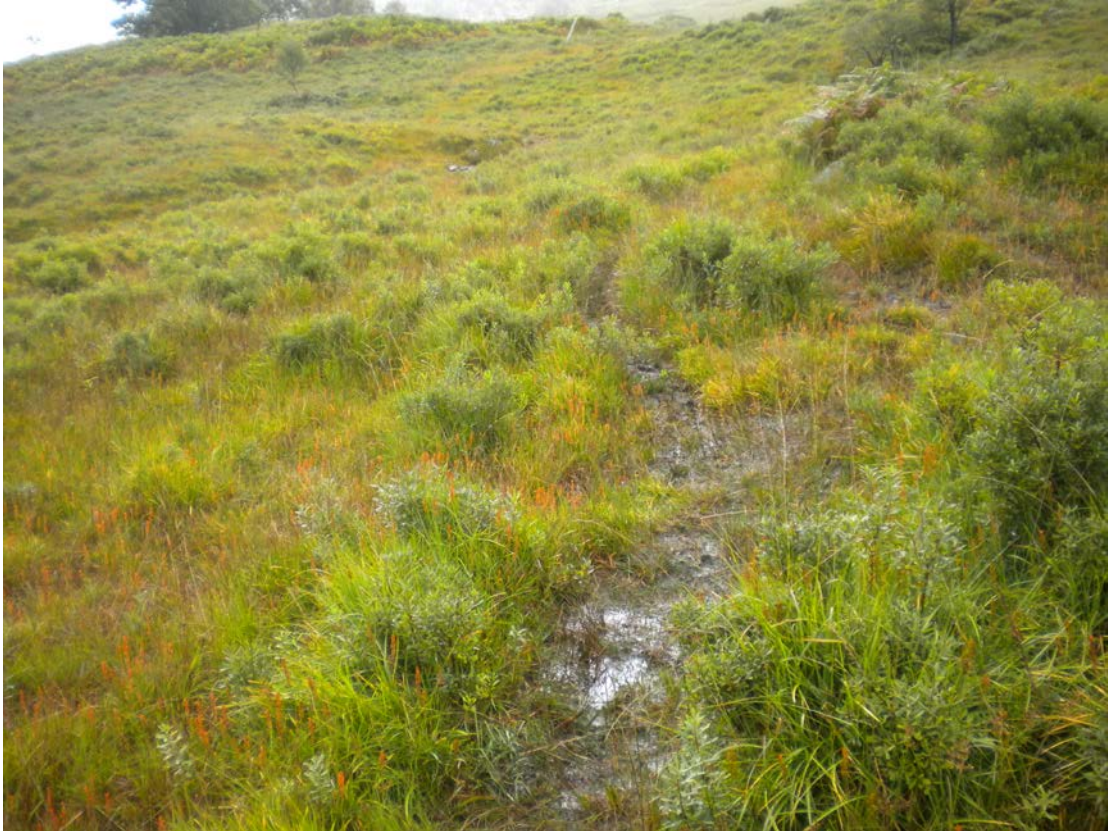
Path Number: LL7	Path Name: Ben Vorlich -Ardlui	Distance: 5.428km	Location: NN3187515126 to NN2958912289
Landowner: t.b.c	Designations: NP, NSA, SSSI	Land Management Priorities: Sporting/stewardship	
Use: One of several routes used to access Ben Vorlich.			
Previous Path Management: No previous path management			
Path Management Constraints: <ul style="list-style-type: none"> The use of ATV's in the Corrie will have a bearing on any path design. 			
Path Condition: <ul style="list-style-type: none"> Very wet sections on the route through Corrie Creagach The path along the North East Ridge is faint in places indicating that other routes to the summit are more popular. 			
Recommendations: <ul style="list-style-type: none"> No work required at the moment. Monitor in the future for signs of erosion 			
Maintenance: No maintenance required.			
Section 1.

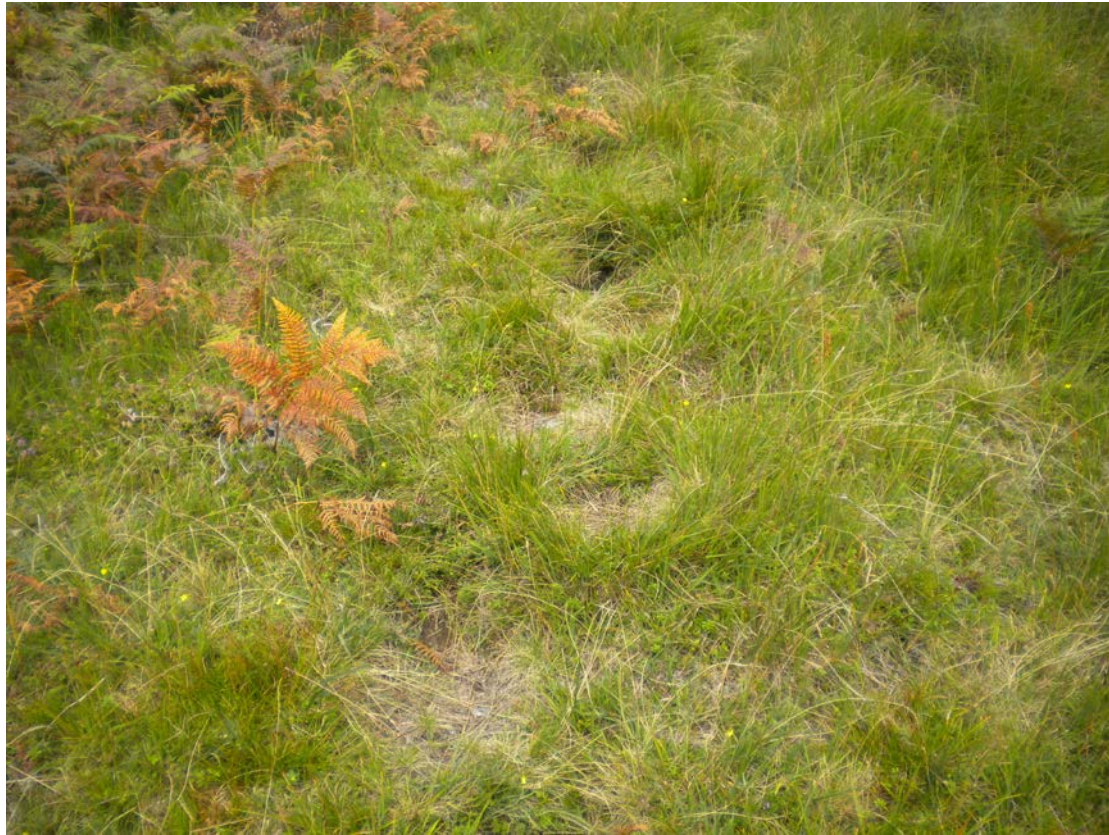
Section 1.

Path Number: LL8	Path Name: Ben Vorlich - Inveruglas	Distance: 2.921km	Location: NN2950809201 to NN2775109841
Landowner: t.b.c	Designations: NP, NSA, SSSI	Land Management Priorities: Sporting/stewardship	
Use: Lightly used route from Inveruglas following the long South ridge onto Ben Vorlich.			
Previous Path Management: No previous path management			
Path Management Constraints: <ul style="list-style-type: none"> • Lack of stone on lower section. Would require materials to be helicoptered in. • Steepness of ground will rule out machine work 			
Path Condition: <ul style="list-style-type: none"> • Very faint path line indicates that this route is not under pressure 			
Recommendations: <ul style="list-style-type: none"> • No work required for now • Monitor future erosion. 			
Maintenance: No maintenance required.

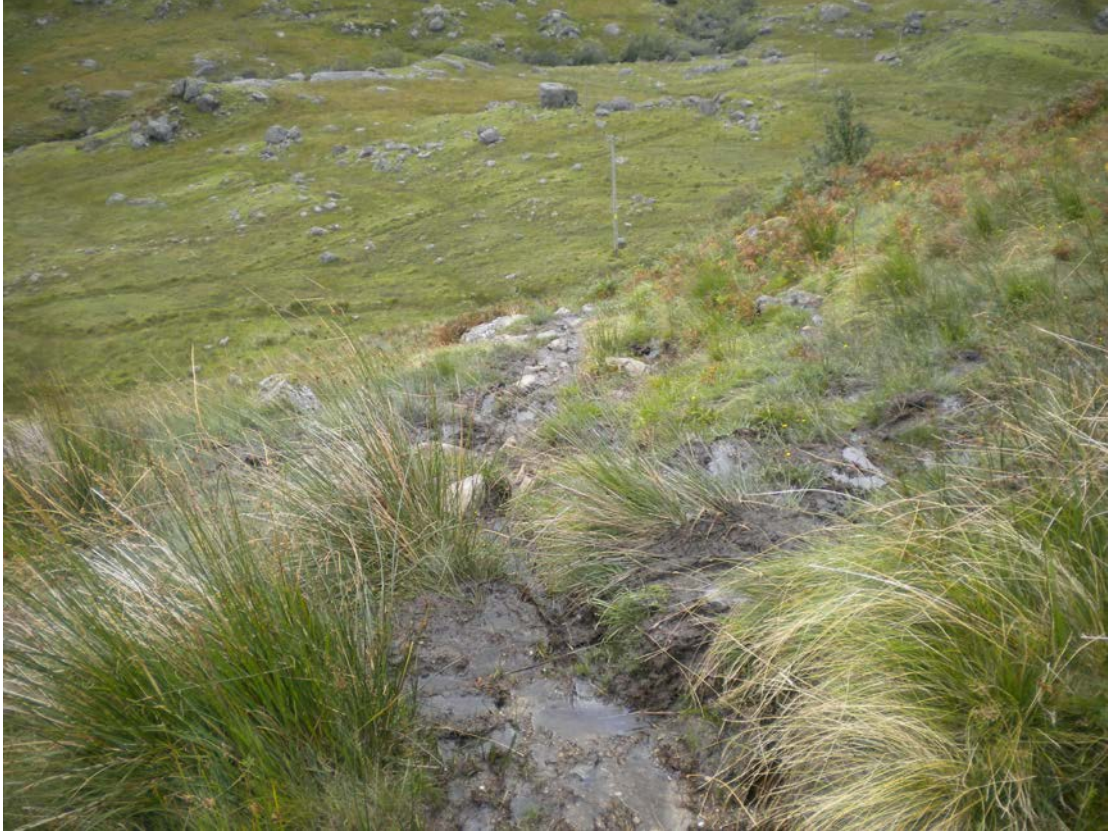
Path Number: LL9	Path Name: Ben Vorlich - Loch Sloy	Distance: 2.740km	Location: NN2953310301 to NN2958912289
Landowner: t.b.c	Designations: NP, NSA, SSSI		Land Management Priorities: Sporting/stewardship
Use: Popular direct route for hillwalkers and munro baggers to the summit of Ben Vorlich from Loch Sloy			
Previous Path Management: No evidence of previous path management			
Path Management Constraints: <ul style="list-style-type: none"> • Due to the steepness of the path line stone may need to be bagged and dropped at the work site • All work will need to be hand – built. 			
Path Condition: <ul style="list-style-type: none"> • Sections 1 – 4 are badly eroded with braiding either side of the path line • Section 6 is a typical ridge path and is well contained 			
Recommendations: <ul style="list-style-type: none"> • Sections 1 – 4 require a high specification robust hand-built path • Section 5 requires some light touch work to prevent further erosion • No work required on section 6 – monitor only

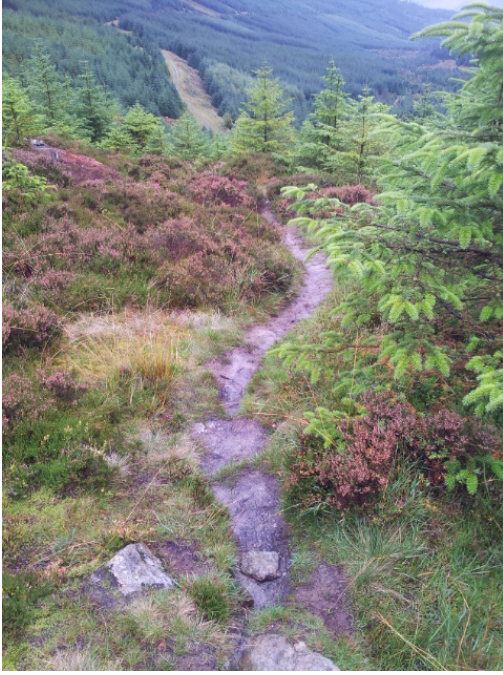
Wear at start Section 1

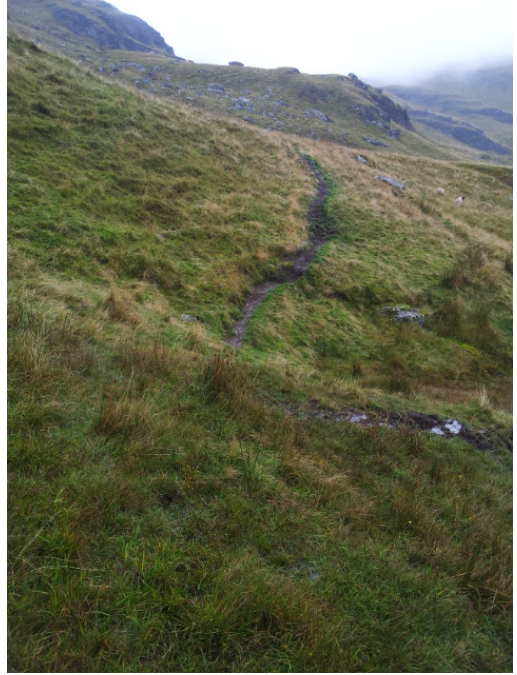
Damaged section 4

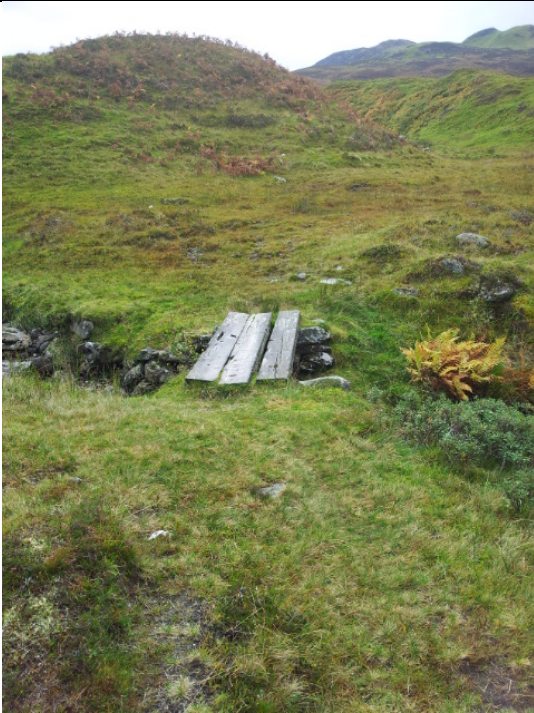
Dangerous bridge section 11

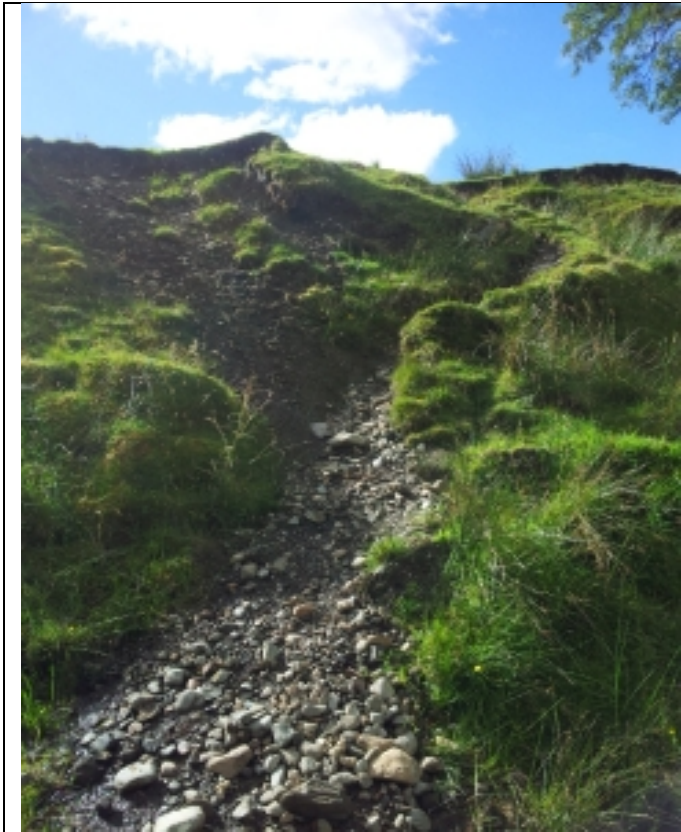
Heavy damage at start Section 1

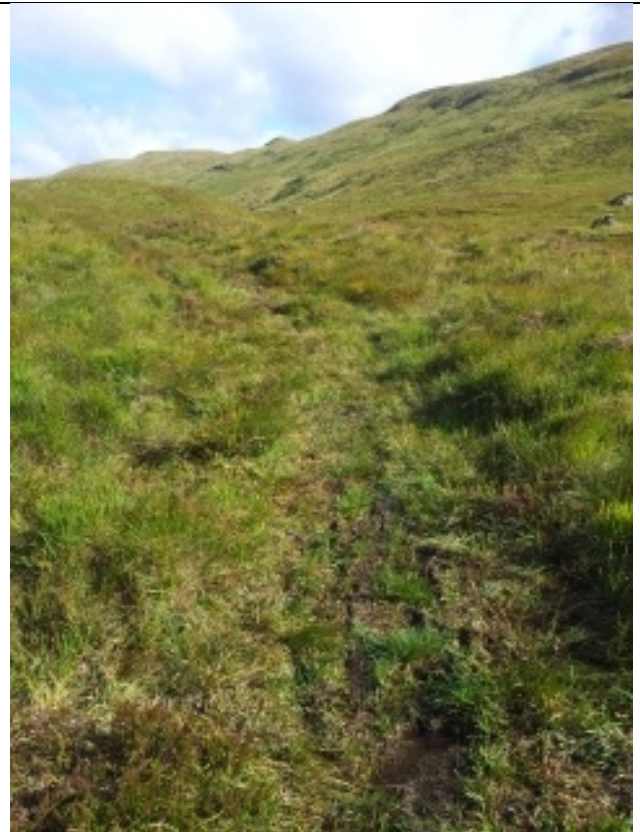
Wet section at end Section 10

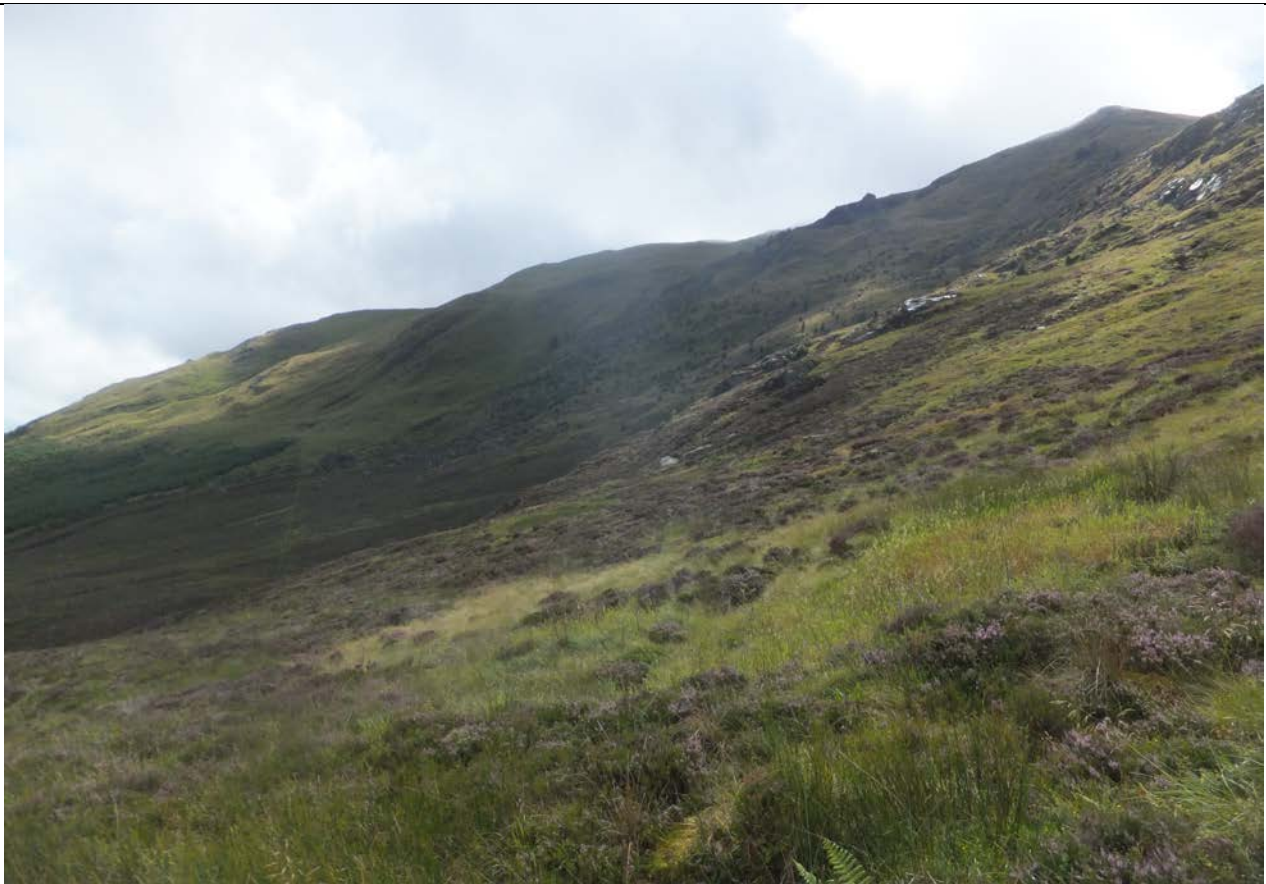
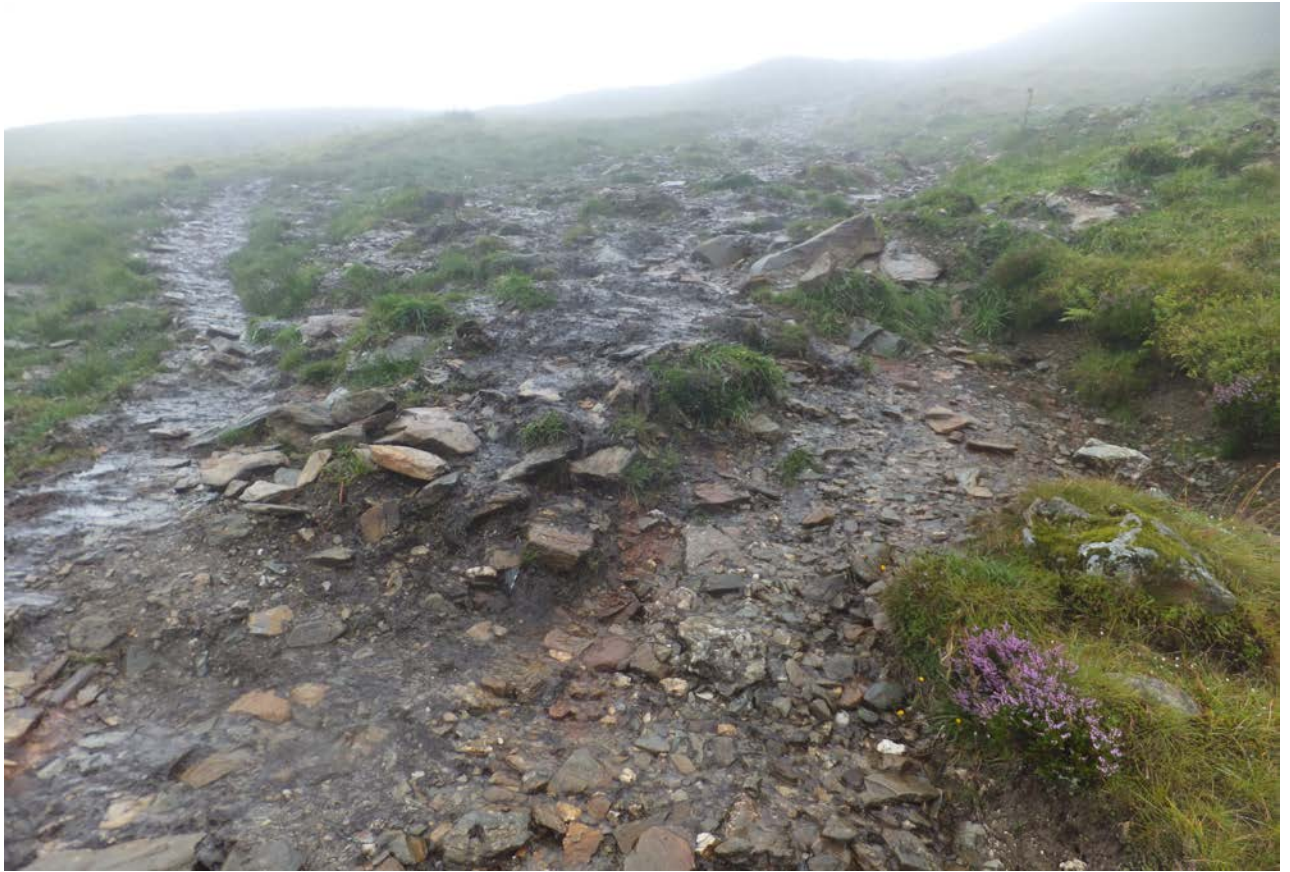
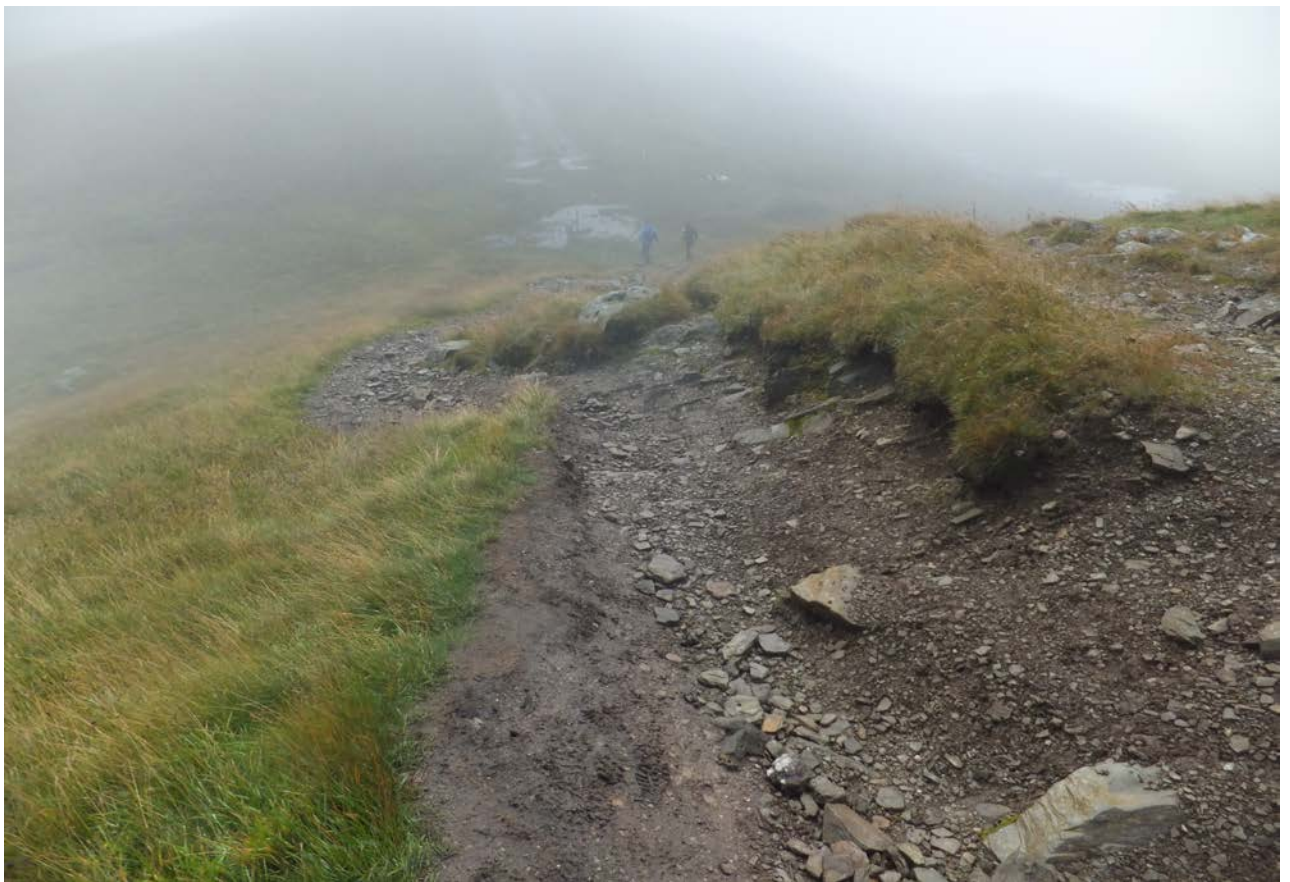
Path Condition: <ul style="list-style-type: none"> Beyond the dyke the path is in desperate condition – with gulying beneath the shoulder and uncontained spread on the approach to the ridge 			
Recommendations: <ul style="list-style-type: none"> Hand build path to shoulder Machine build higher up if access possible 			
Maintenance: Regular maintenance will be required once work has been completed.

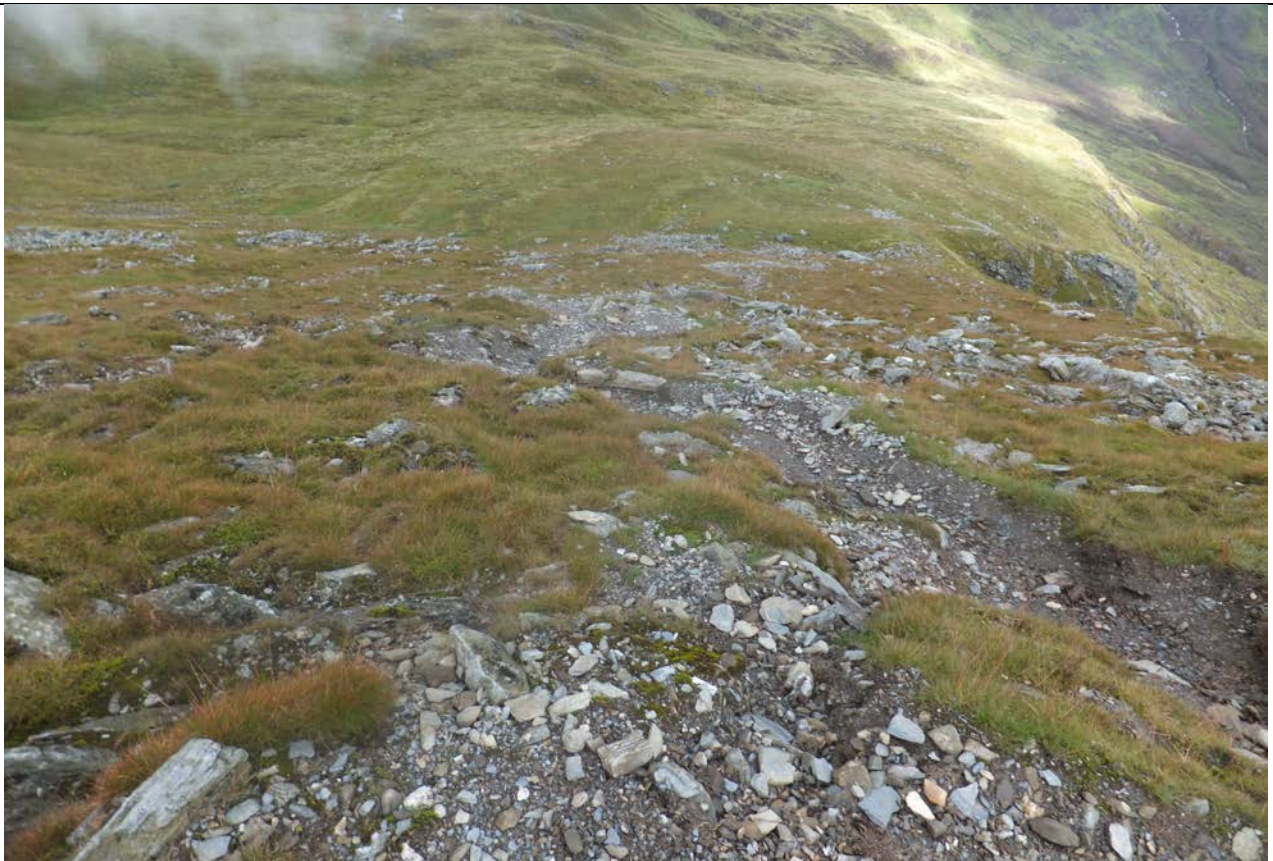
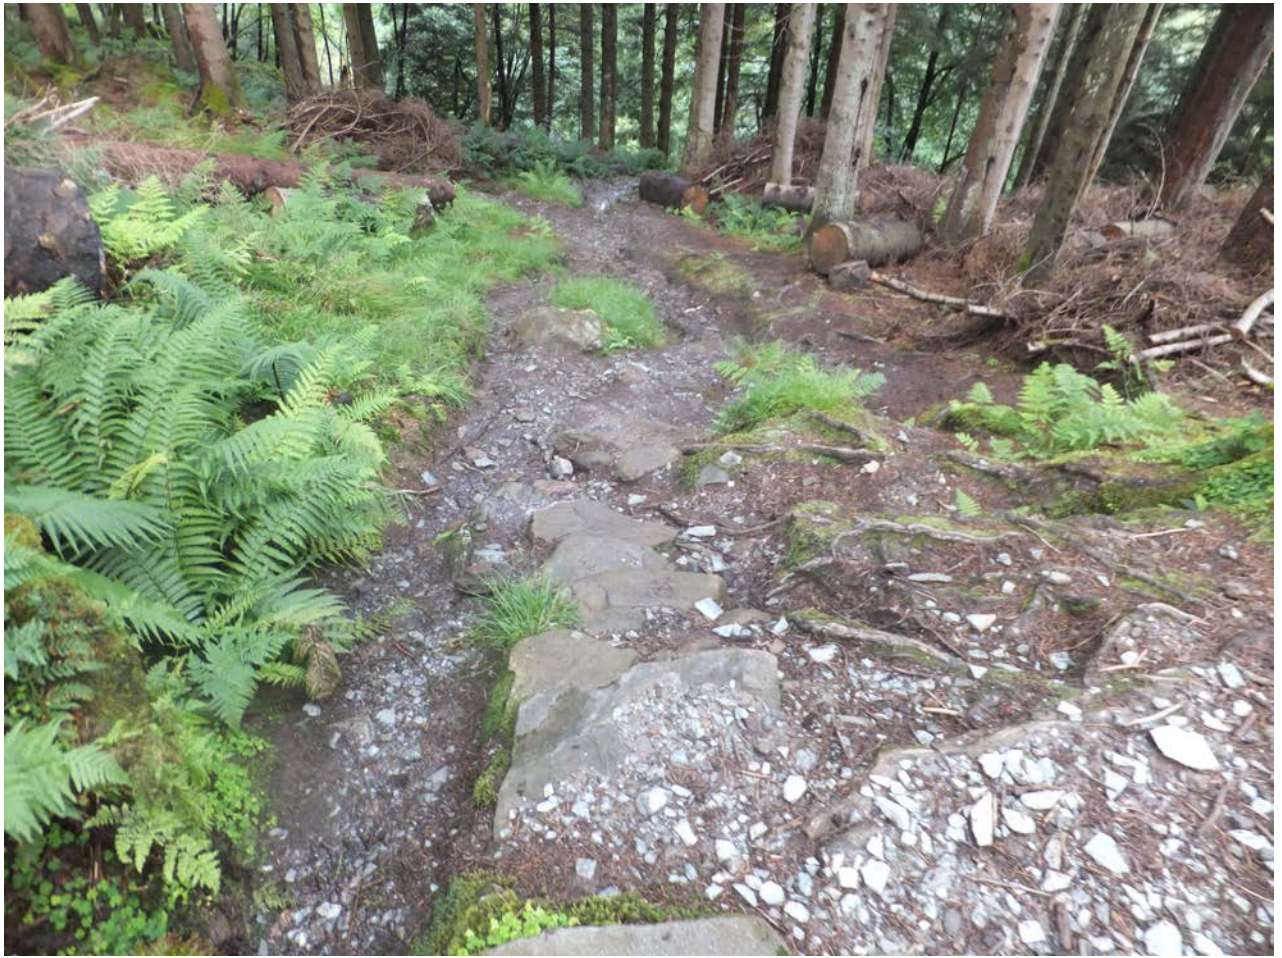
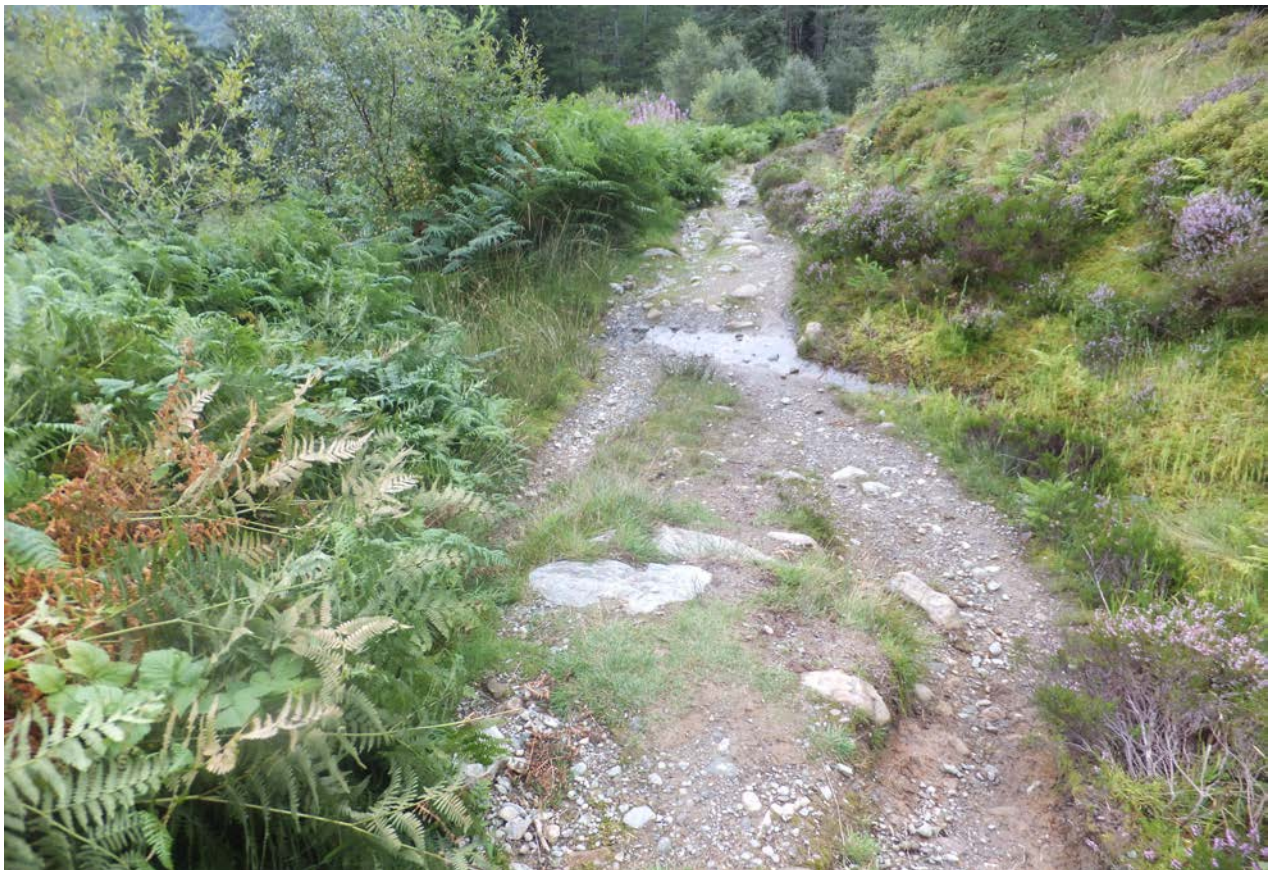
Path Condition: <ul style="list-style-type: none"> • The path beyond the stile still has comparatively low use, and whilst very wet is not very damaged • The path sections within the forest on the lower section are very badly damaged 			
Recommendations: <ul style="list-style-type: none"> • Hand build path on lower sections with imported materials • Pre-emptive light touch works only on the upper mountain 			
Maintenance: Regular maintenance and pre-emptive works will be required once work has been completed.

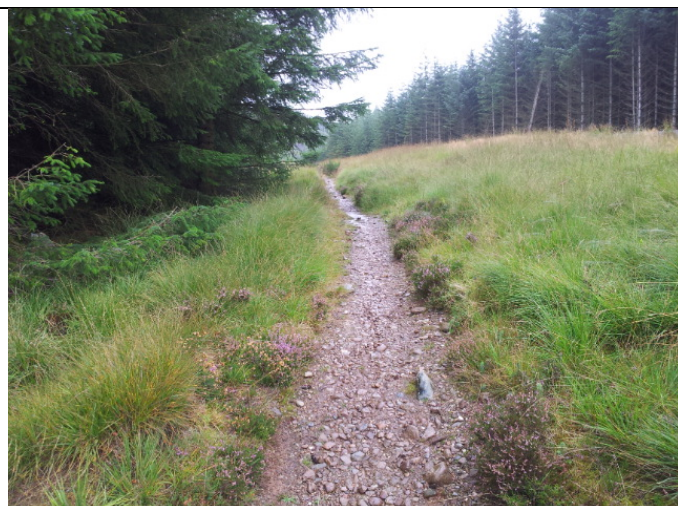
As dug path section 8
