MacGillycuddy's Reeks Upland Path Audit 2015

Upland Path Audit, Remedial Plan and Indicative Costings

MacGillycuddy's Reeks
Mountain Path Audit 2015

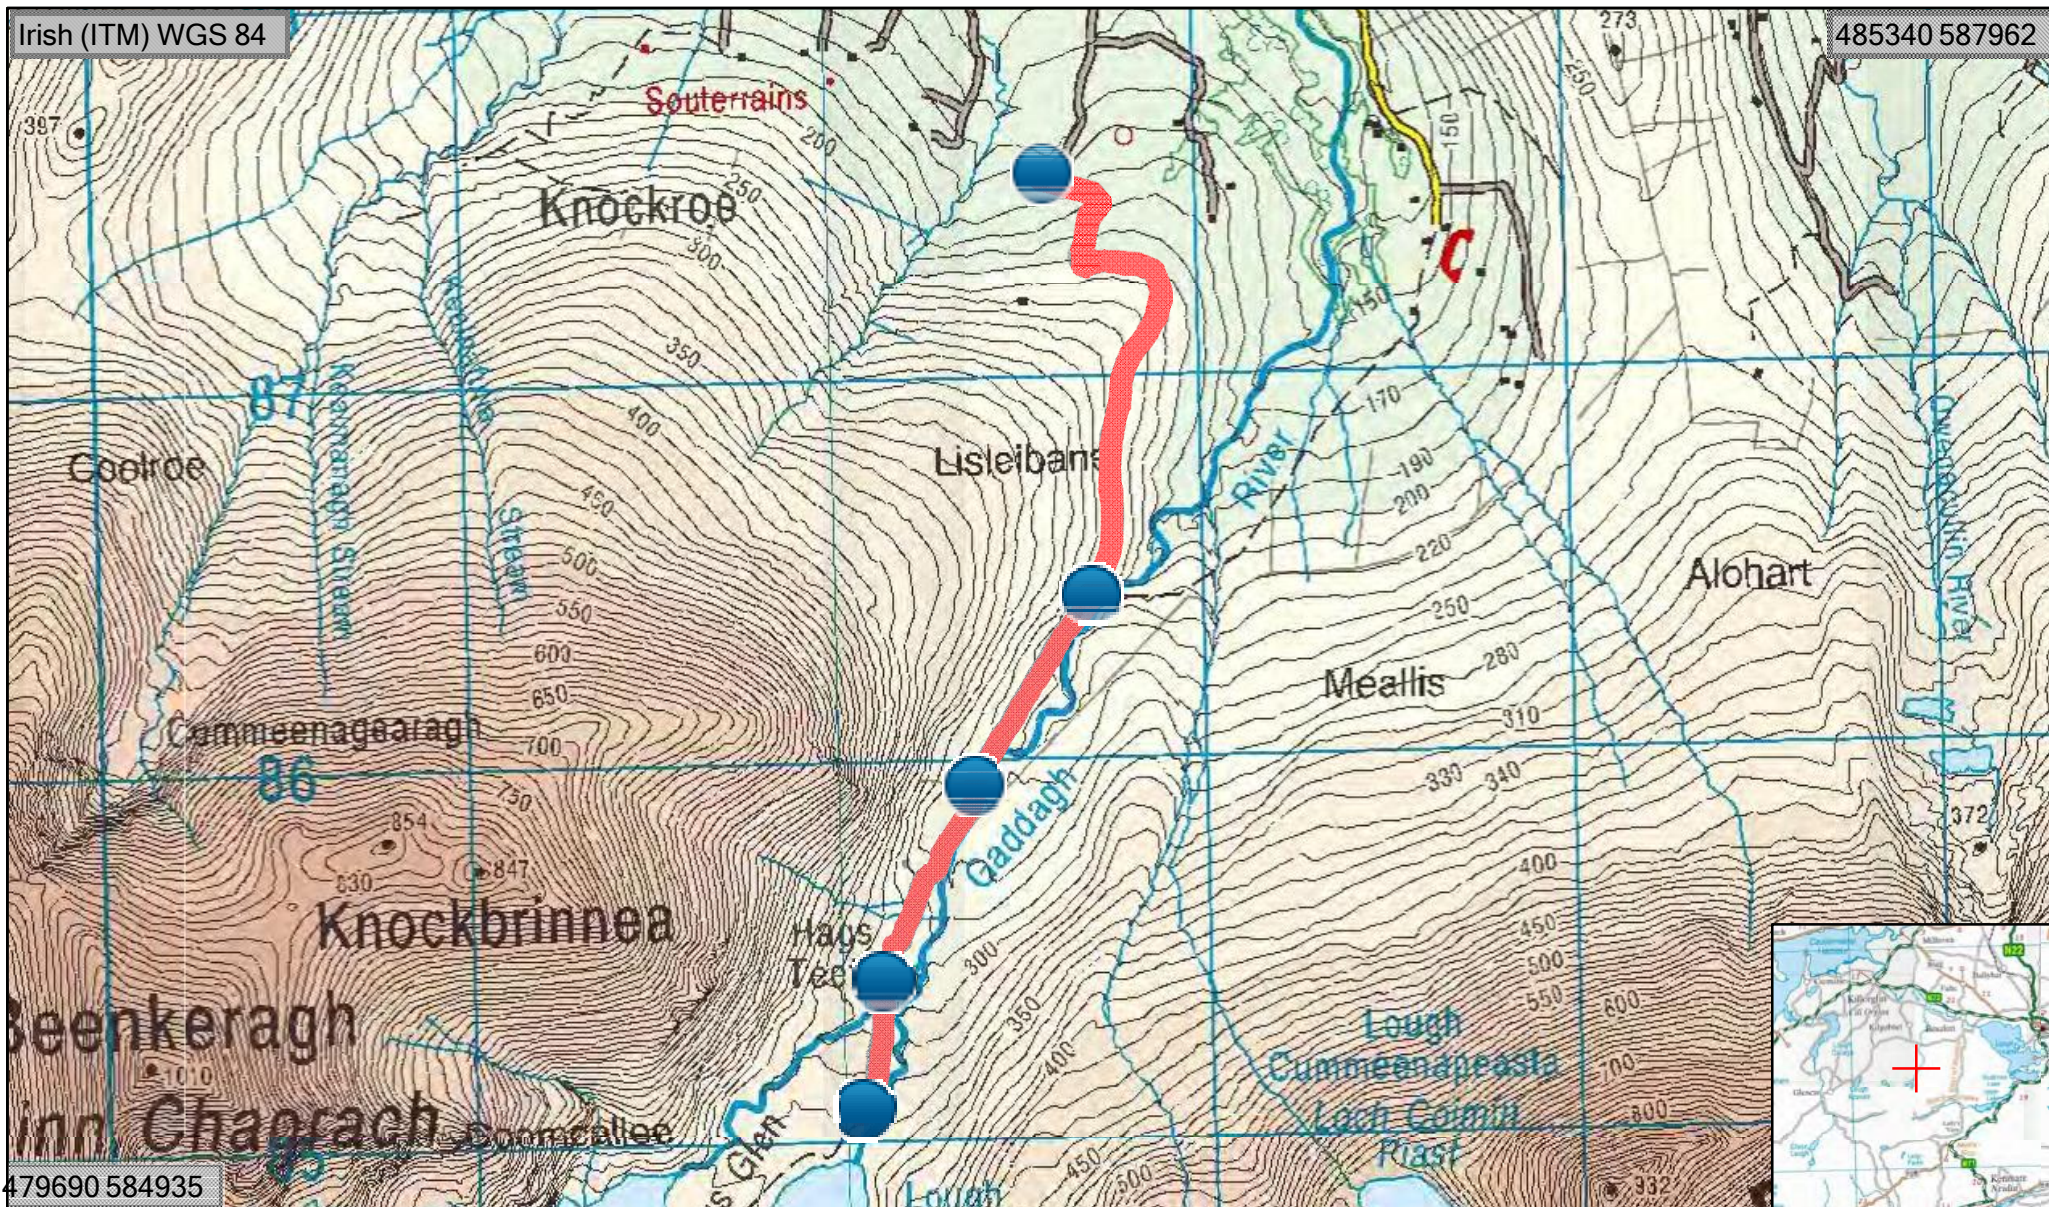
MR1 - Lisleibane

Figure 2 - Surface Loss and Drainage Problems

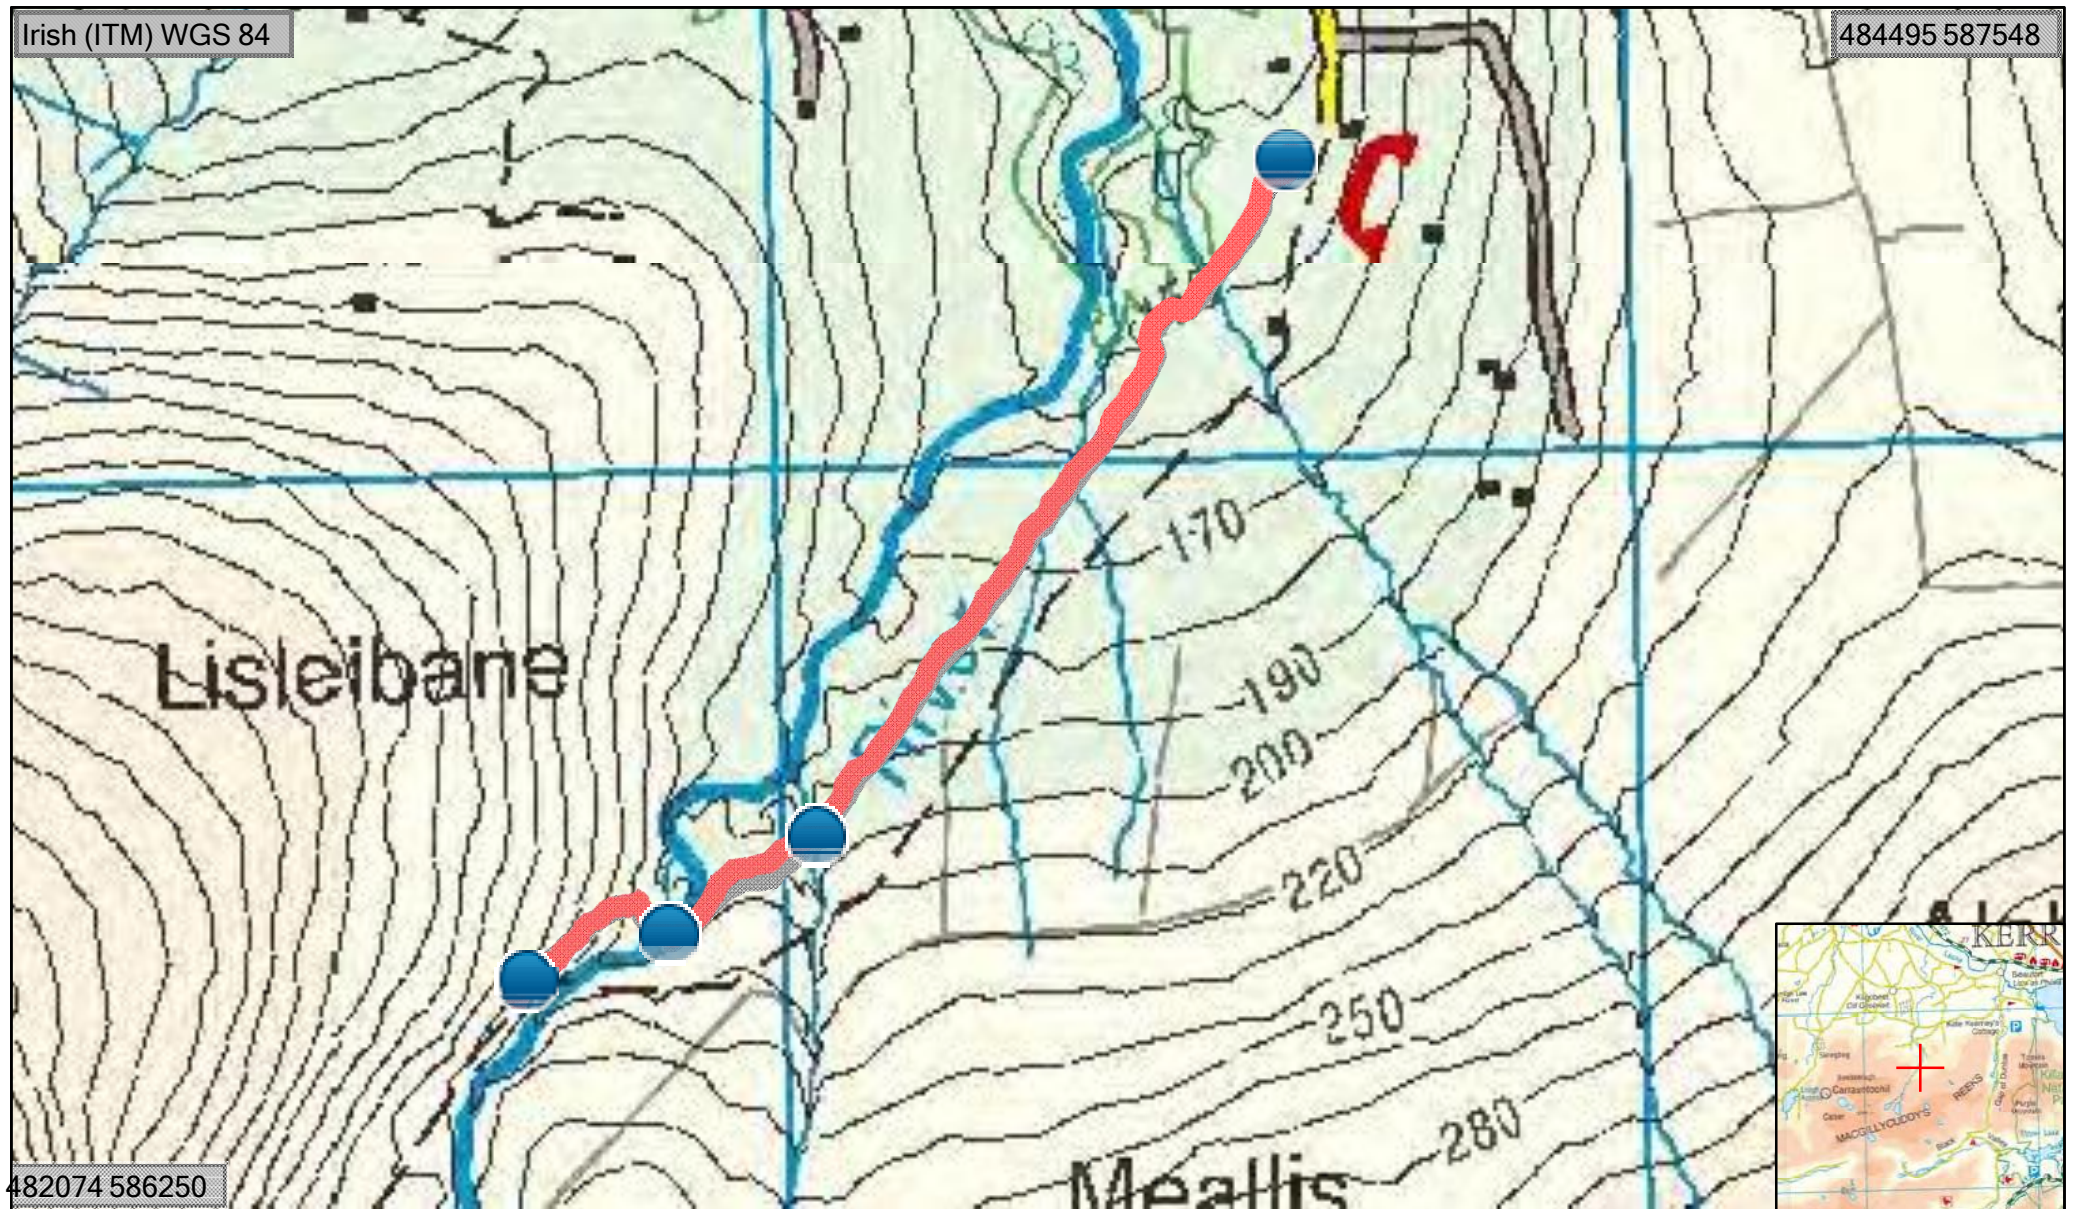
MR2 - Cronins

Figure 2 – Badly eroded path at Section 3

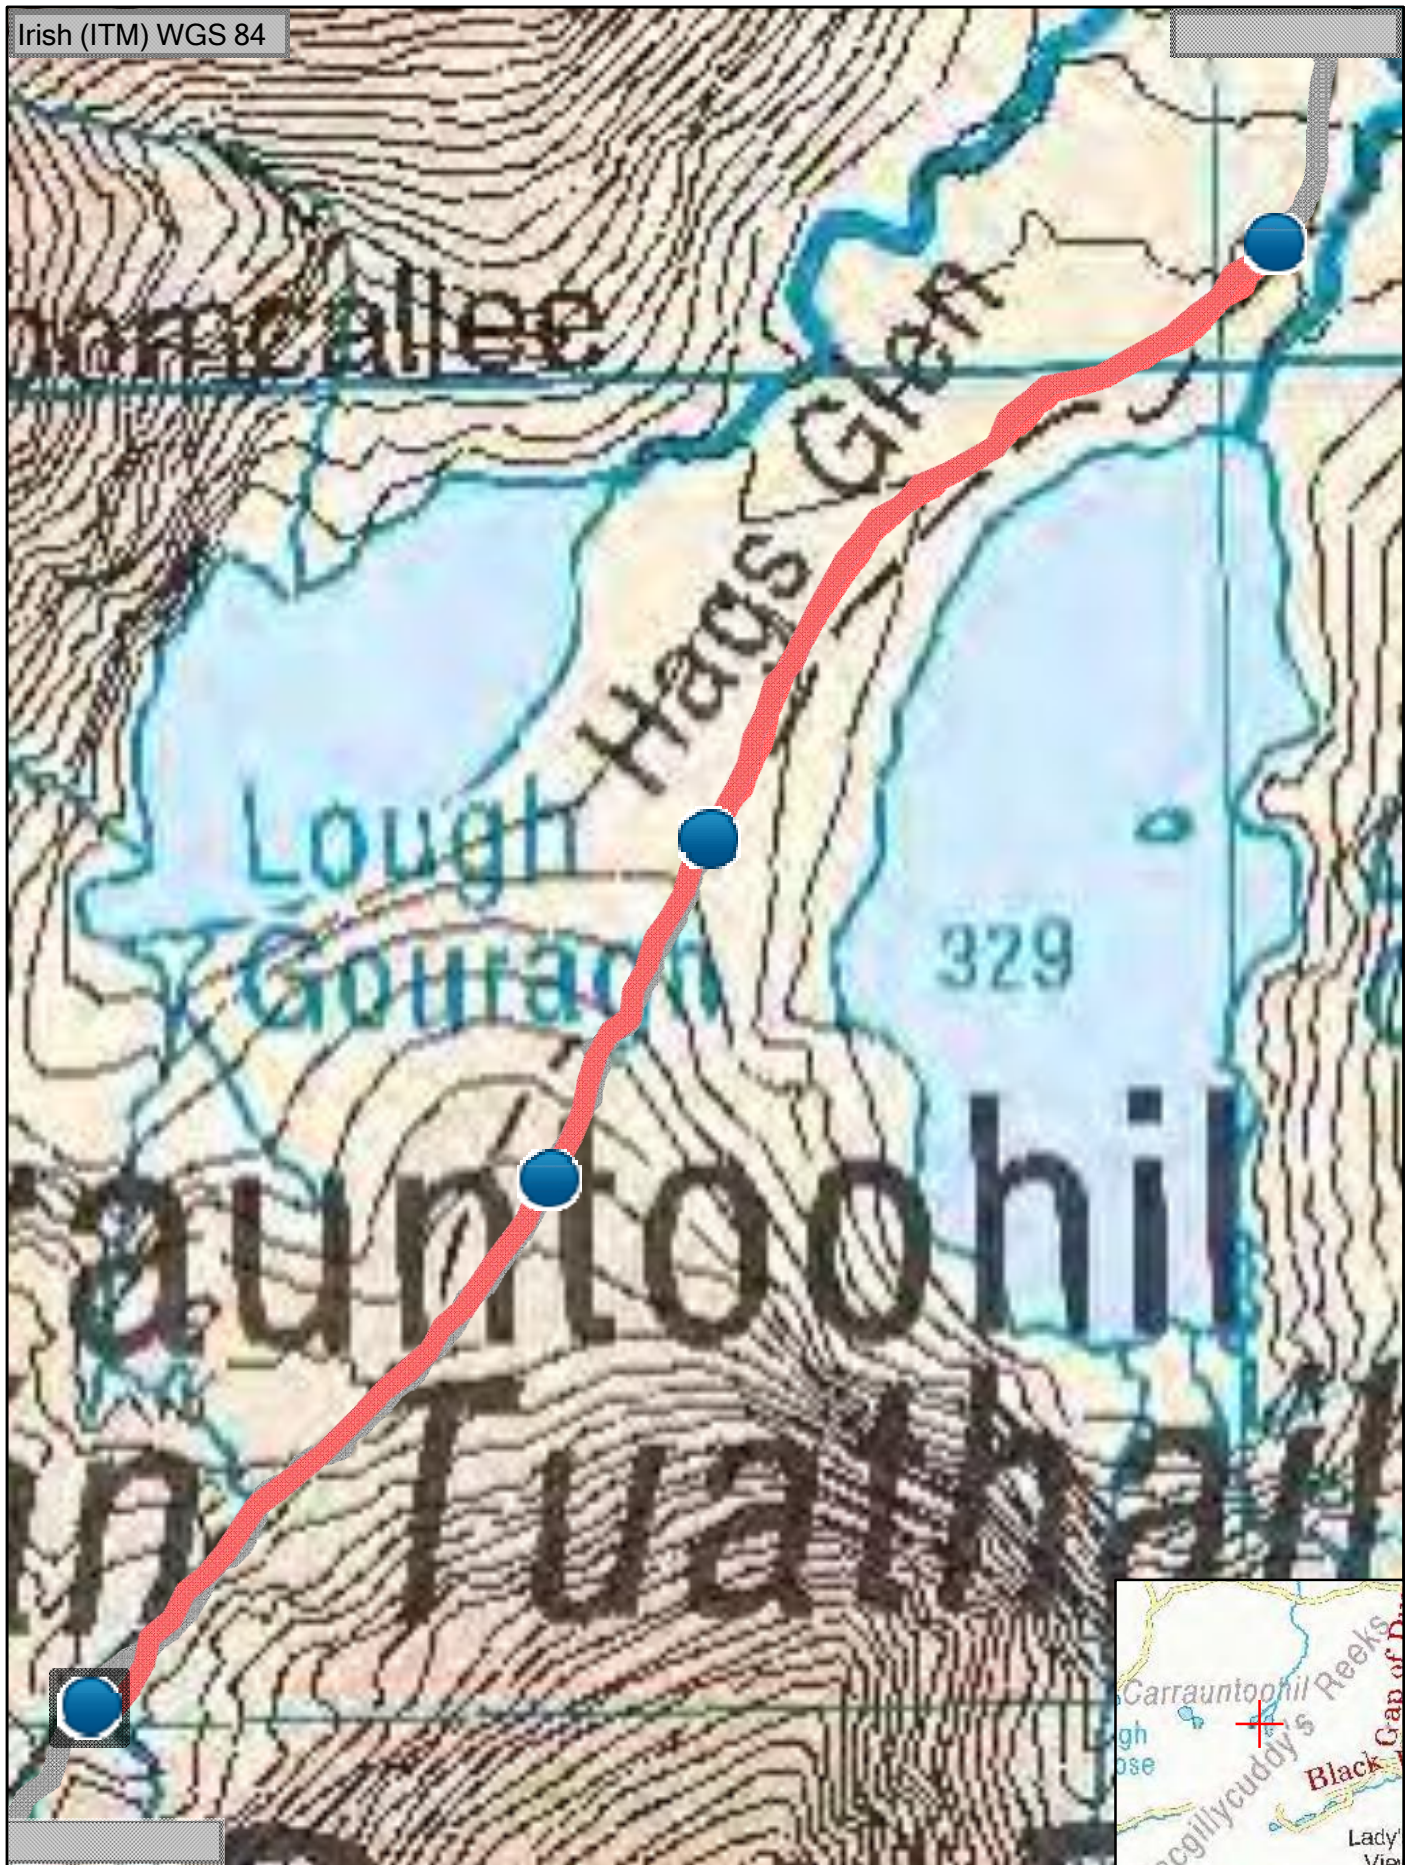
MR3 -Hag's Glen

The *MR3 Hag's Glen* path is almost opposite to the Devil's Ladder, in that the erosion is spread over a wide area on robust but worn terrain. The damage zone is well over 10 m wide in places and continuing to widen. The overall priority was 2, which is still very high, as the path is prominent, the damage is already high, and the dynamism is also high. Unlike the Devil's Ladder however, Hag's Glen can be repaired with well-established techniques, much of it by machine if this is permitted, and if not would certainly be an excellent site to develop path skills locally whilst repairing a highly visible scar on the landscape.

Figure 2 – Gullied Section

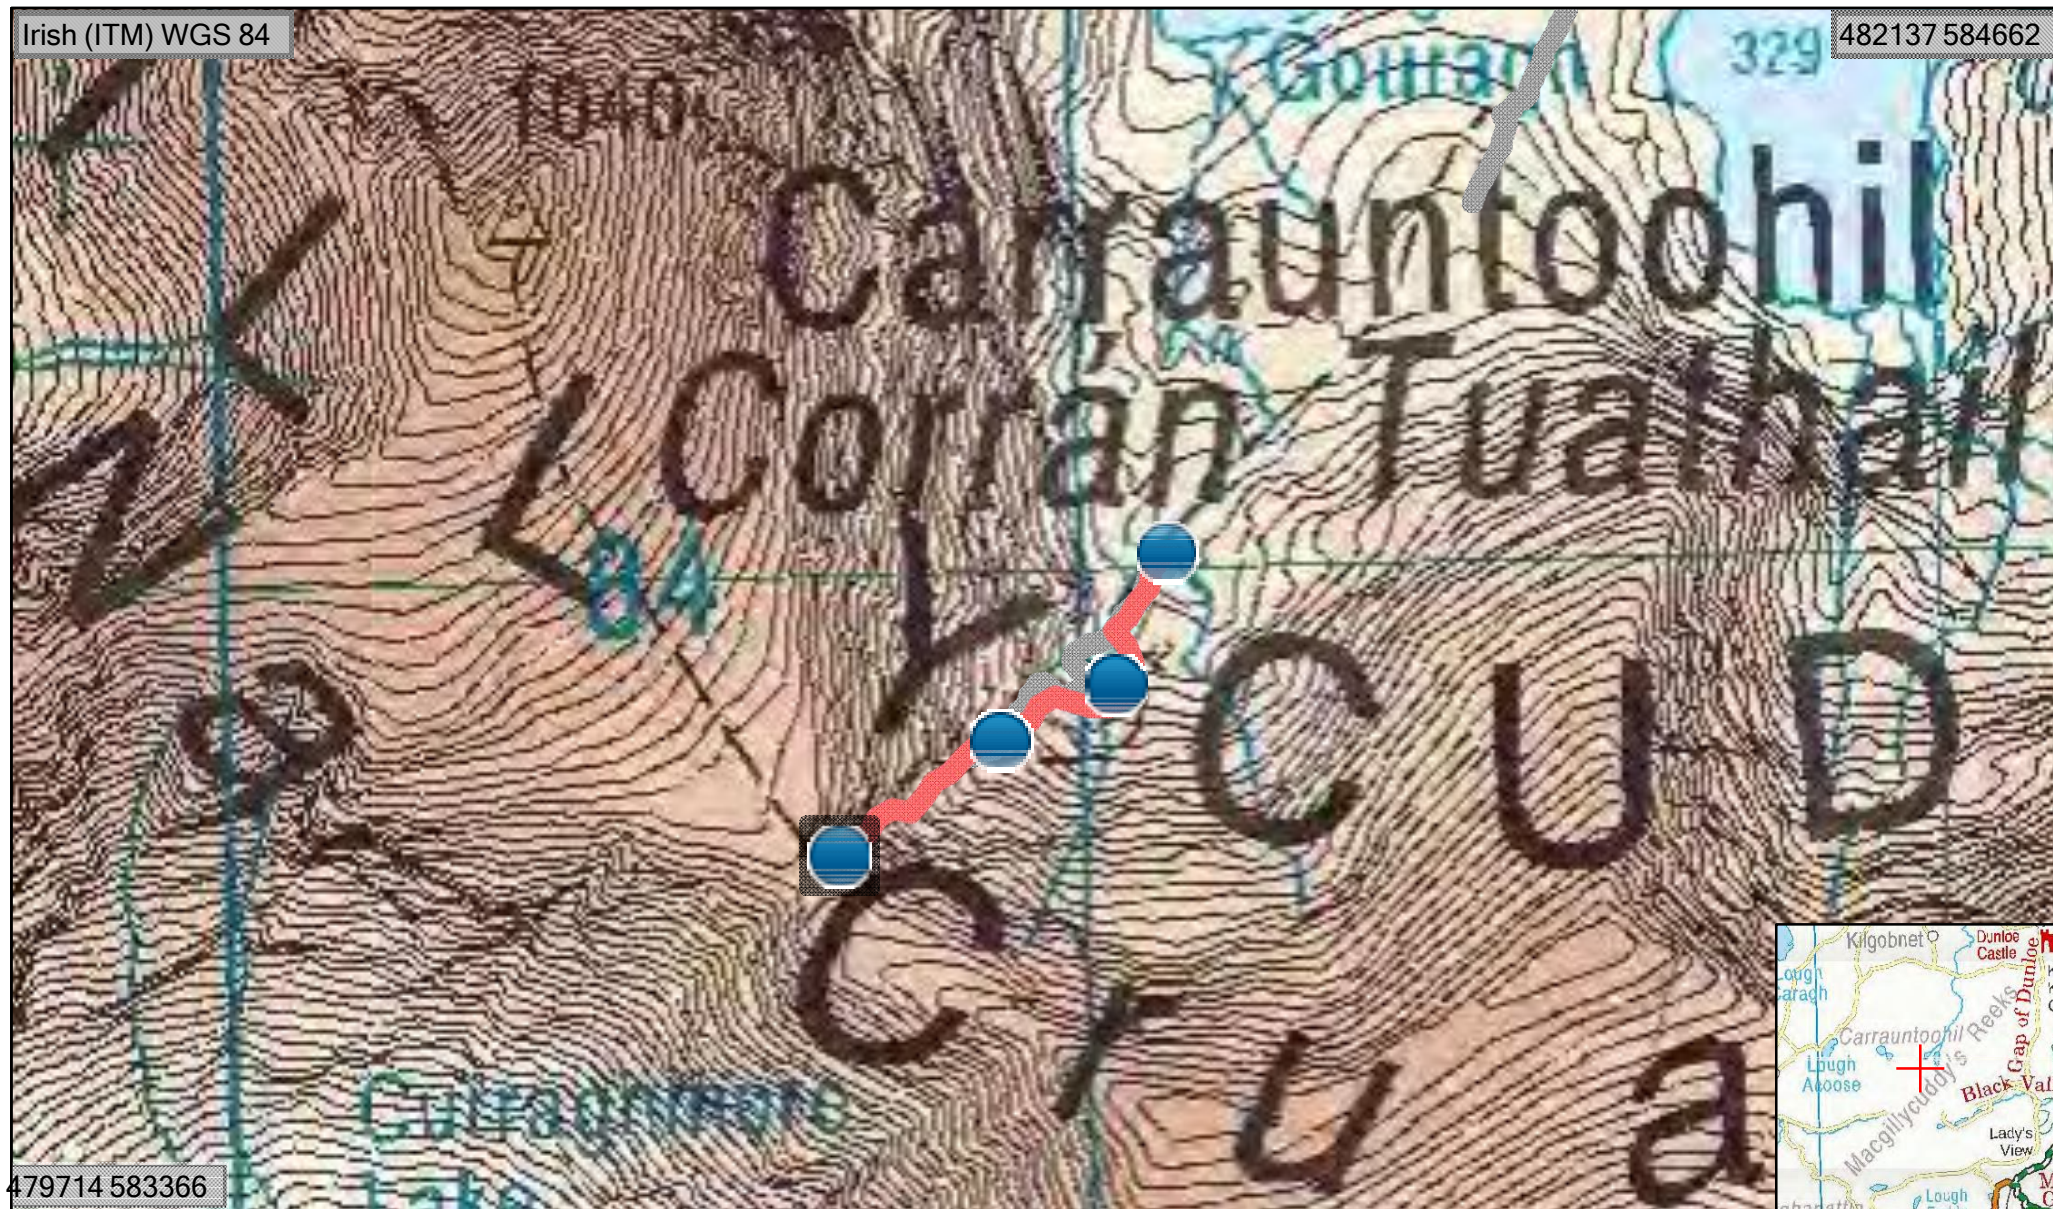
MR4- Devil's Ladder

The *MR4 Devil's Ladder* was clearly the highest priority, and certainly the one that everyone was talking about in terms of erosion. It has been suggested in some places that the path is dangerous, and should be avoided with use being moved onto ZigZag. The level of danger has been overstated in the surveyor's opinion, and avoiding the issue by spreading the problem elsewhere does not seem a sensible solution. The path is fixable and good similarities can be seen elsewhere, particularly in Glencoe and Torridon in the Scottish Highlands where solutions have been found that work without detracting from the landscape. It should be noted however that the evolution of upland path skills in Scotland was a slow and managed process with input from NGO's, Local Authorities and National Public Bodies, and the ability to carry out work of this complexity and challenge should not be attempted without a skilled work force with good experience of the techniques that will need to be used – pitching, revetment, alignment, light touch etc. The Devil's Ladder is sustainable however once fixed, as it is contained within a gully. This is not the case with the ZigZag, which is on open ground and has the potential to spread damage over a very wide area indeed in time.

Figure 2 – Severe Gullying beneath the Summit Ridge

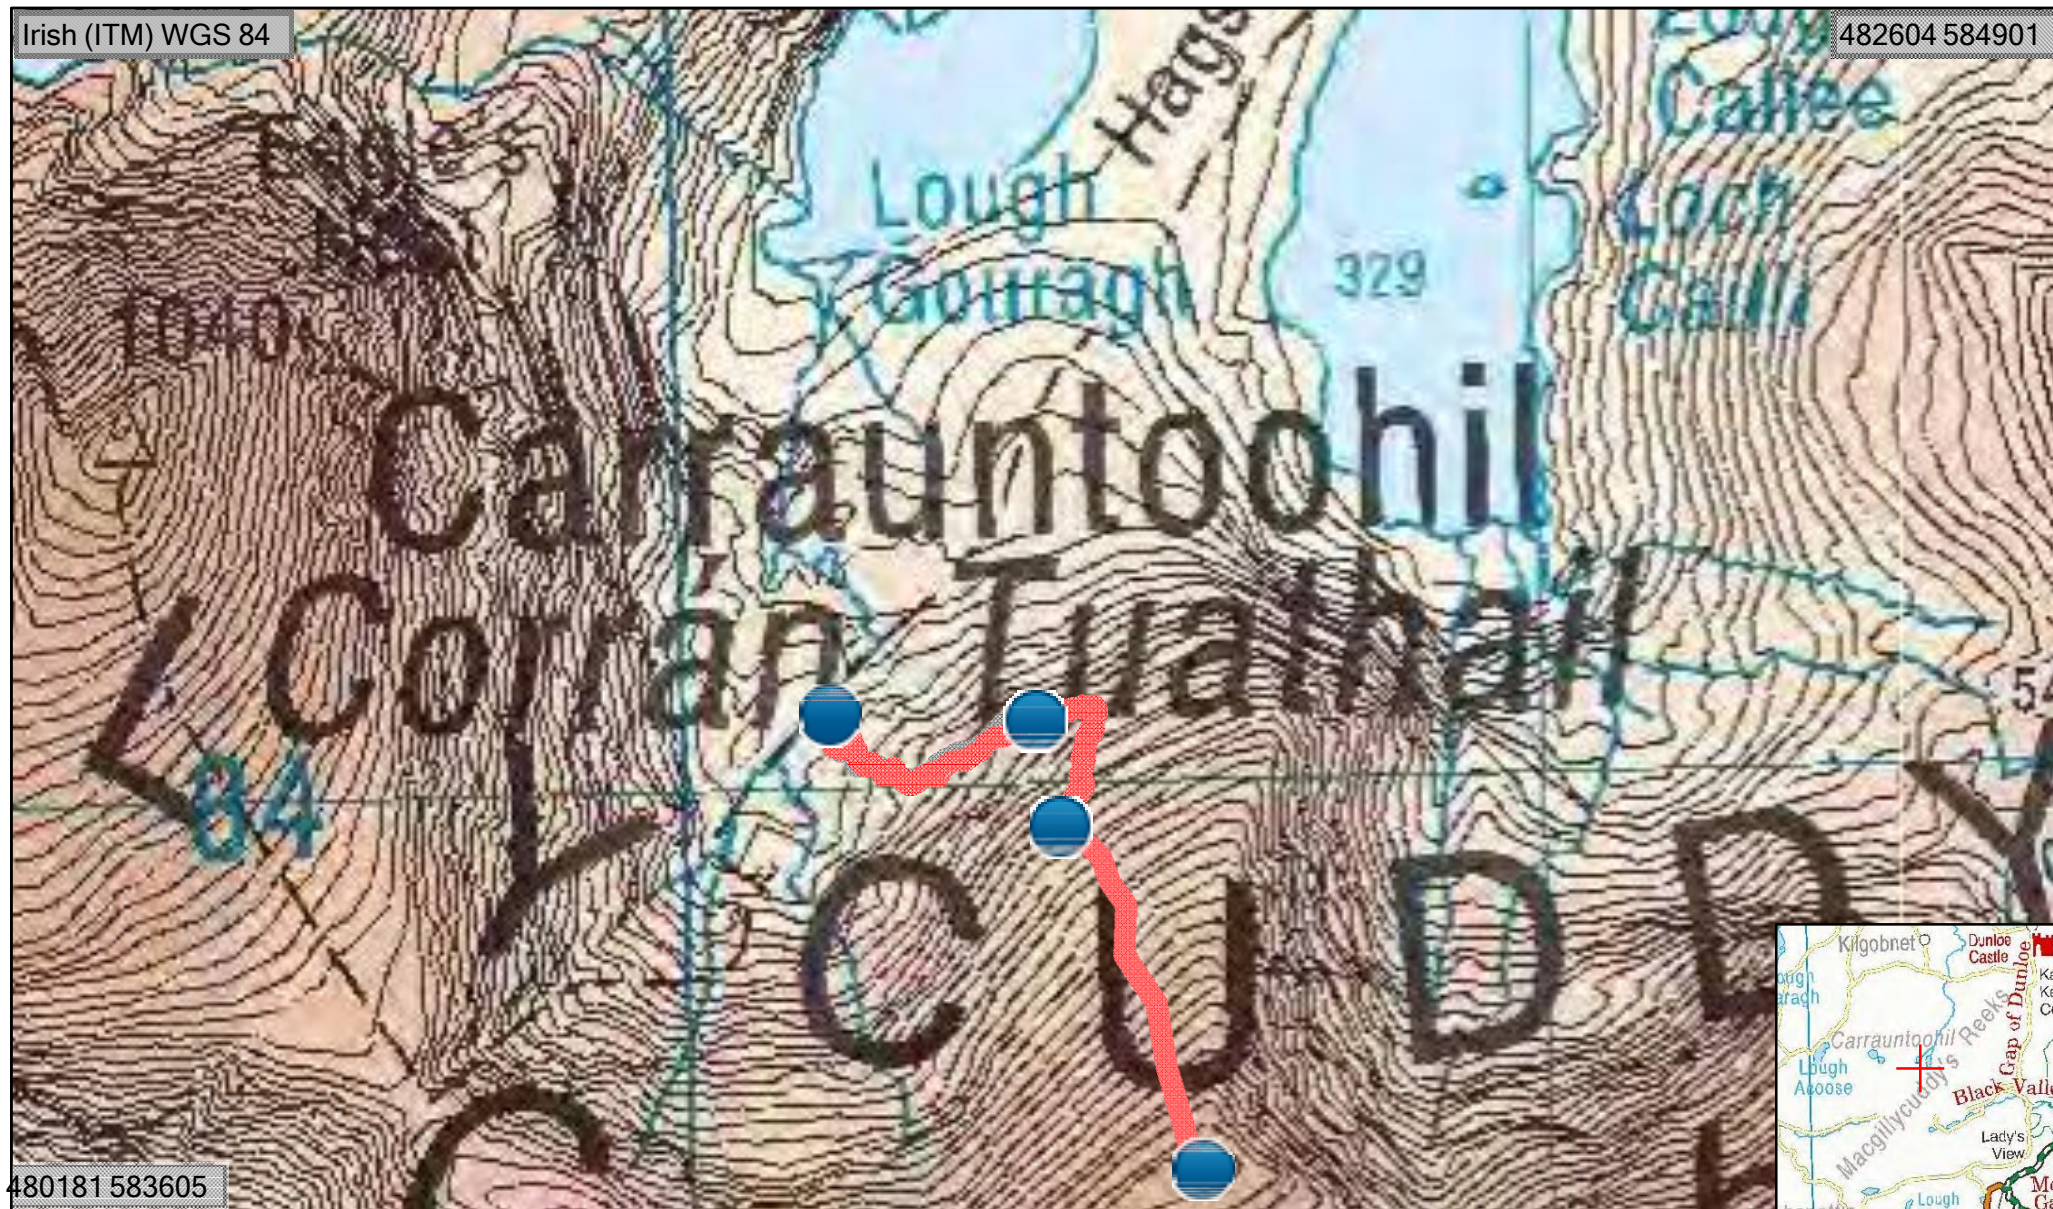
MR5-ZigZag

MR5	ZigZag	1,183	ZigZag is a developing route in preference to the Devils Ladder. It would be better to deal with the Devils Ladder and treat this path in a more light touch and pre-emptive manner. Monitor to see if use can be moved back onto a repaired Devils Ladder for main Carrauntoohil approach in future.	3	€26,000	2
MR6	ZigZag to Carrauntoohil	1,787	The path from the top of Zig Zag to the Devils Ladder is peaty and wet, basically okay, the approach to Carrauntoohil has numerous paths and braids and would benefit from light touch and pre-emptive works to reduce future damage.	3	€13,000	5
MR7	Caher	2,664	The Caher Path is fairly robust, though the lower peaty section is in bad condition. Machine construction on the lower sections would be fine here if done sensitively – Further up light touch and pre-emptive work would prevent further erosion.	3	€73,000/ 280,000	5
MR8	Beenkeragh	3,733	Excellent ridge hike and scramble over Beenkeragh, minor issues until reaching junction with the top of O'Shea's Gully. Worth doing some light touch and pre-emptive works to prevent further erosion.	4	€11,000	2

Figure 2 – Narrow path traversing the slope

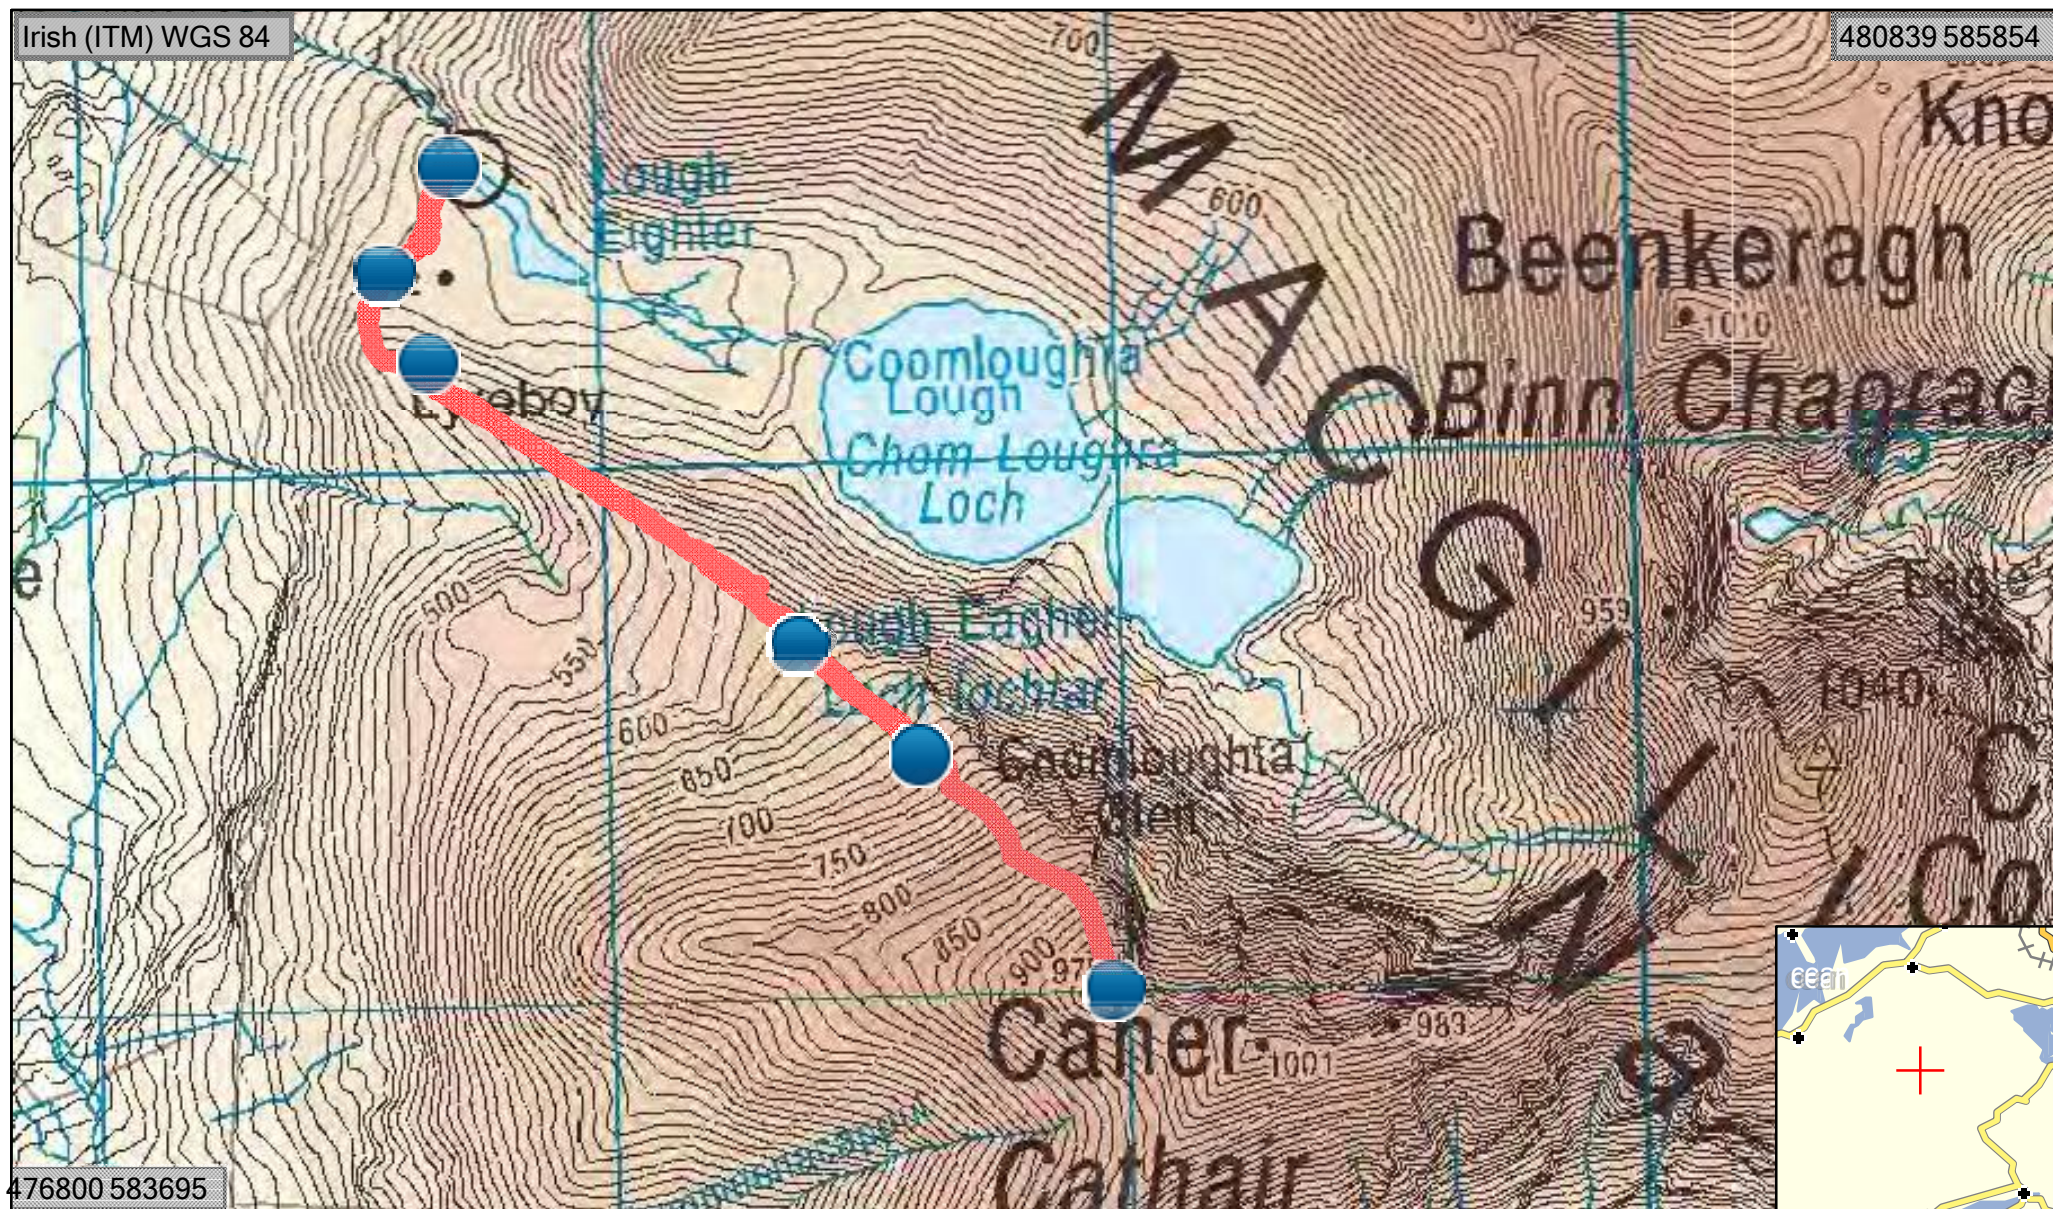
MR7 - Caher

Figure 2 – Small scale path erosion and spread on the summit approach

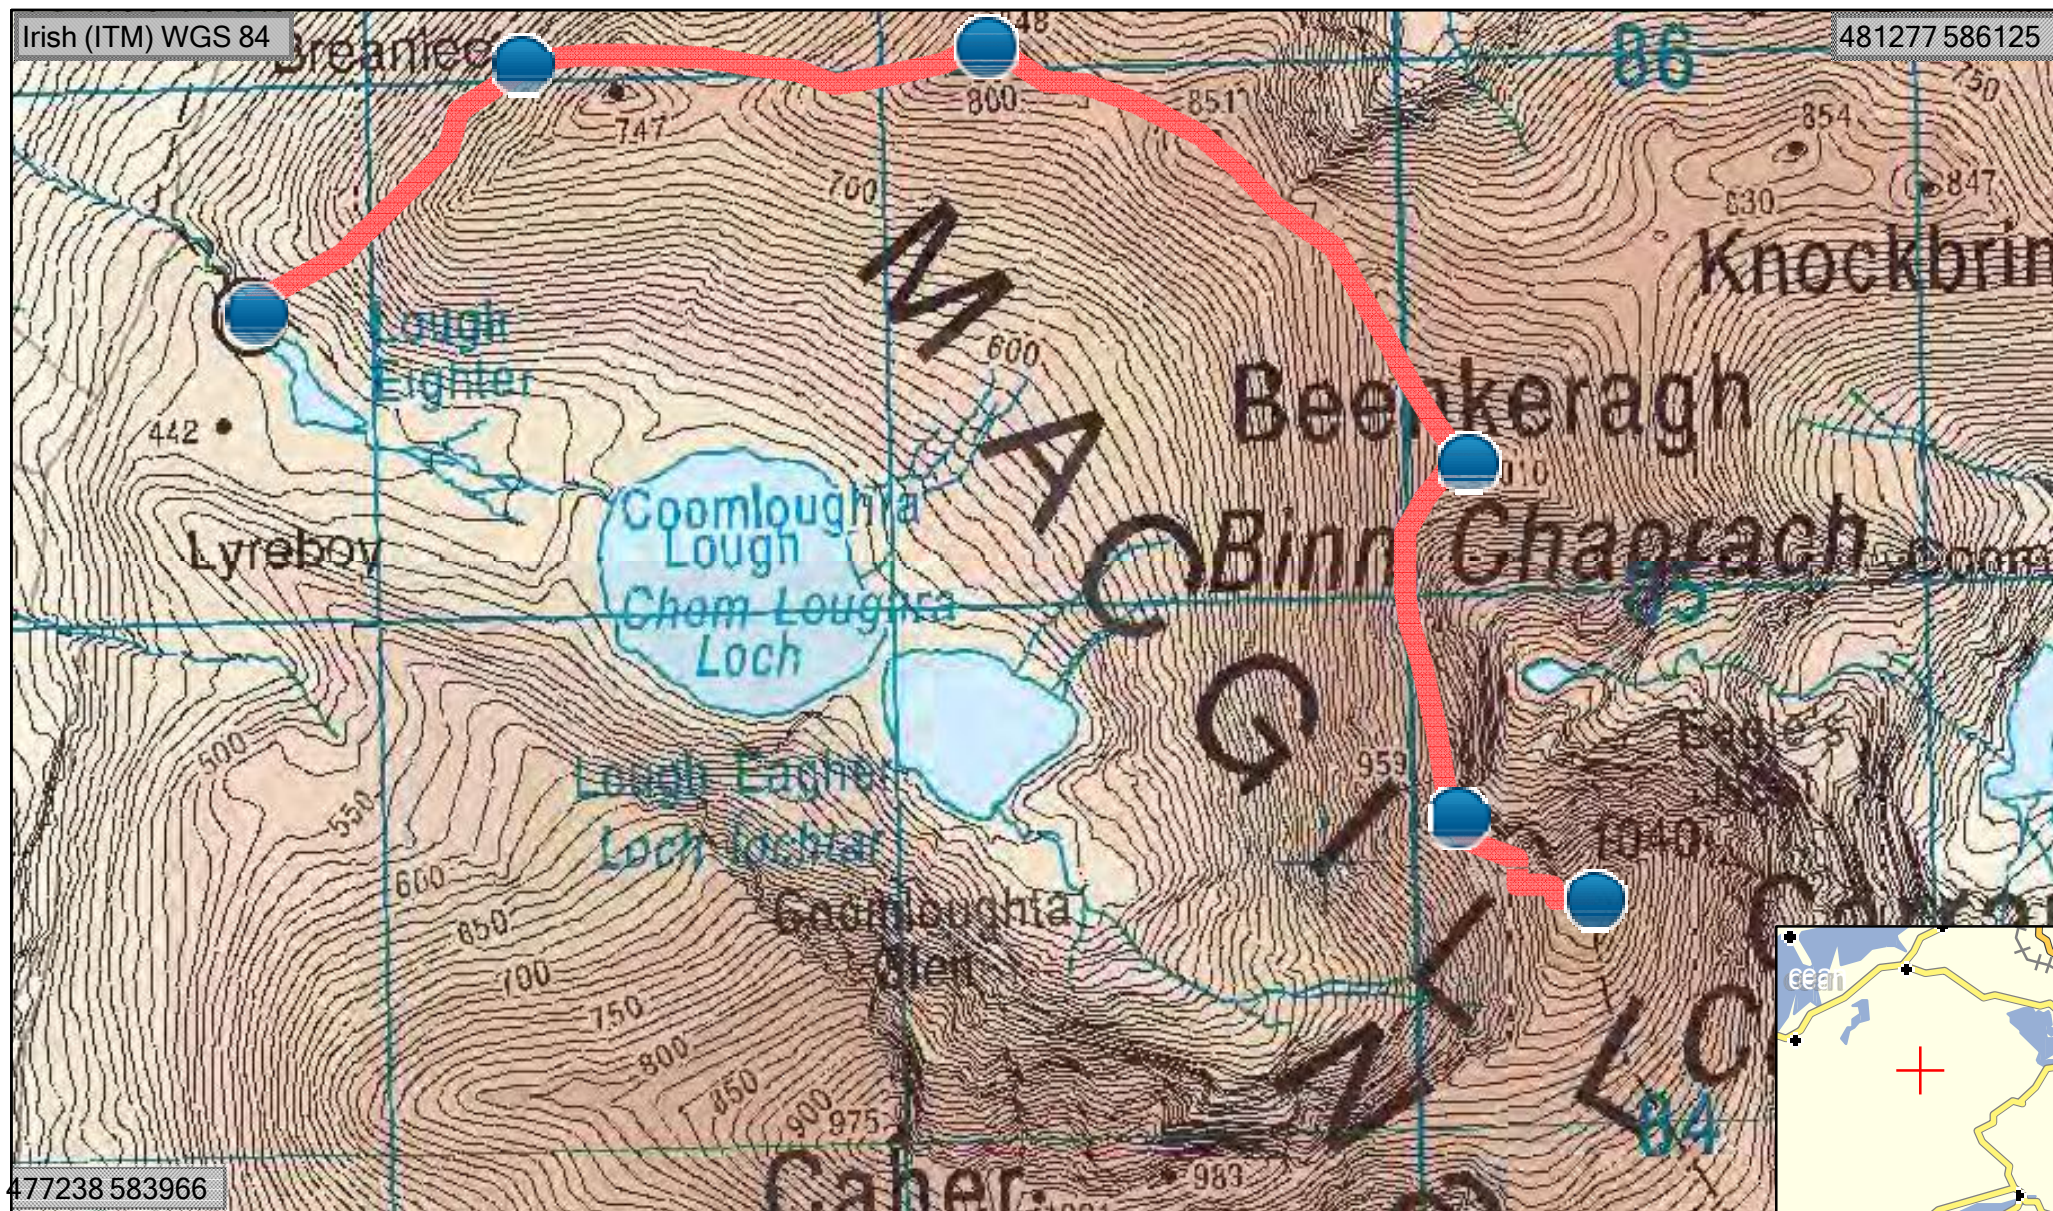
MR8 - Beenkeragh

Figure 2 – Narrow and robust approach Ridge path

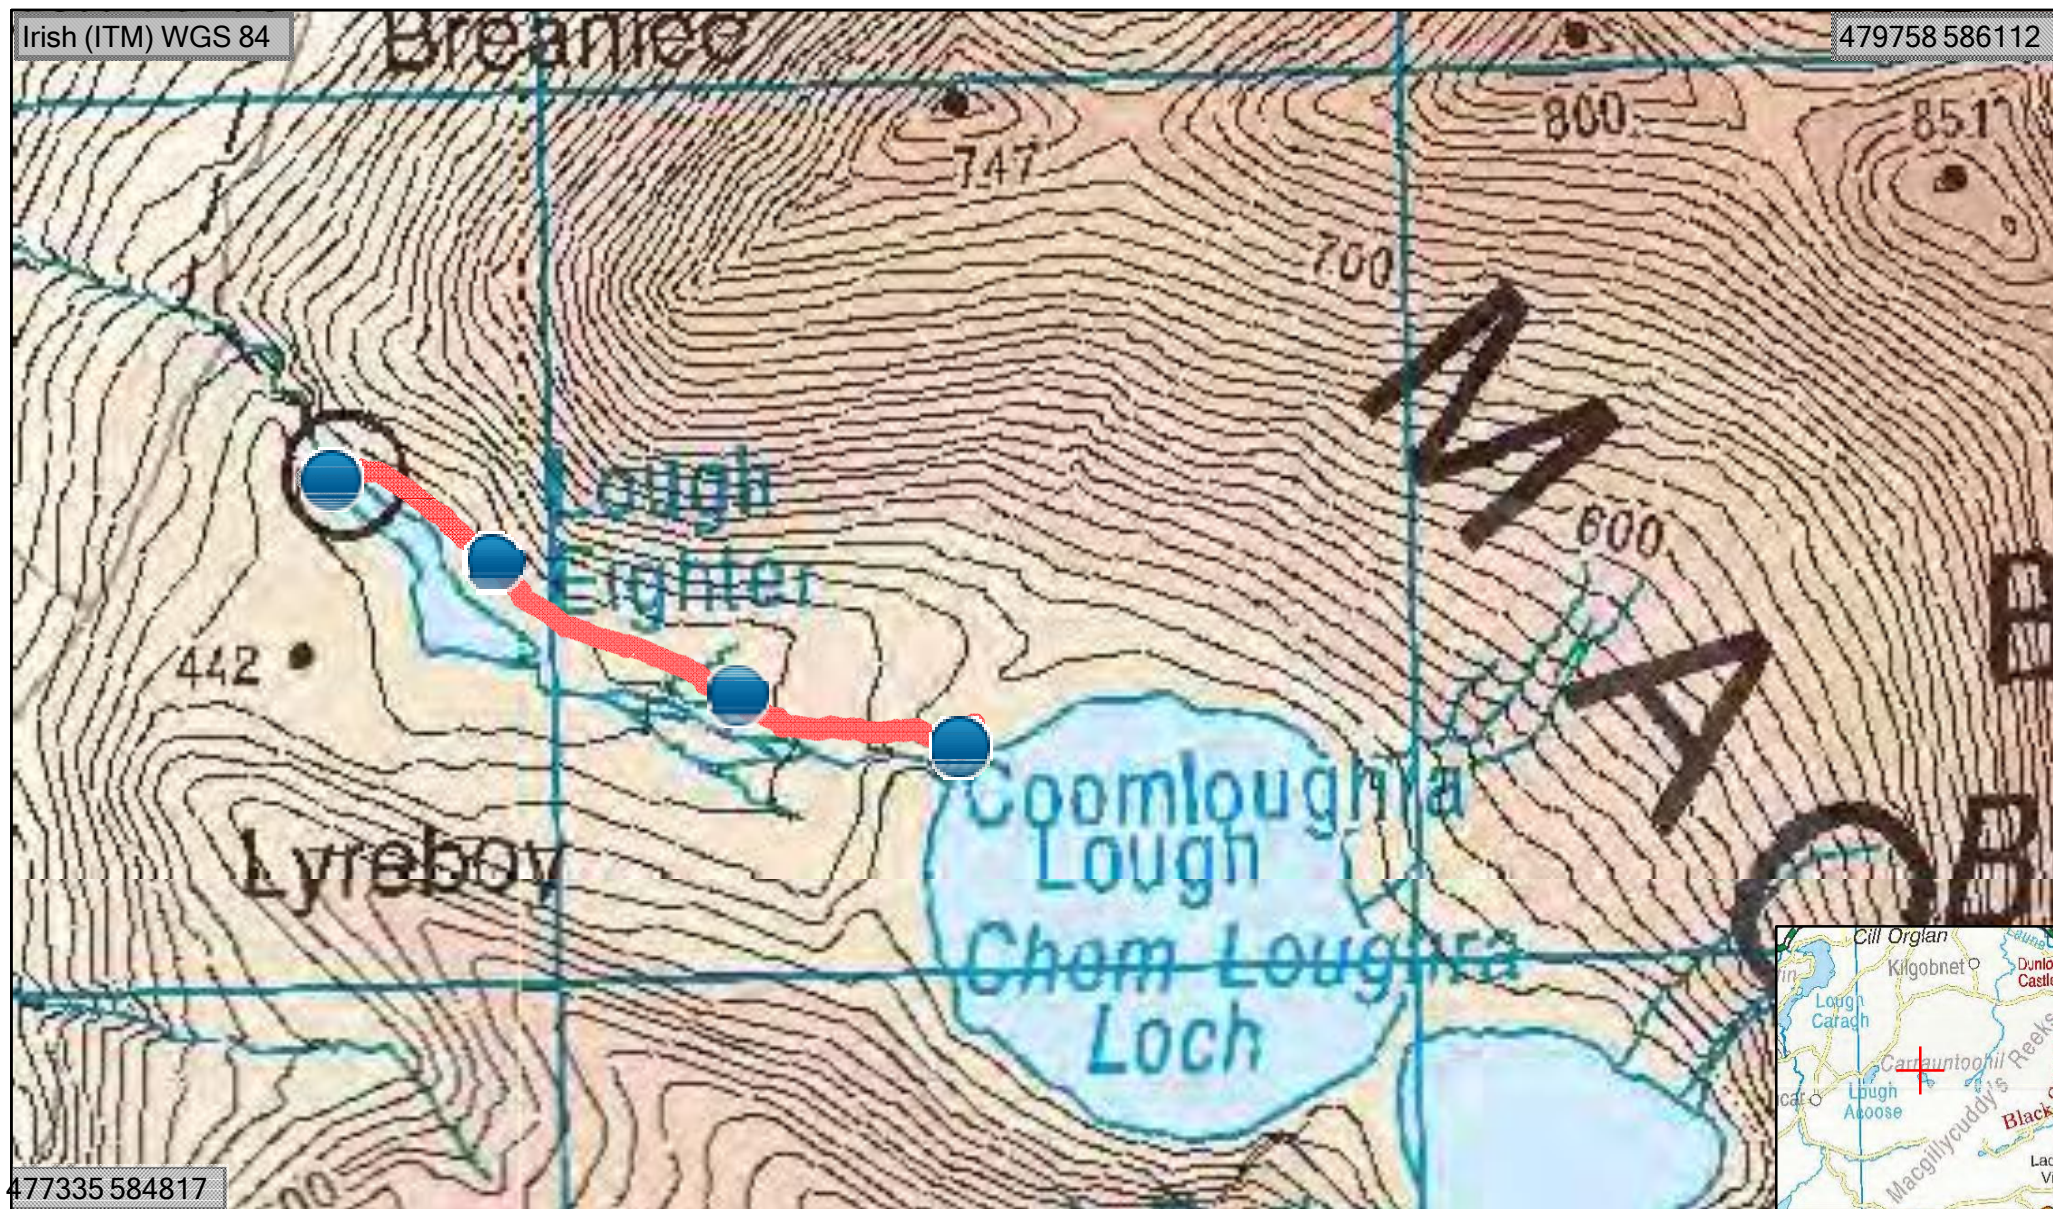
MR9-Coumloughra

MR9	Coomloughra	908	The Coomloughra Path is a worn and heavily used path as a viewpoint for the Caher Horseshoe, worn but fairly robust, would be easy to fix with a machine built path.	4	€28,000	1.5
MR10	O'Shea's	2,205	Lower sections from Hags Glen pretty good though spreading where path undefined/indistinct; V dynamic start to OSG proper at junction with Hags Glen path: Eroded, dynamic upper section	3	€54,000	3
MR11	Heavenly Gates	994	Majority of Heavenly Gates path in good condition (tight goat track) except for lower eroded section where joins OSG path; some work would be beneficial here with light touch only further up	4	€16,000	3
MR12	Turf Path	3,264	Hand Build track, with drainage largely slumped/blocked now, requiring repairs and drain excavated along full length. New from end of path to top	3	€83,000	5
	Totals	22,892			€612,000 /929,000	43

Figure 2 – Spread erosion approaching the Lough
