Pentland Hills Regional Park

Upland Path Audit 2016

Upland Path Audit, Priorities and Indicative Costings

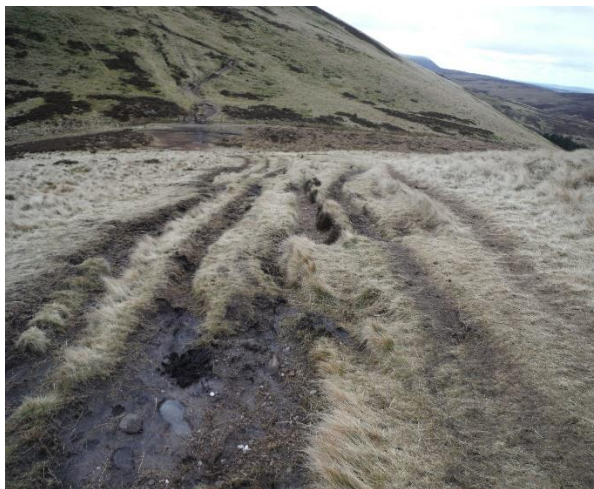
Uncontained High Level Erosion, suitable for machine build

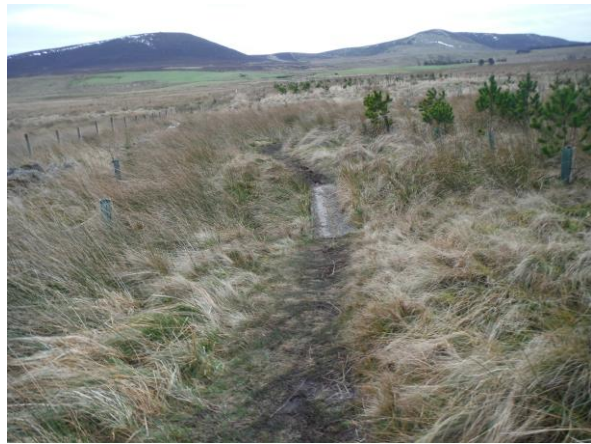
Section 2

The path appears to receive a low to moderate level of use, despite the quality of landscape and proximity to Edinburgh. This is likely to be in part due to lack of awareness of the route, and partly due to the poor quality of path there, with much of it wet and boggy.

- A raised machine built aggregate path is recommended from top to bottom.
- The bridges should be surveyed by a qualified engineer and look like, at least in part, that they should be replaced

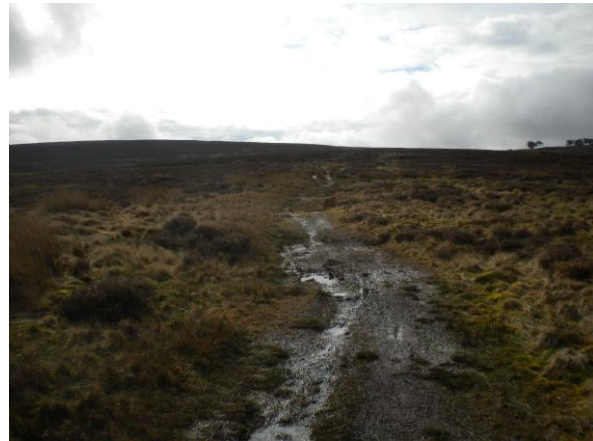
**Section 2**

Path Condition: <ul style="list-style-type: none">Section 2 is very wetSection 3 has had no previous work

- A raised machine built aggregate path is recommended for Section 3
- There is no work required on sections 1 and 2, where there is an existing vehicle track

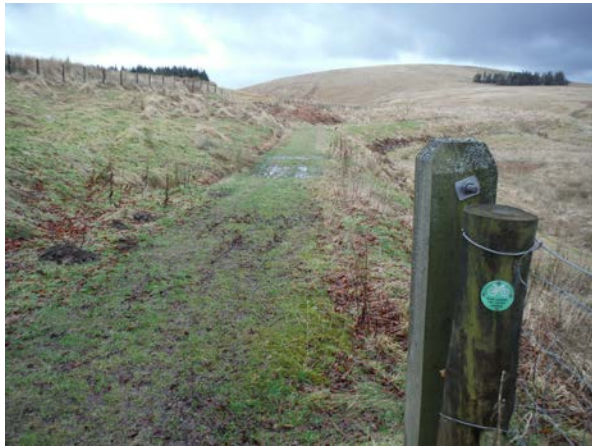
Section 1.

Wet, peaty and eroding path ascending from North Esk Dam up to Bore Stane. Require heavy build solutions top to bottom, apart from first 2 sections where track improvement only is required. Some hand build required due to steep crossslope

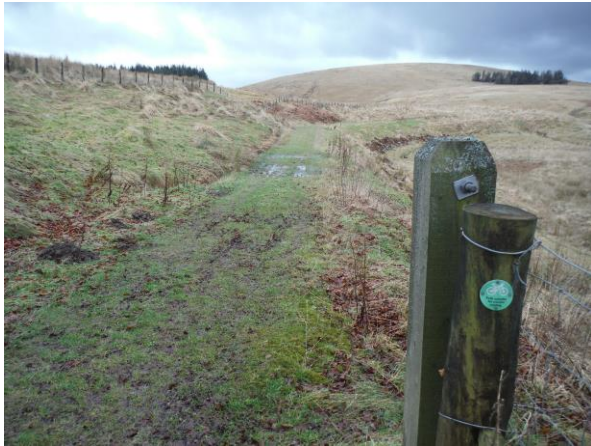
**Indicative Photographs of Path Condition
Section 1.**

Path Condition: <ul style="list-style-type: none">The track is generally in good condition throughout, and appears to be regularly maintained			
Recommendations: <ul style="list-style-type: none">No work required

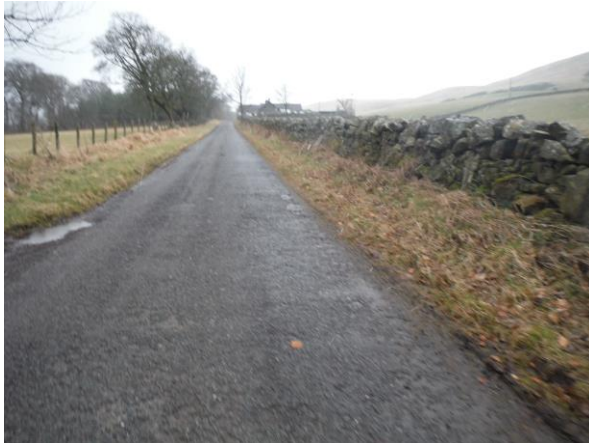
Indicative Photographs of Path Condition
Section 1.

Path Condition: <ul style="list-style-type: none">The Road is in good conditionThe Path is in poor condition and requires full build

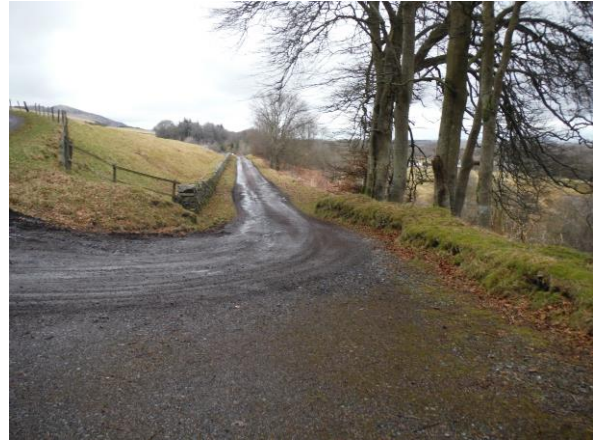
**Section 2**

Sections 1 and 2 are built road. Section 3 is an eroding pedestrian route to the Carlops Road, and well worth upgrading/repairing. Requires handbuild due to site constraints

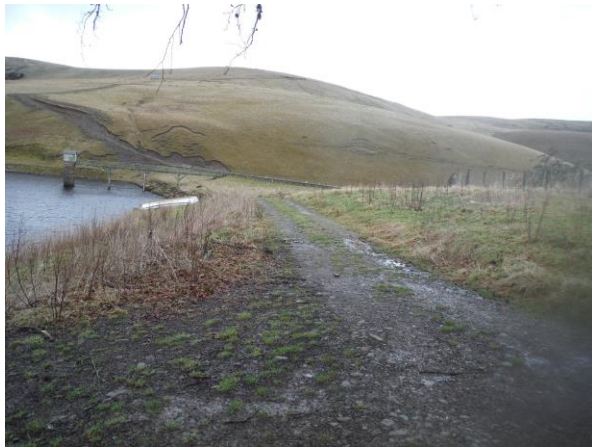
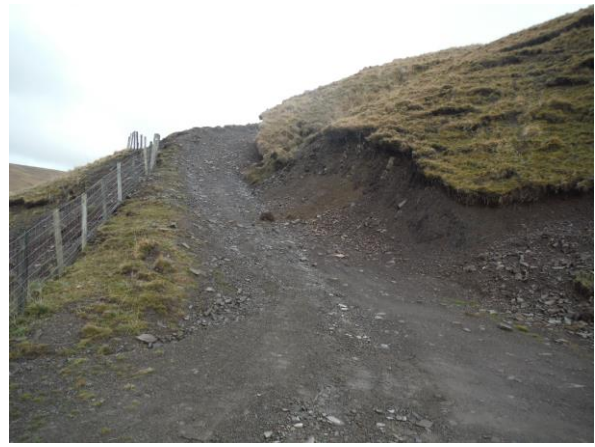
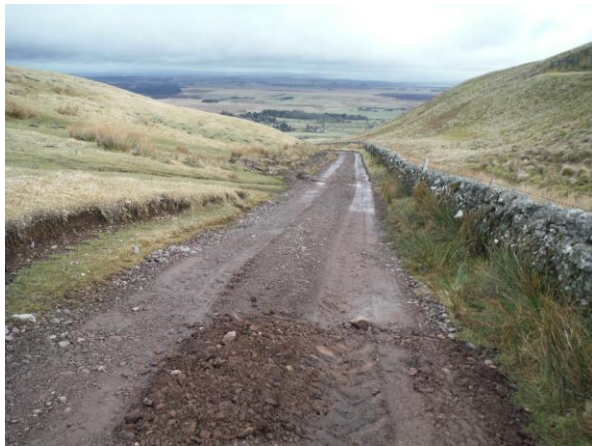
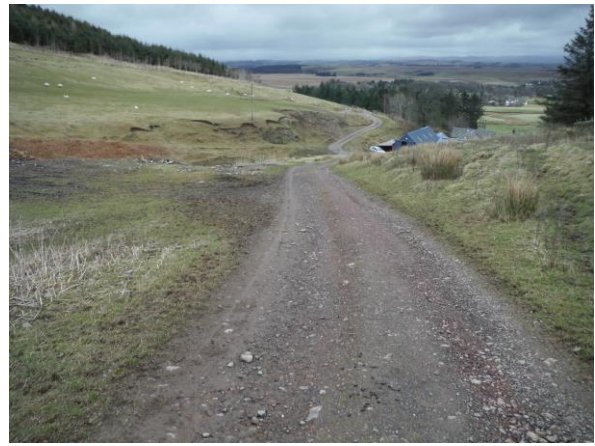
Path Condition: <ul style="list-style-type: none">The Road is in good condition			
Recommendations: <ul style="list-style-type: none">No Work Required

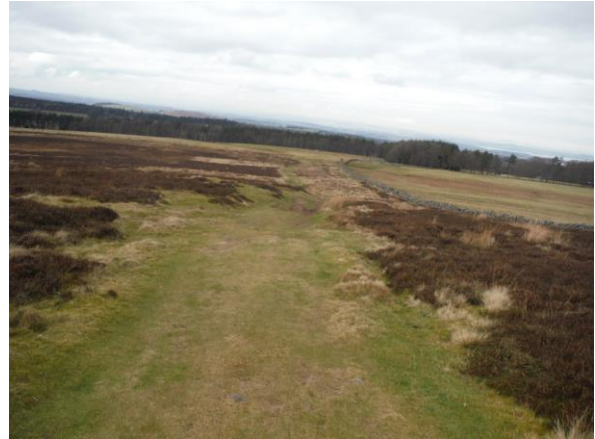
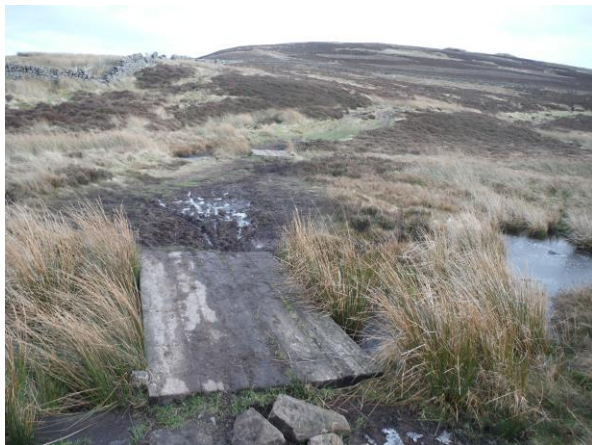
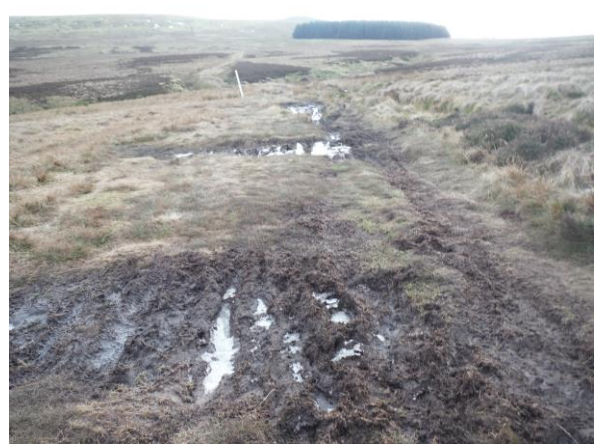
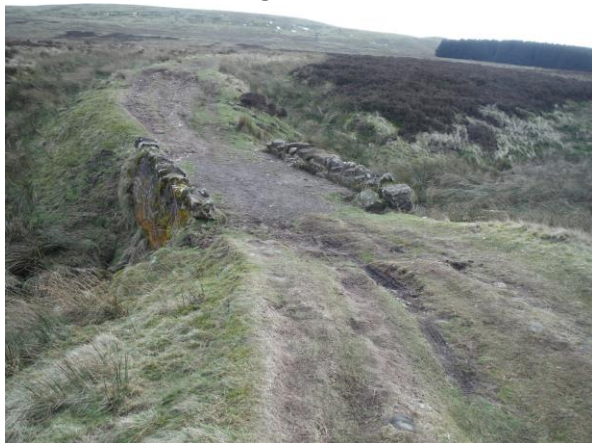
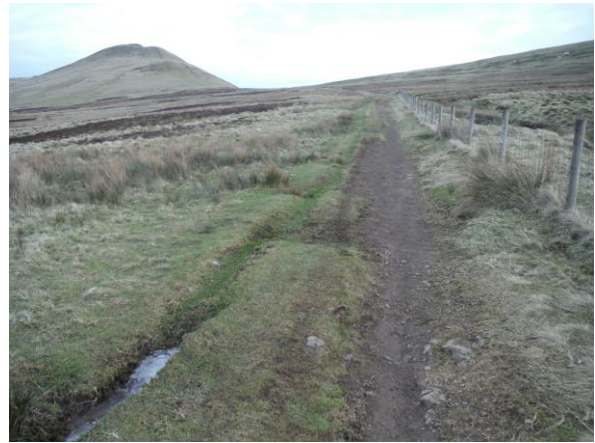
Path Condition: <ul style="list-style-type: none">The ditches are slumping and the drainage system is breaking down. The surface itself has also slumped in places, and is generally overlain with a layer of soft muddy material

Built Track up the high point, and junction with the path over the tops. Soft and beginning to break down. Could use ditch excavation and surface built up for Sections 3, 4 and 5. Minor drainage (2m+ Water Bars) on grassy sward at section 2

Recommendations: <ul style="list-style-type: none">Full Machine Build for the entire length, with ditches re-excavated and surfaces scraped and raised 150mm

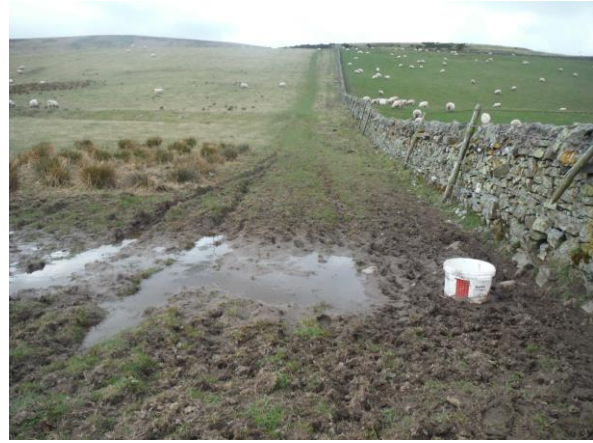
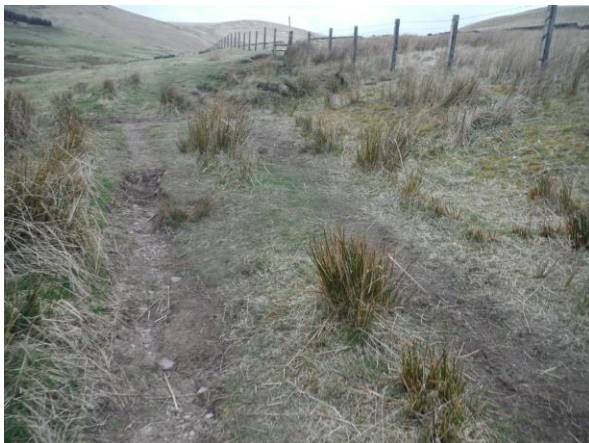
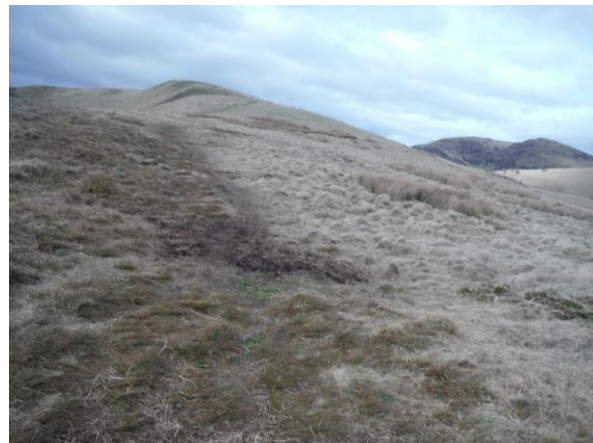
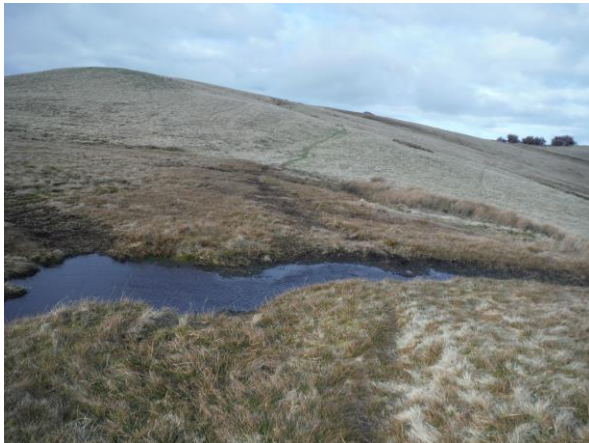
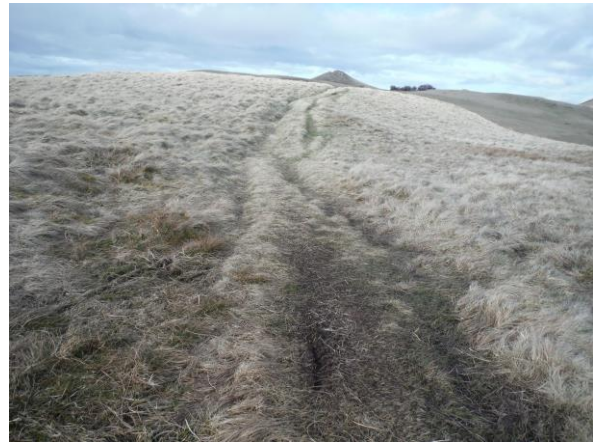
Path Condition: <ul style="list-style-type: none">The path is a trod for its entirety, and is soft and beginning to break downUpgrading the track would prevent further deterioration and make it more attractive for a wider range of users

Path ascends the rib to the Col, a very pleasant route giving great views of the Pentlands. Beginning to break down, lower priority requiring machine build path

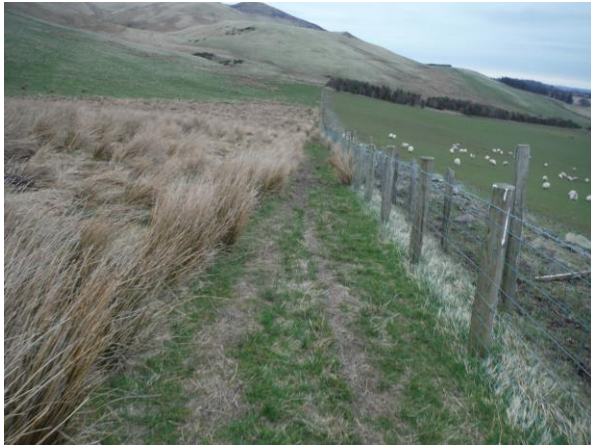
**Indicative Photographs of Path Condition
Section 1.**

- The path is a mixture of muddy wet trod lower down, with sections of old atv track further up, and beginning to break down in places
- Upgrading the track would prevent further deterioration and make it much more attractive for a wider range of users

Muddy wet trod over moorland to Quarrell Burn. Full machine build

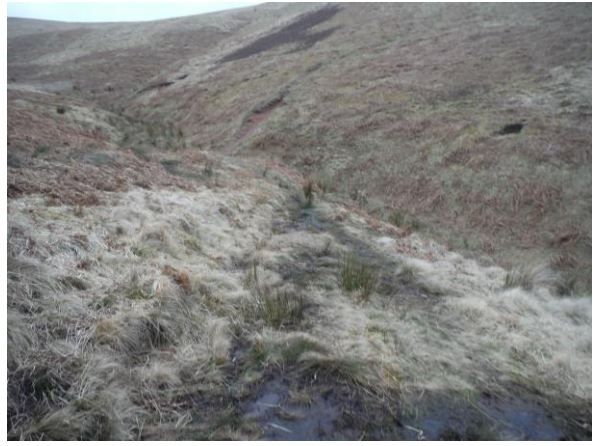
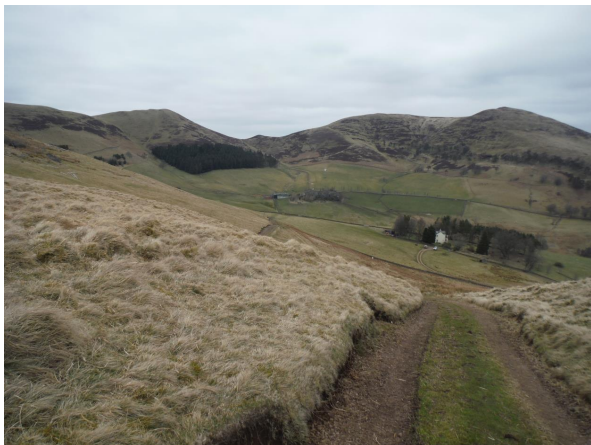
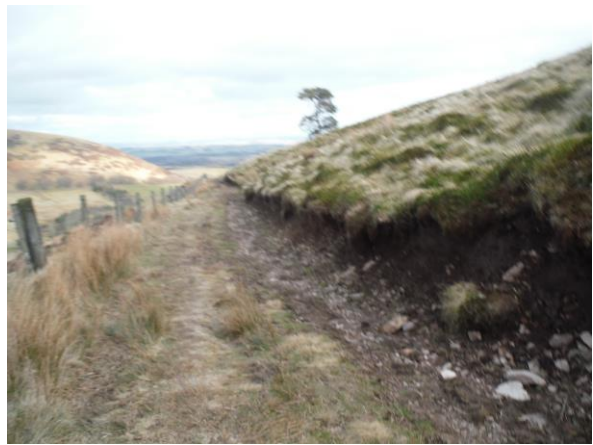
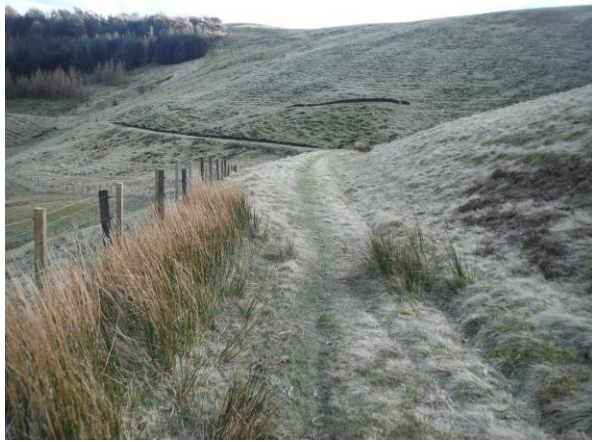
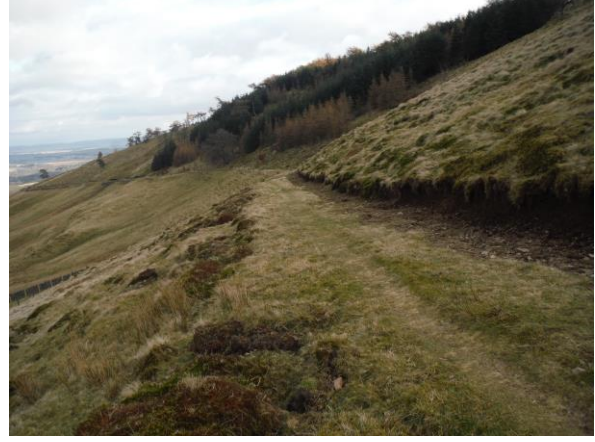
Old built benched vehicle track traversing slope, getting broken up in places. Could use lateral drain along length, skimmed and built up 100mm

Gate to stile at Col. Grassy overgrown vehicle track, in good condition. No Work Required

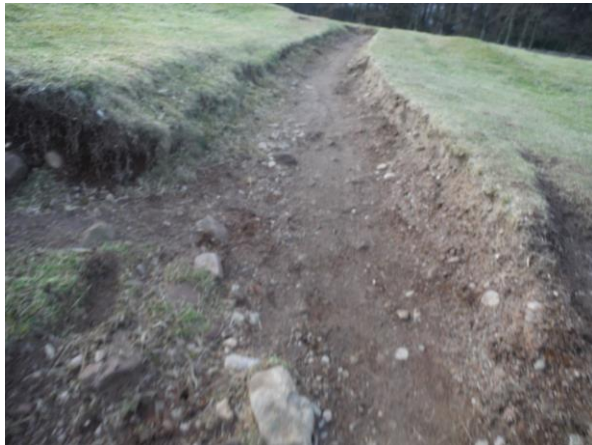
**Indicative Photographs of Path Condition
Section 1.**

- Built section 2 mostly good but needs drainage
- Section 1 is breaking down badly and gives a poor first impression of the standard of route Full Build required
- Sections 3 and 4 need some attention, and if there is a bridge being built this would help greatly with realignment

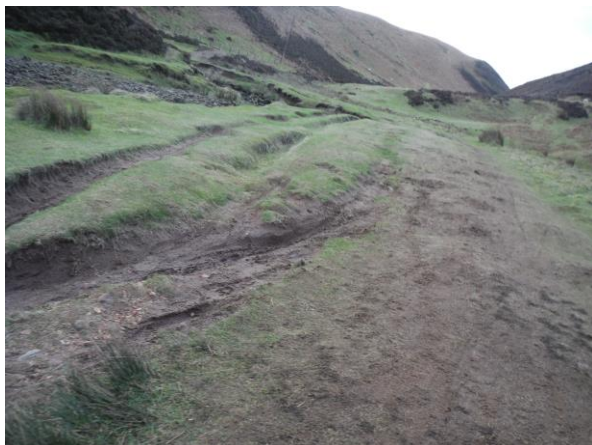
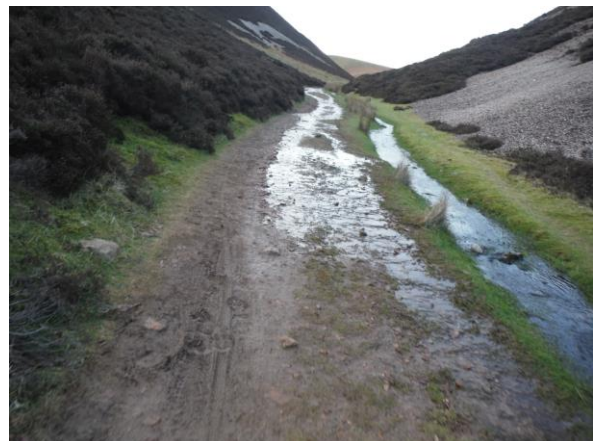
**Section 3**

Track to burn crossing. There is evidence onsite of bridge foundations for a new bridge to be installed. If so this would be a great help. Track worn in places, needs drainage badly, plus skimmed and raised 100mm

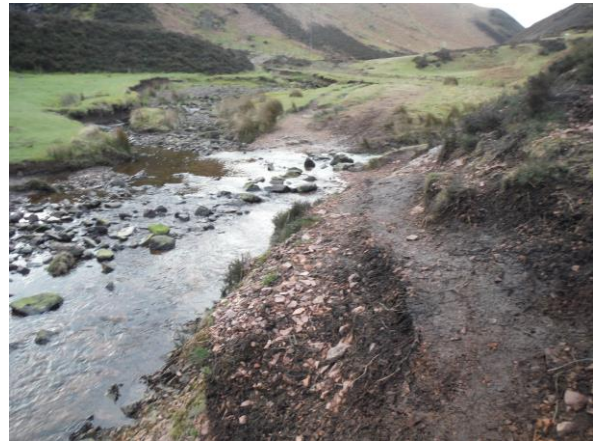
Section 4 – could be realigned from problem area with new bridge?

broken down section to burn crossing. If a new bridge is to be built the path could be realigned to cross the burn earlier, which would improve things markedly

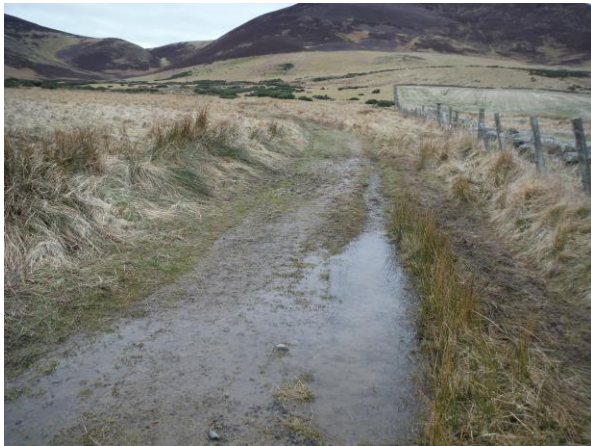
**Indicative Photographs of Path Condition
Section 1.**

- Section 1, 2, 3 and 4 all need a full build along the entire length
- Section 5 is a bit worn, but on an open and robust slope. The work on this section is of a lower priority than the others.

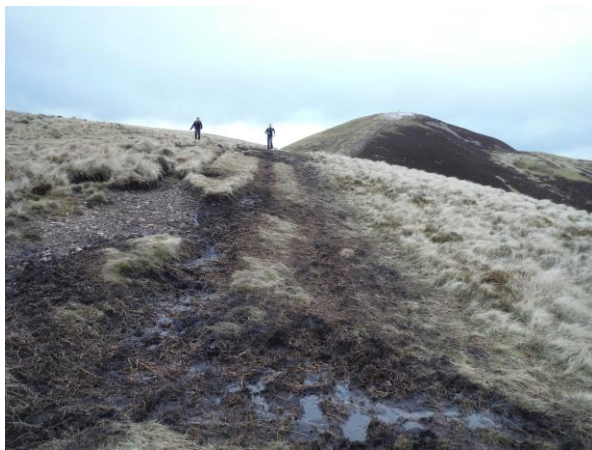
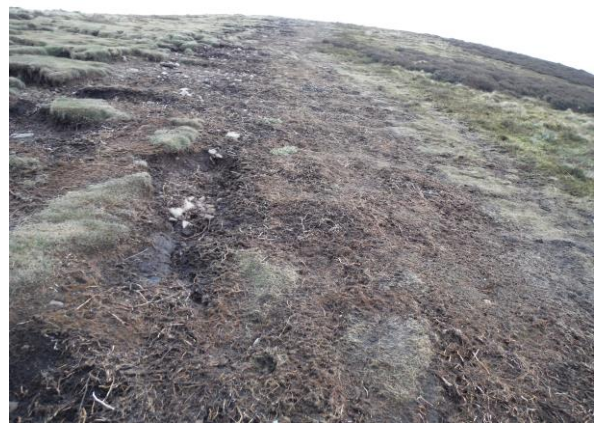
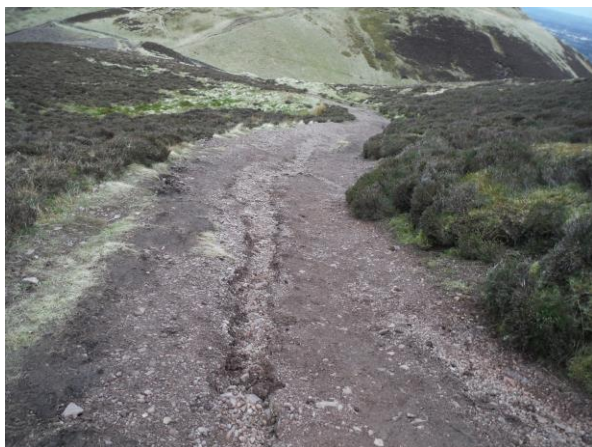
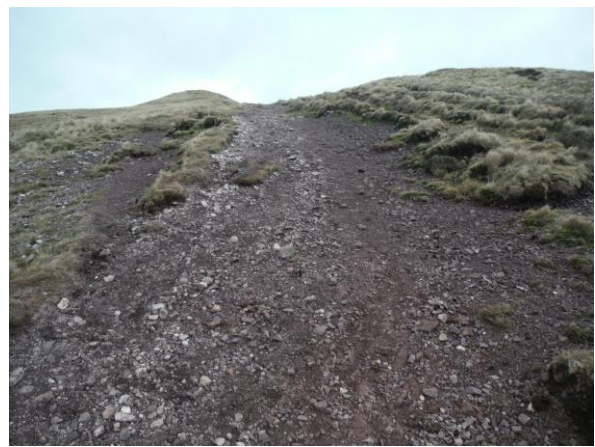
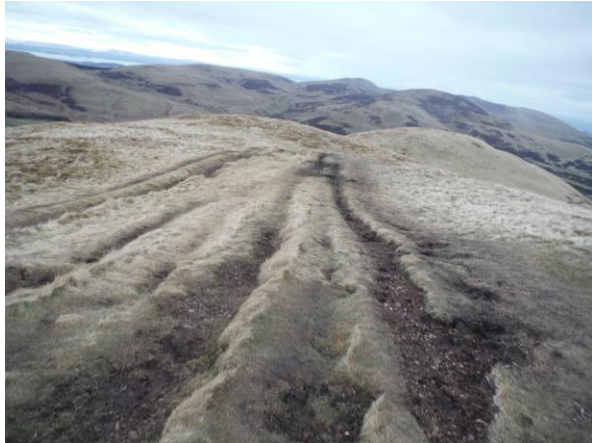
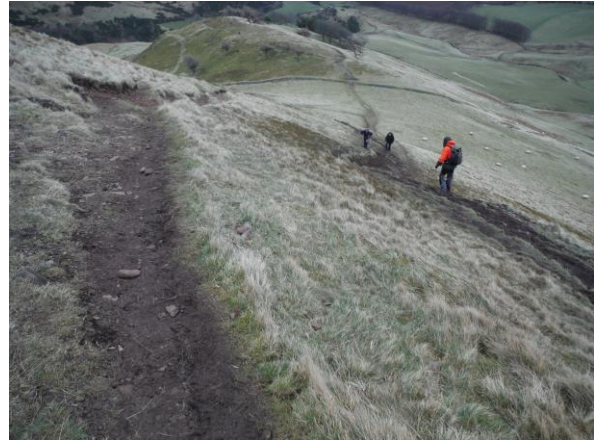
- The path is breaking down along its length, even though it is on generally fairly robust ground. There is multiple braiding, many wet muddy areas where the fabric of path is breaking, and other sections where the steeper sections are scouring, gullying and approaching a critical point in their condition

High ridge path crossing Carnethy and Turnhouse Hills, and one of the most popular routes in the Pentlands. Eroded along entire length and requiring full build construction along entire length
--

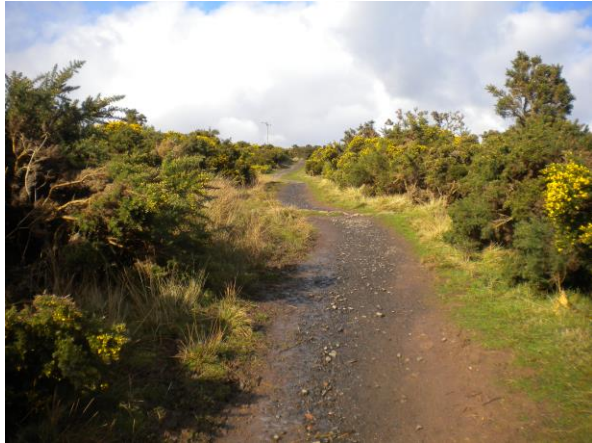
Generally good condition. Some waterbars need rebuilt and some additional anchor bars are needed. Would suite a handbuild maintenance contract

Maintenance required on section 1. Stone available on site. Machine build section 2

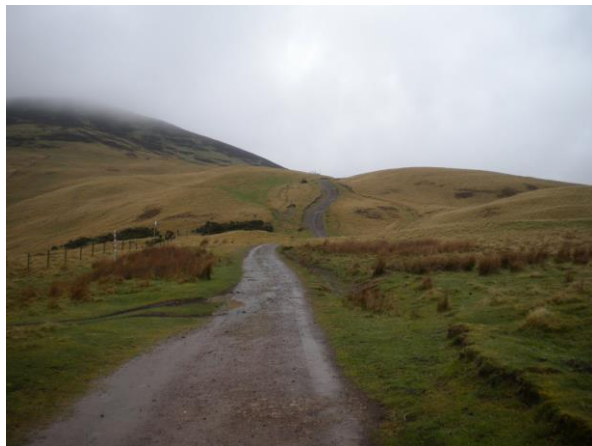
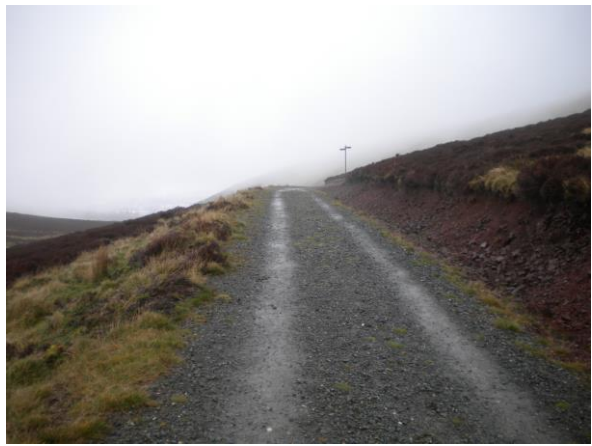
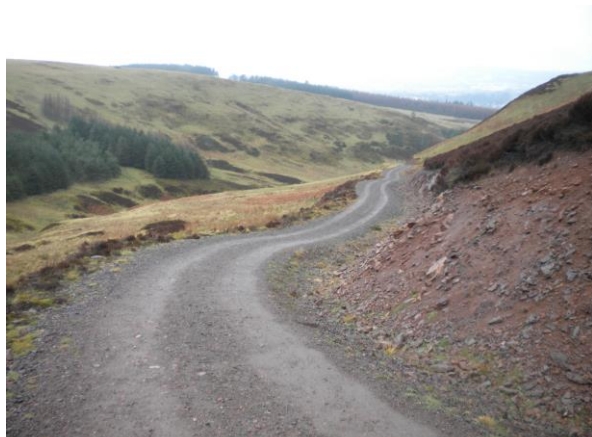
Landrover track in good condition. No work required

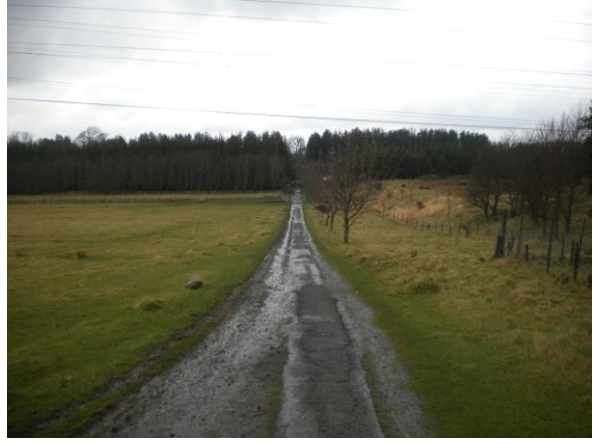
Section 6

Sections 1 to 3 follow a landrover track which is in very good condition. Recommend full machine bild on sections 4 & 5 to lik up with the carpark at Dregghorn. Machine access is straightforward.

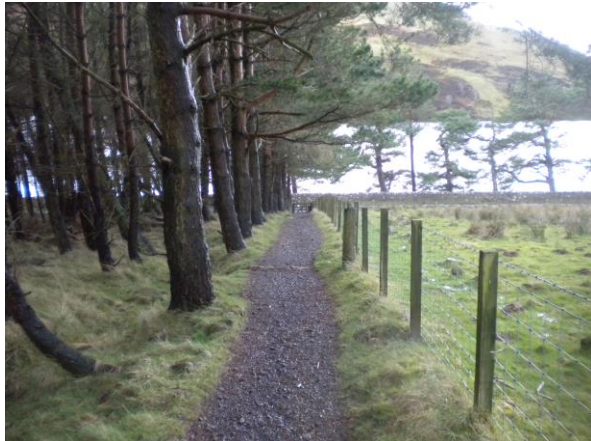
No work needed on this route.

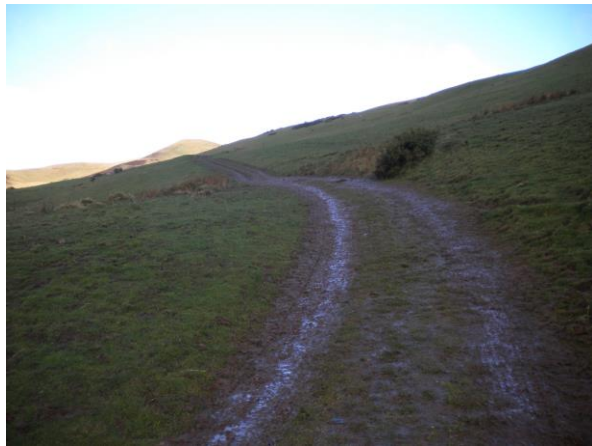
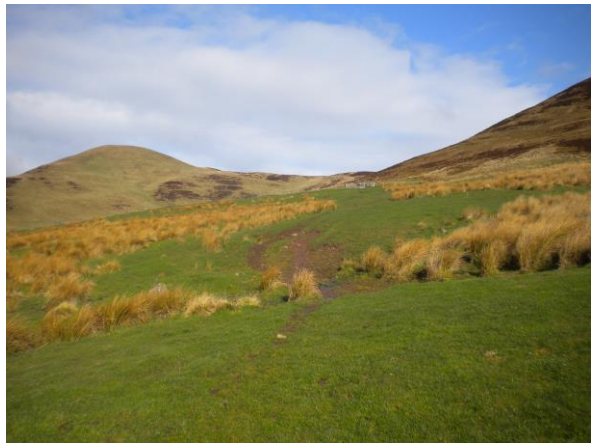
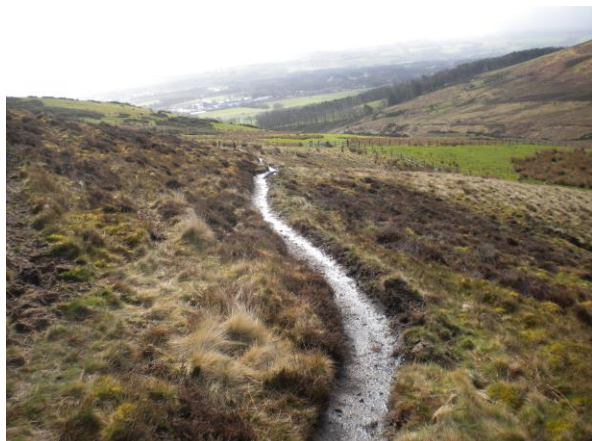
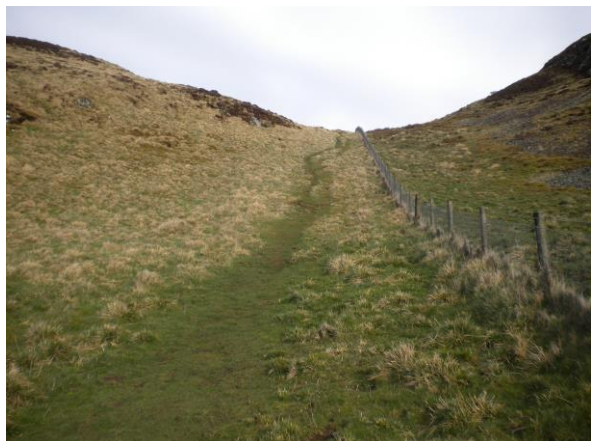
Does not seem to be a well used route. Path line in geneareally in good condition. No work necessary.

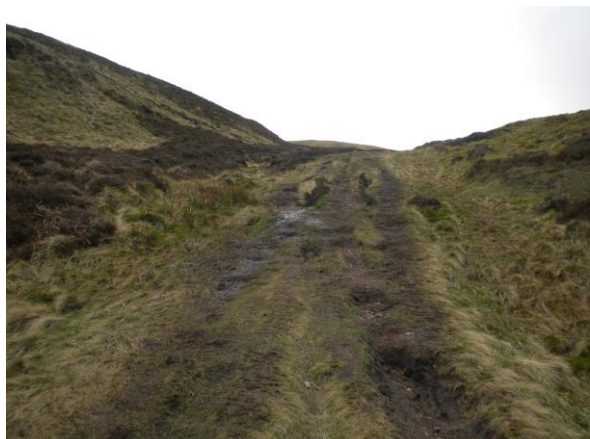
Section 4

Grass covered route. Solid under foot. Pigeon holes on steeper sections and some damage from horses. Not an priority but machine build.

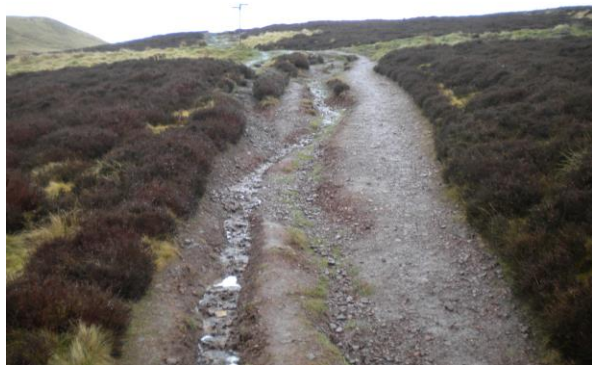
Very wet with no drainage resulting in gullying. Machine build recommended

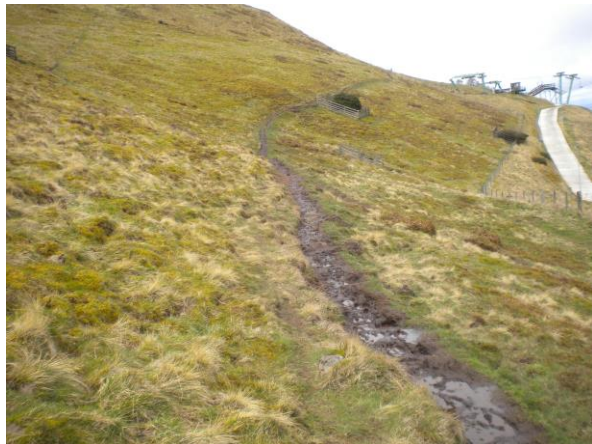
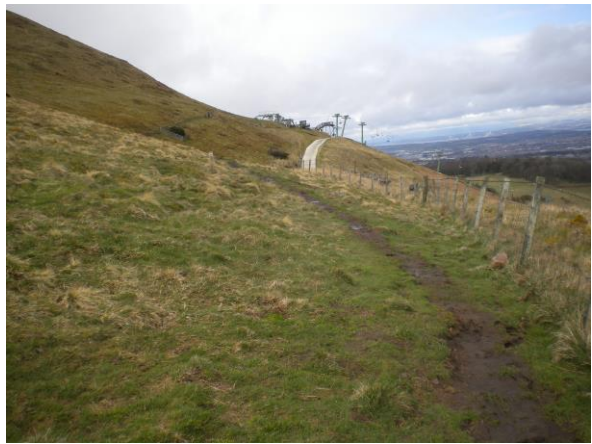
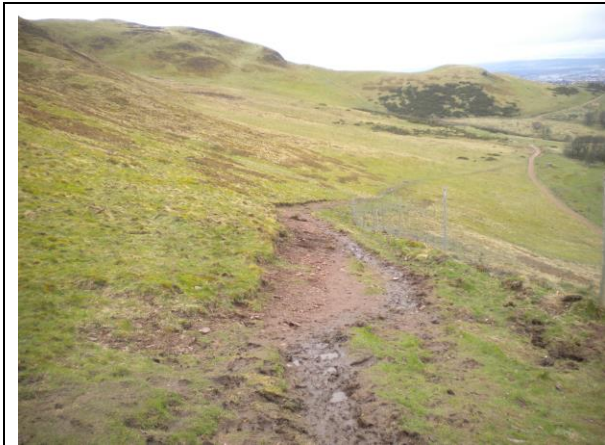
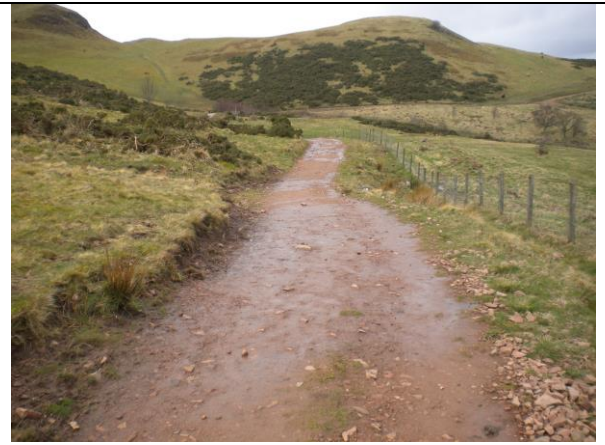
Route signposted as 'capital view walk' and appears popular. Any path design should take into account that the route is used by horse riders.

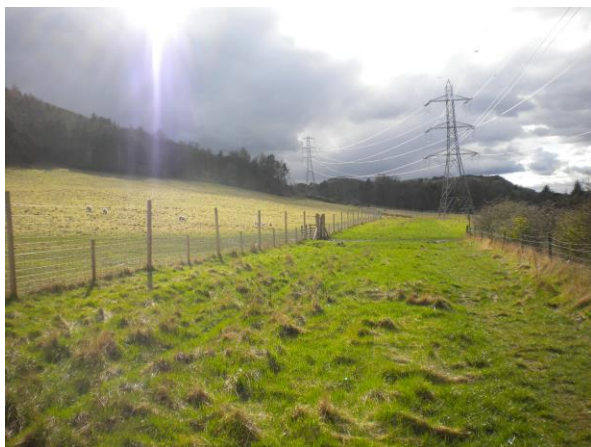
This path is in good condition and only will require ongoing maintenance on section 3.

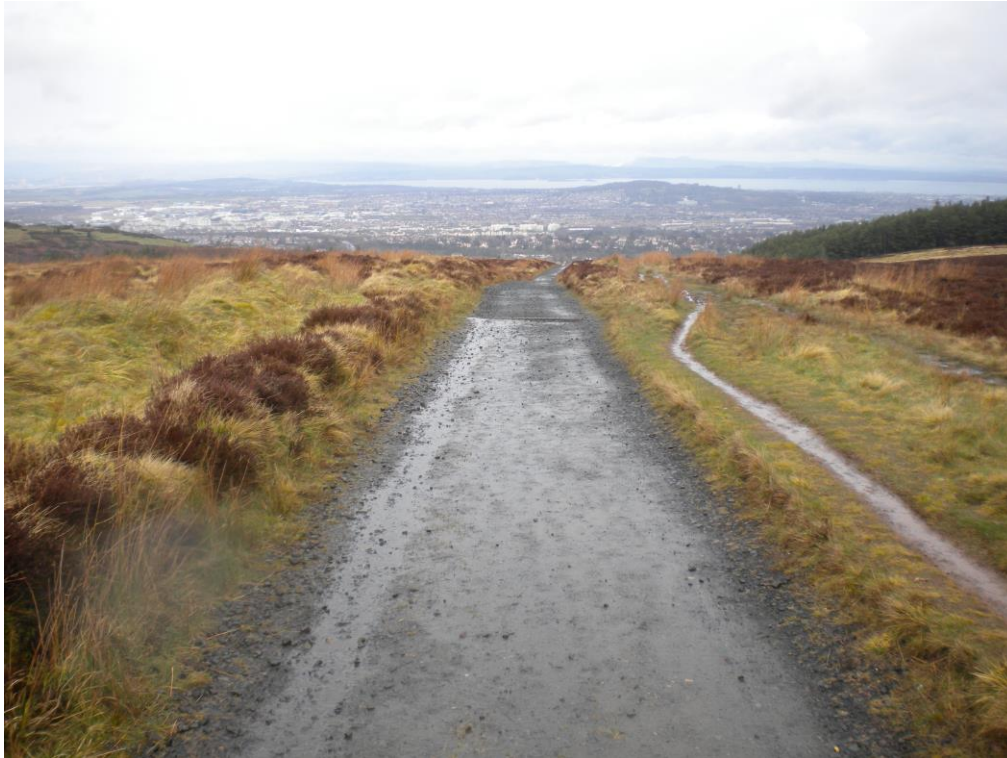
Section 2

Landrover track in good condition. There is a braid to the left of the track along part of this section.

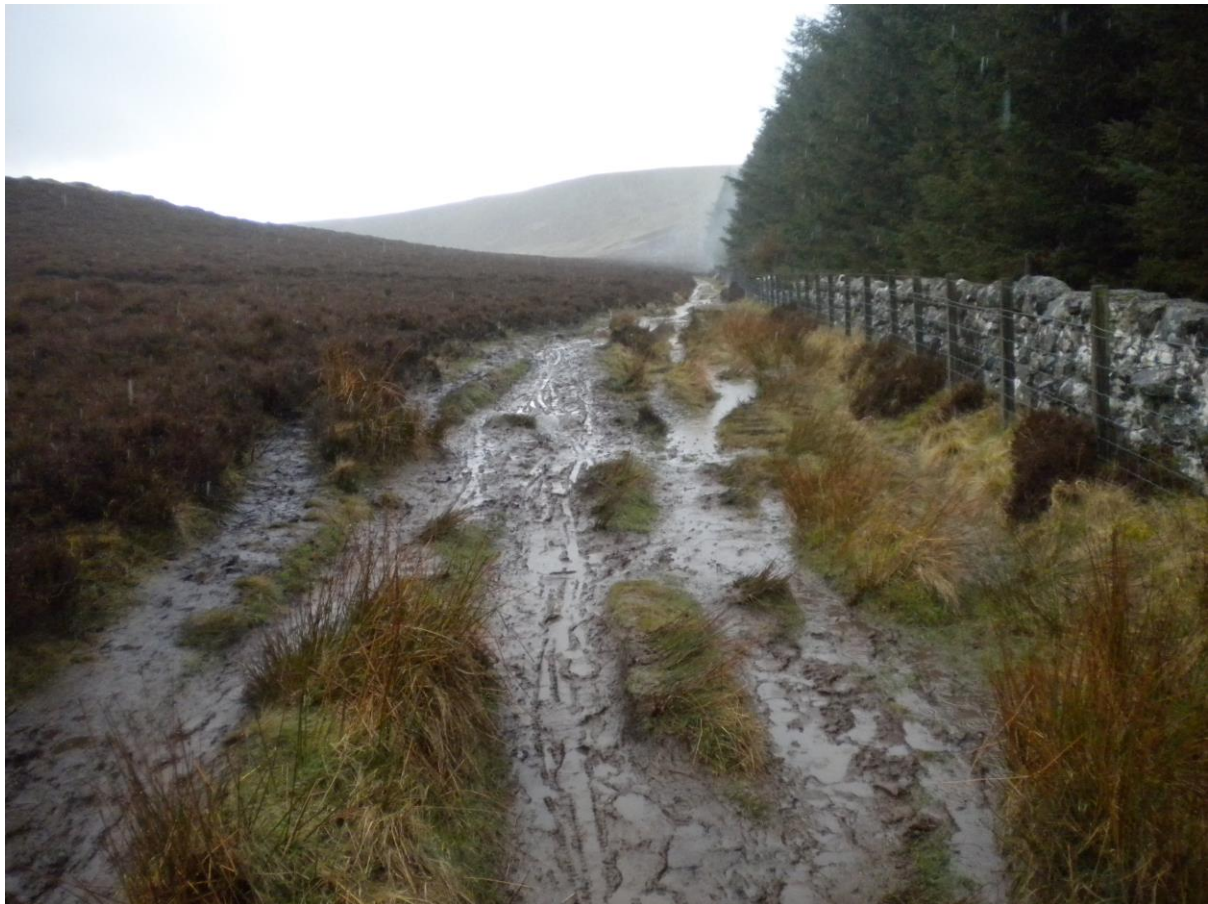
Section 1.

very wet leading to path spread. Some old drainage features need re-built
Recommend full machine build.

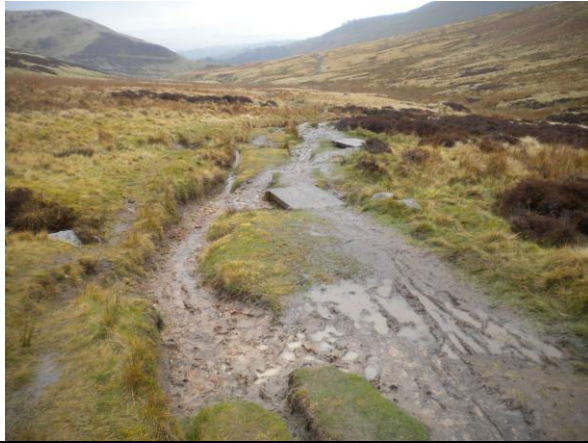
Section 2

Wet with braids. Some minor work has been carried out. Full machine build recommended.

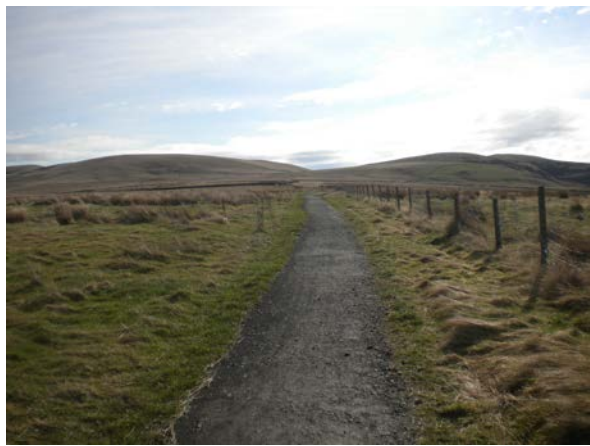
section 2

worn machine built path. Would benefit from re-surfacing with a camber
