Scotland's National Parks - Upland Path Project

South and East Cairngorms

Upland Path Audit 2013

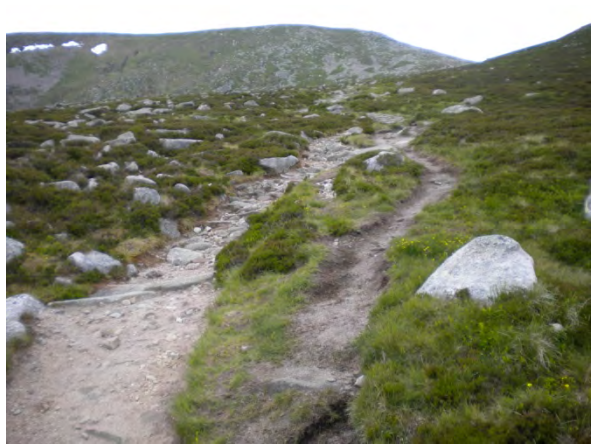
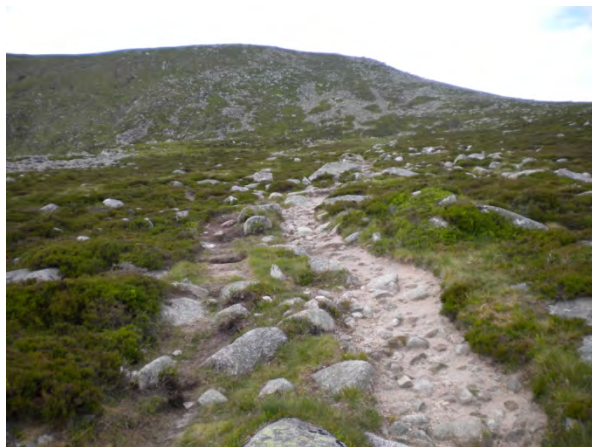
Start of main Lochnagar path to saddle. Very solid footpath but path surface rough in places resulting in brading. Recommend resurface entire section with additional anchor bars

Section 1 is very rough in places causing path spread. Entire section should be resurfaces with additional anchor bars in places and blocking of braids. Machine job possible

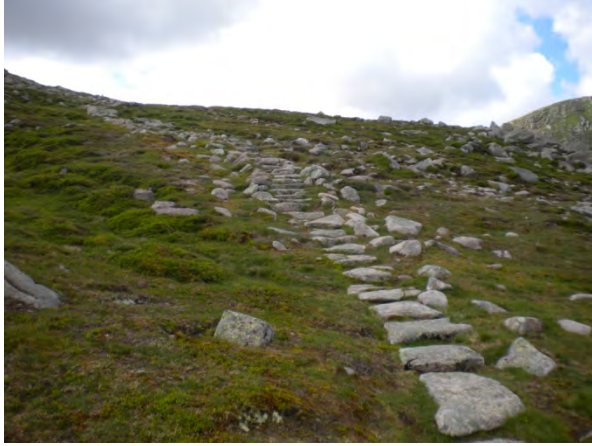
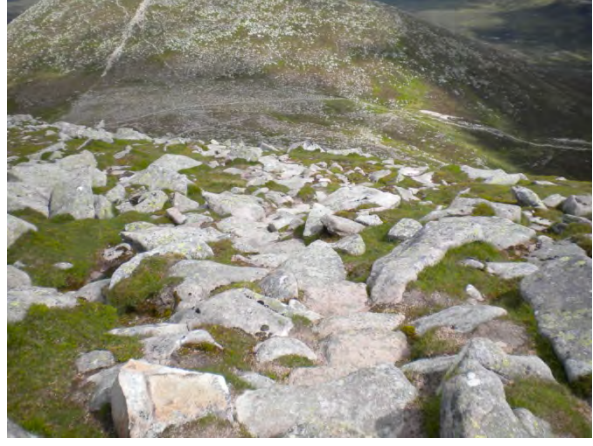
Pitched section to Corrie rim. Excellent condition. Maintenance only.

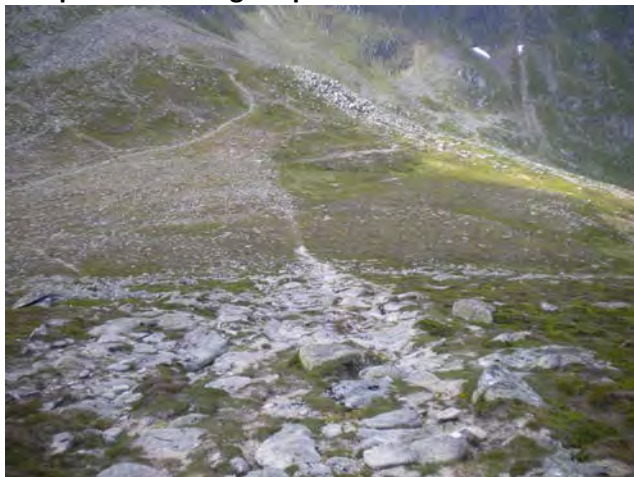
Steep section straight up face

No built path up Meikle Pap. Scar very visible. Steep route would need defining and some wbs and anchor bars using local materials with 'light touch' approach.

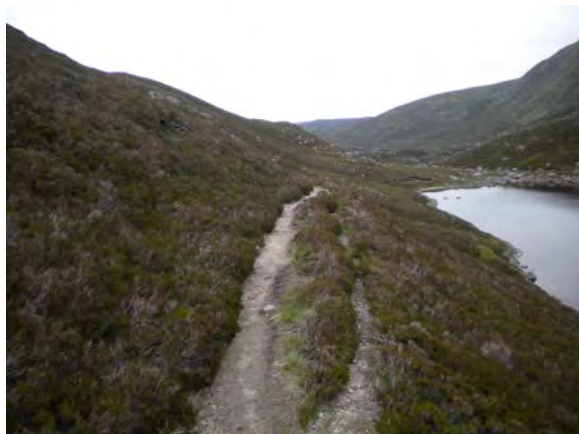
Section 3

From an increase in gradient at large rocks to burn crossing. Evolved line in good condition. Needs some light touch work to prevent braiding and path spread and improve drainage

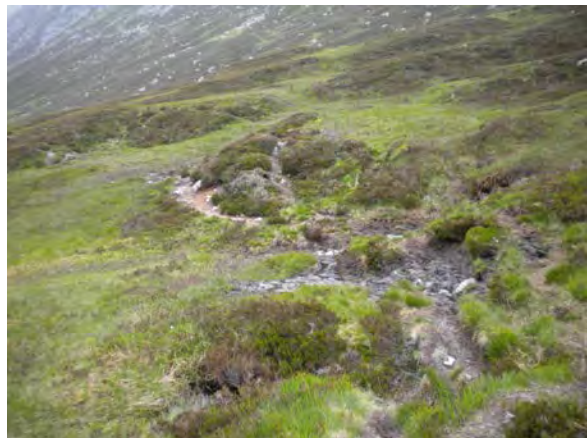
Section 4

Path deteriorating and in need of full build with side ditch, water bars and surfacing. Absence of block stone for most of section.

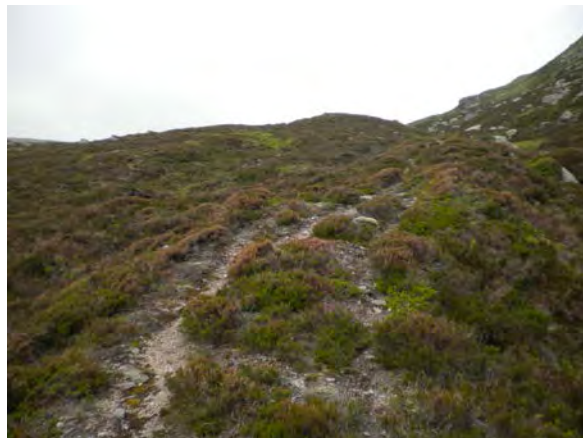
Section 5

Evolved line continues up corrie to the right hand side of the burn. Poor condition. Full build required.

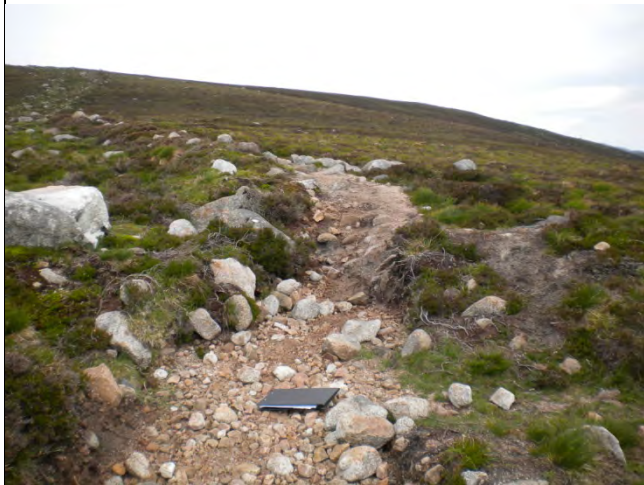
Section 3

Evolved line from vehicle track to shoulder of Broad Cairn. Path is badly eroded with 15m trample width in places and evidence of gullying. Recommend full machine build.

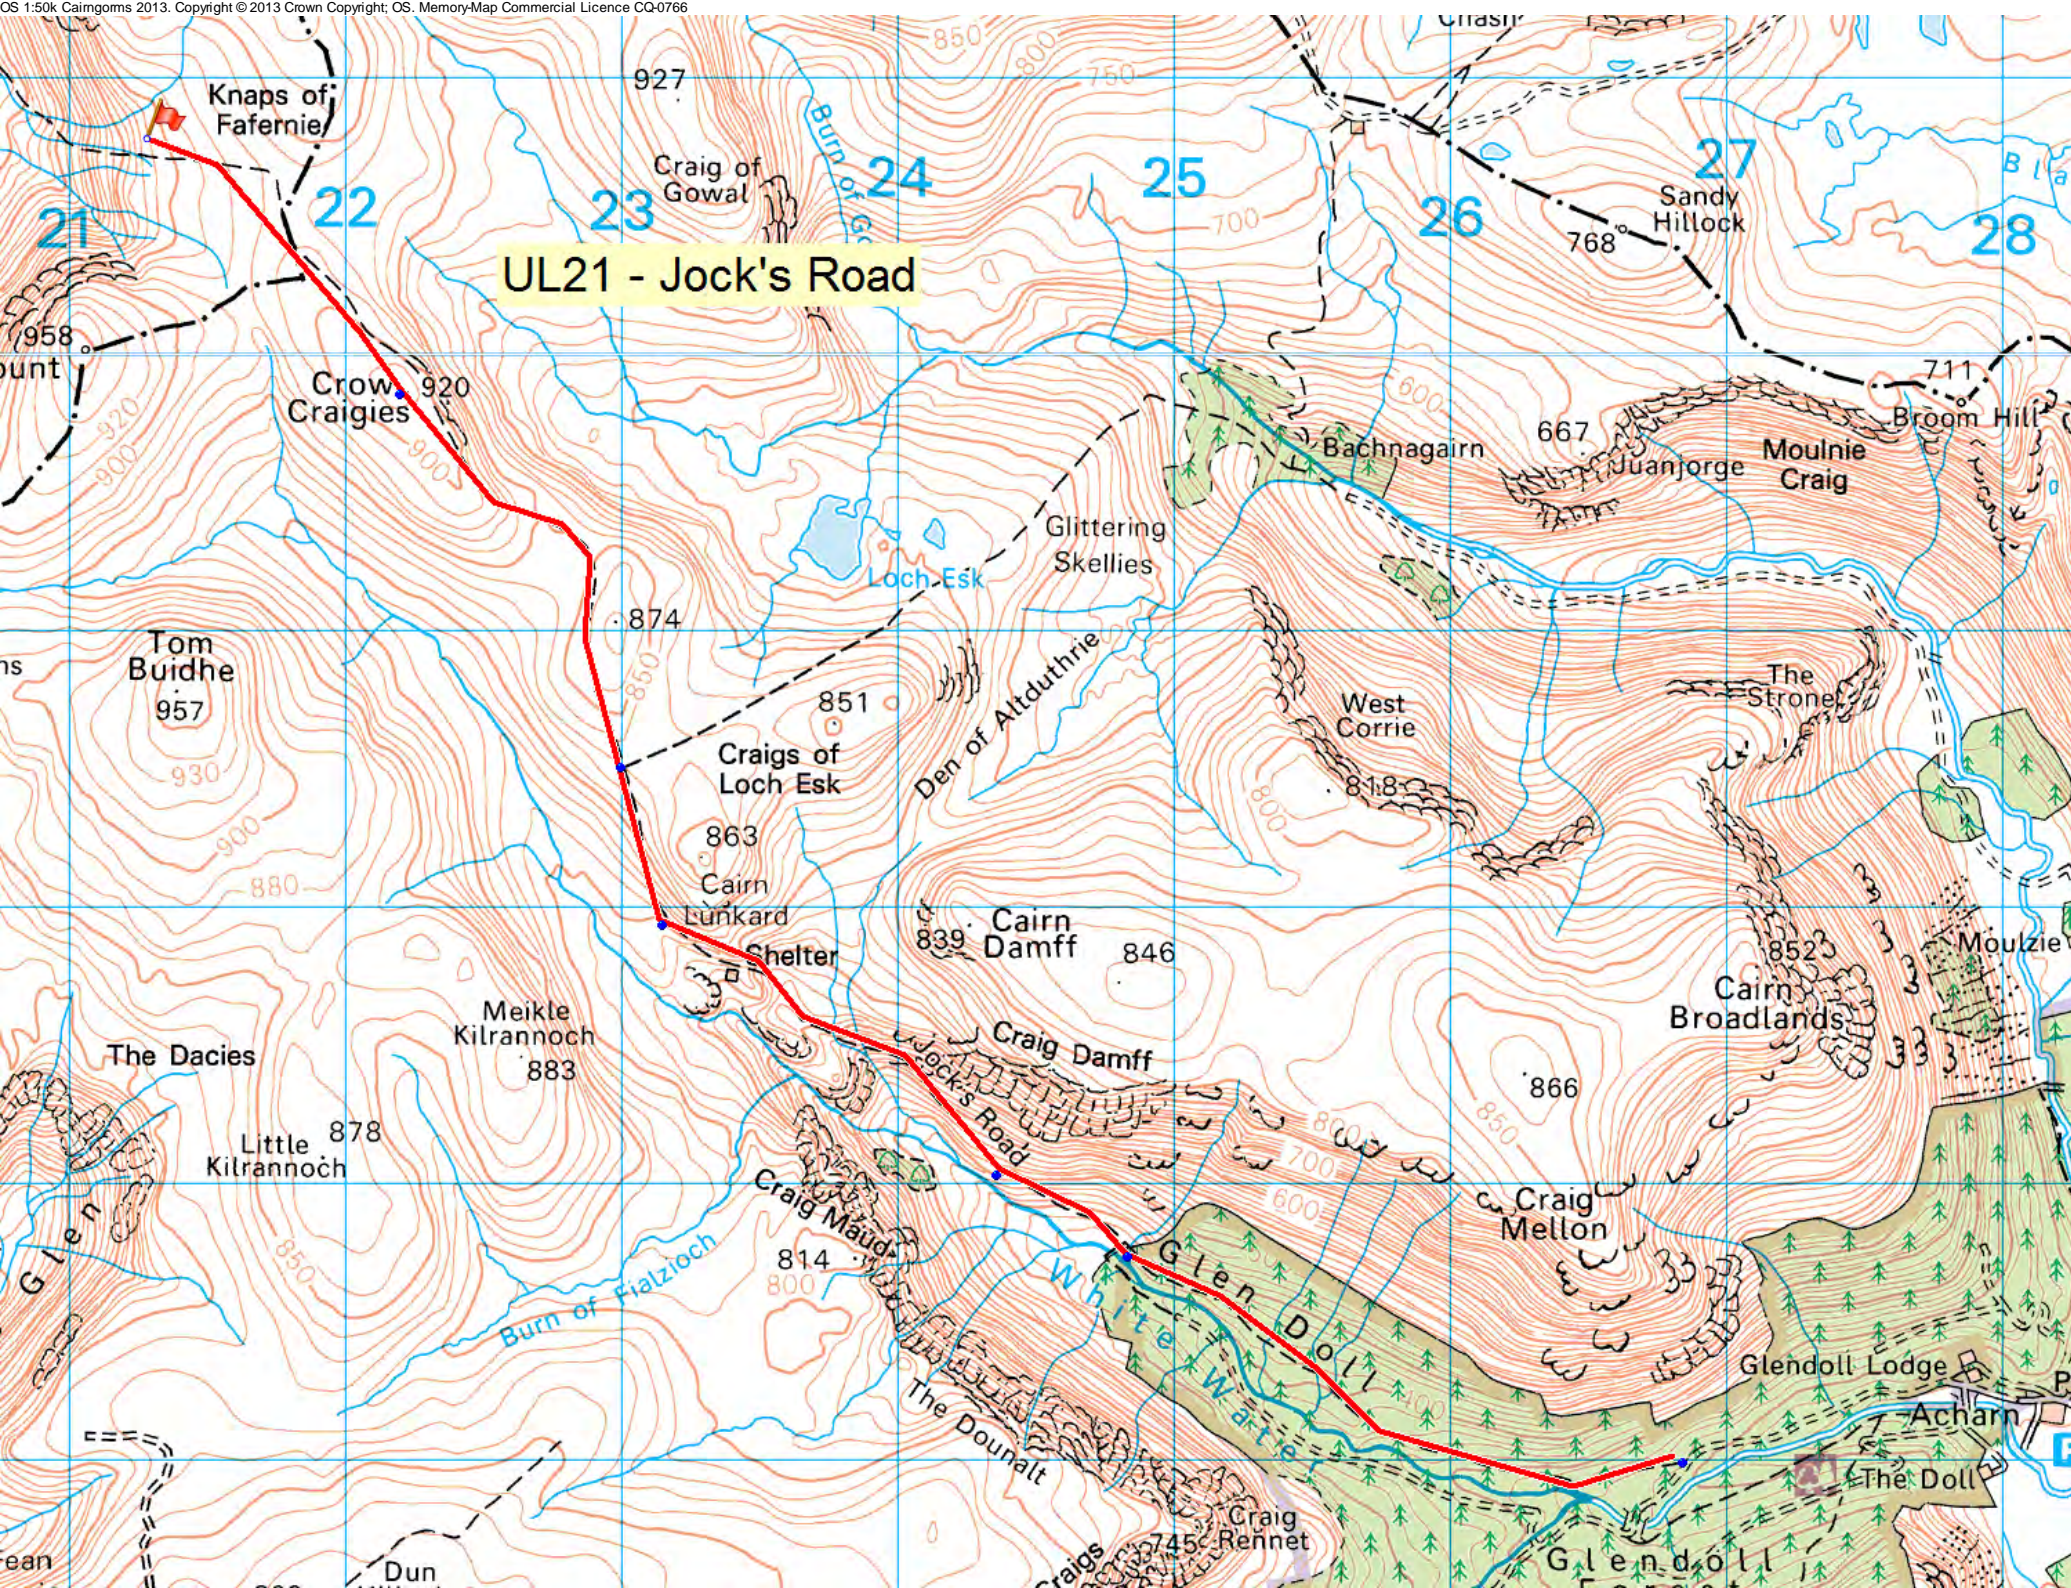
Worsening path needs fairly substantial work needed lower down with light touch approach higher up.

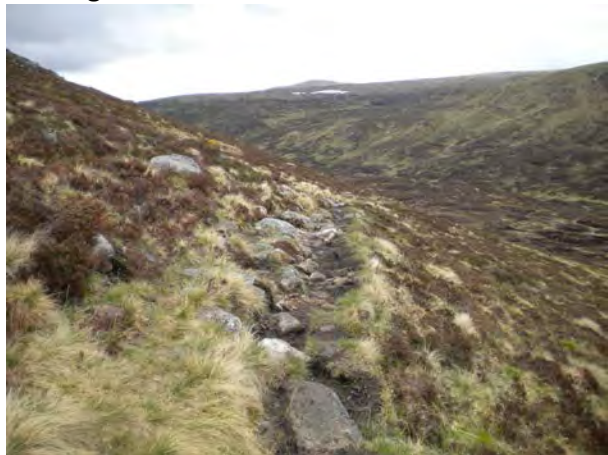
Looking back on section 4

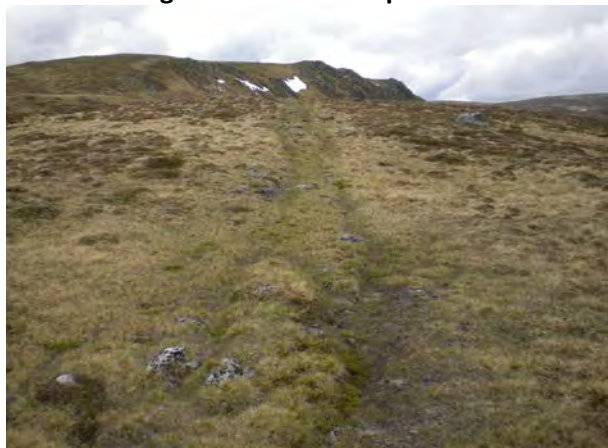
Path definition required on section 5		Section 5 – light touch work required

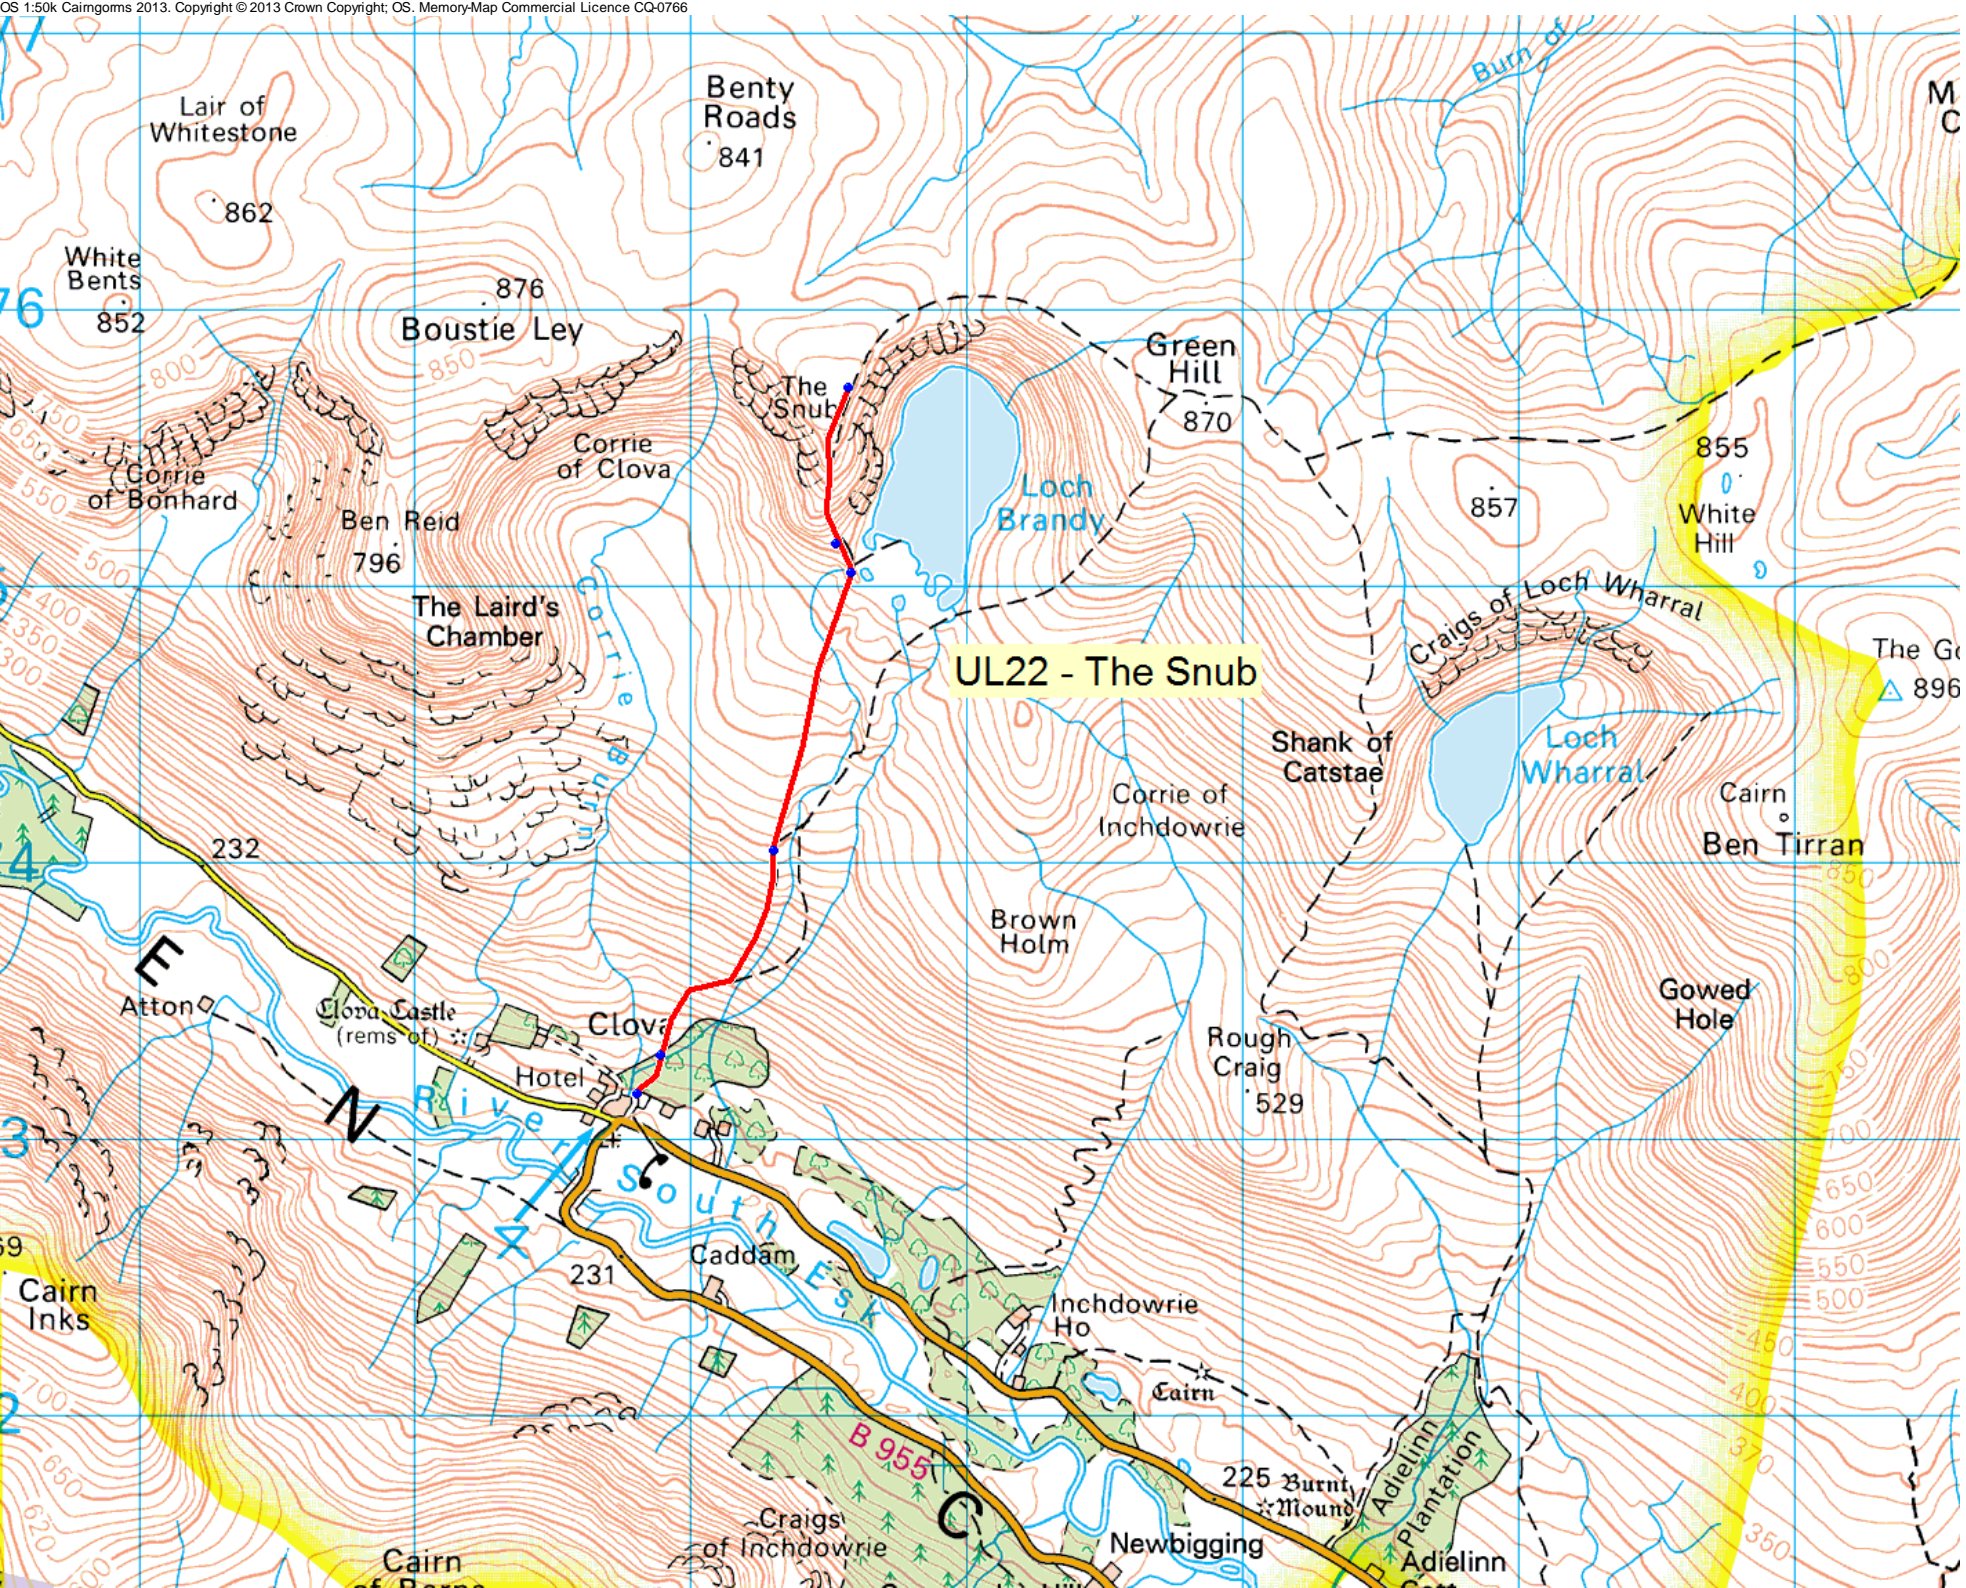
No capital works required up to end of S3. Low maintenance path. High build recommended on section 4 and possible light touch works higher up.

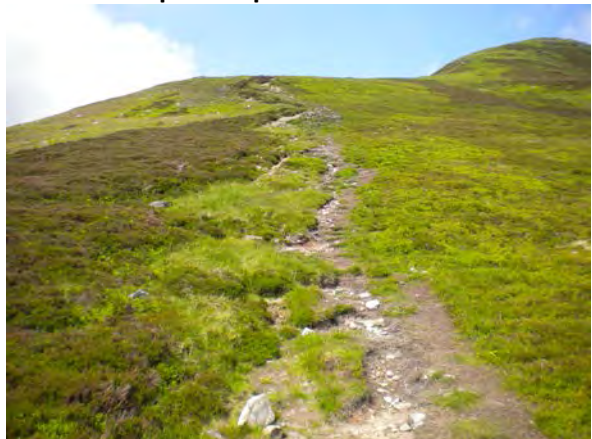
Full build required up Snub – Section 5

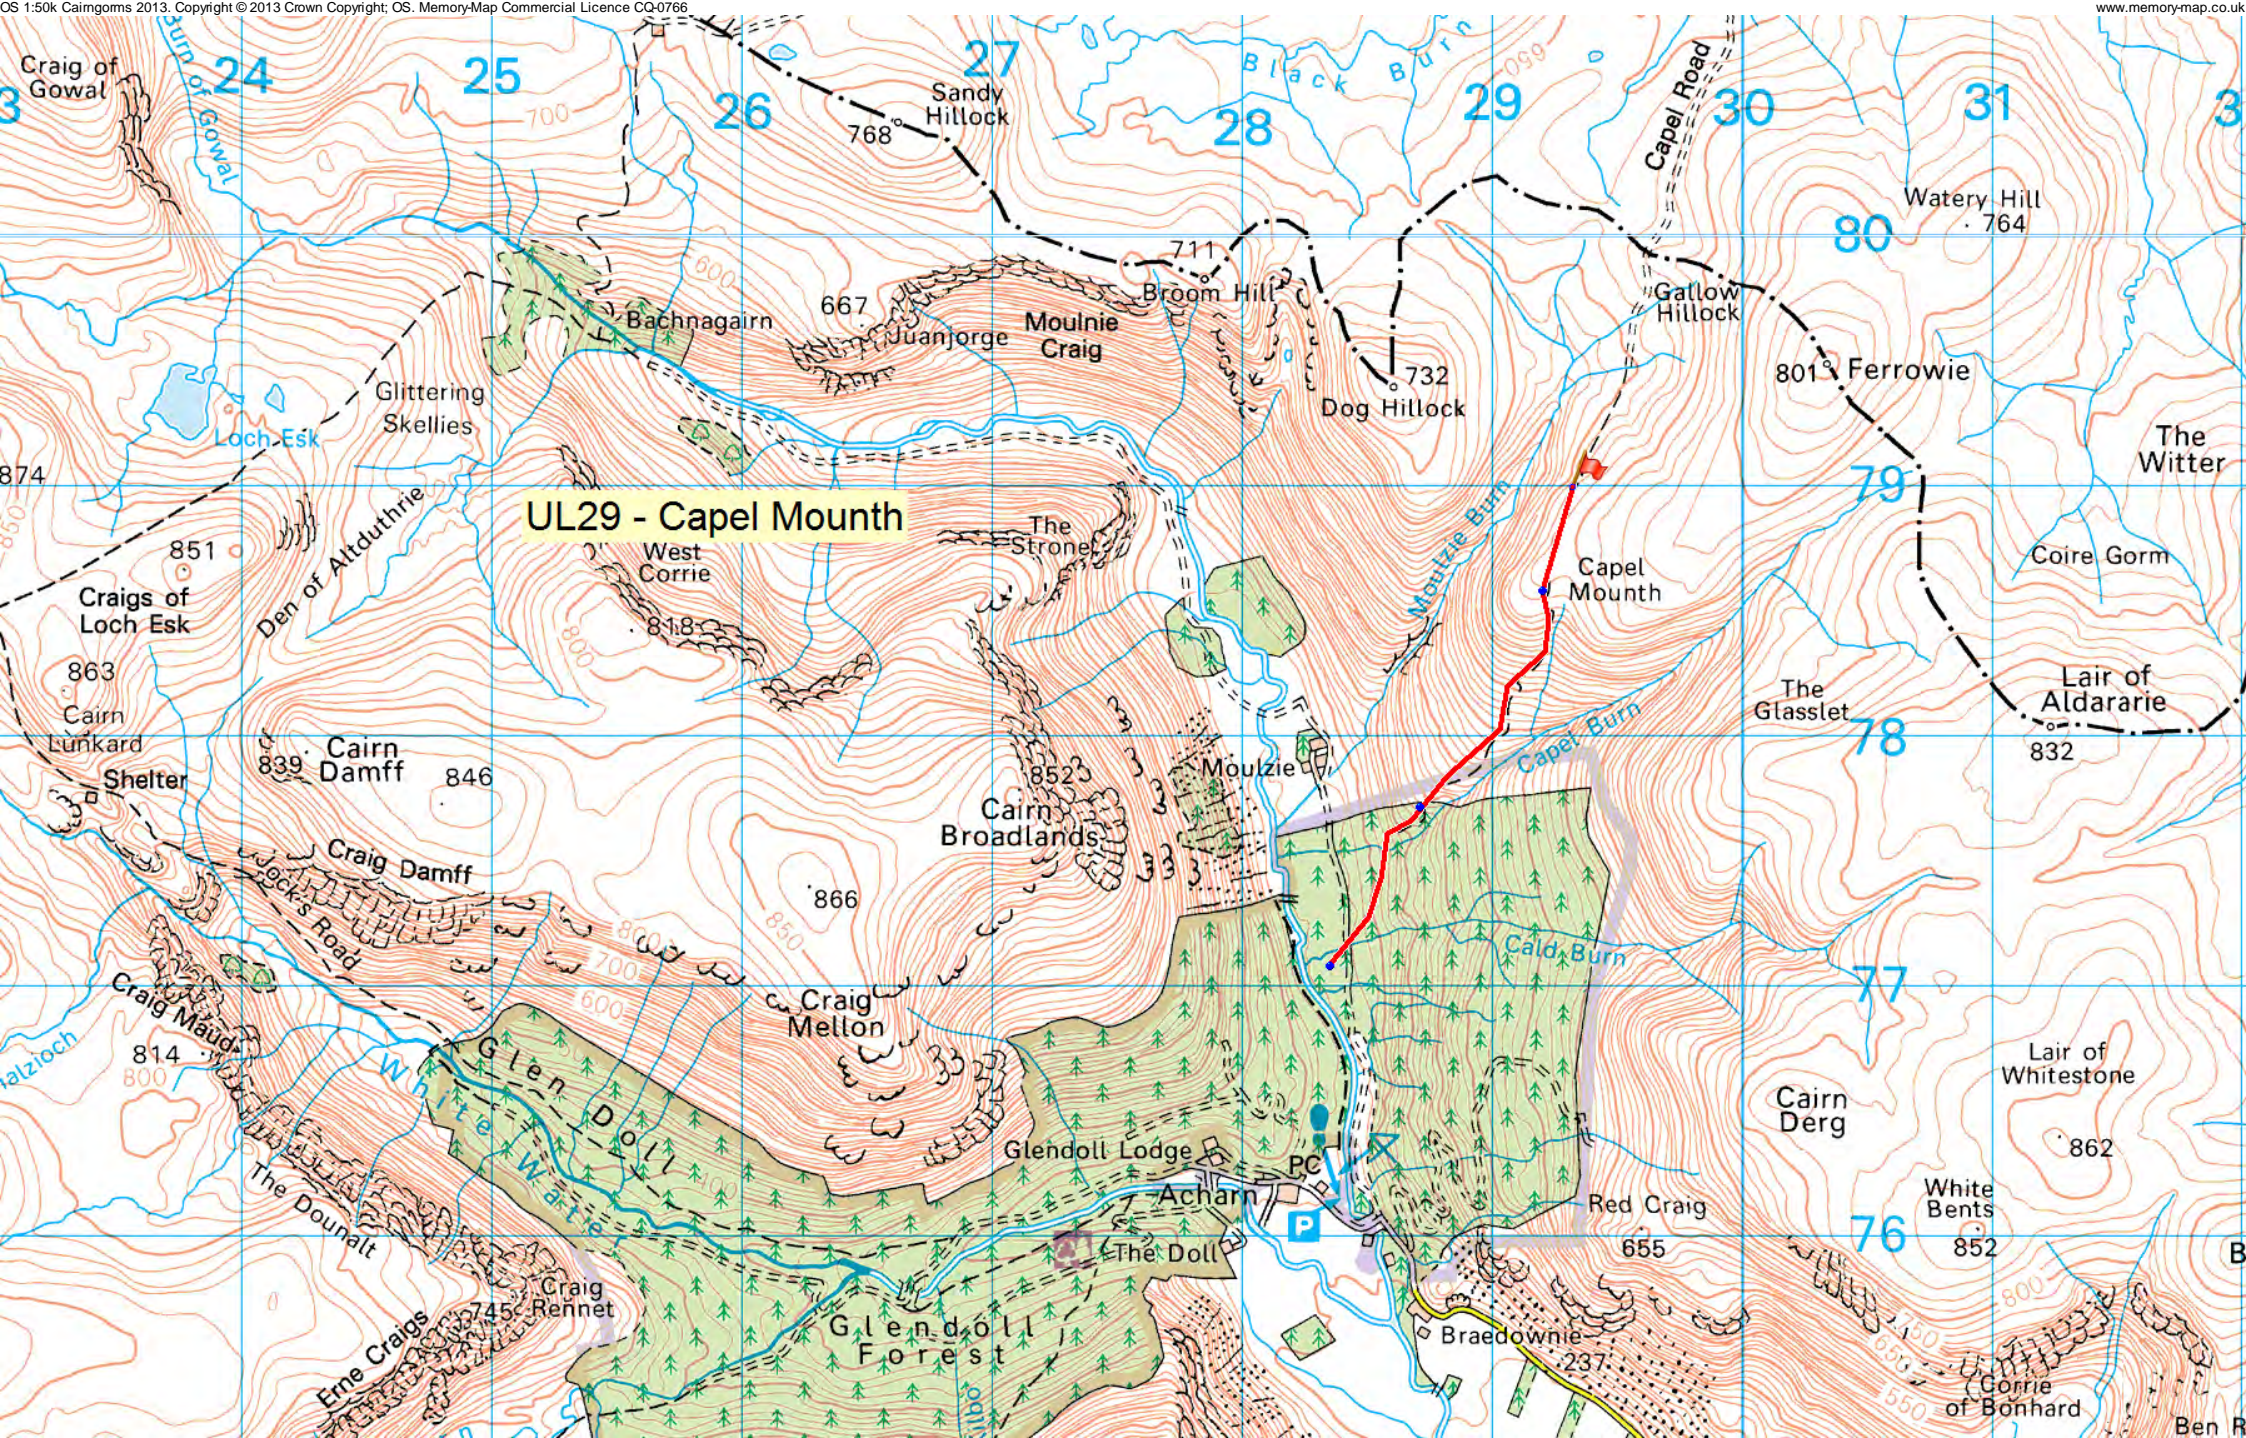
Path up to high point above Loch Brandy - Path to loch built heavily and beginning to need maintenance - path beyond eroding rapidly and needs intensive repair.

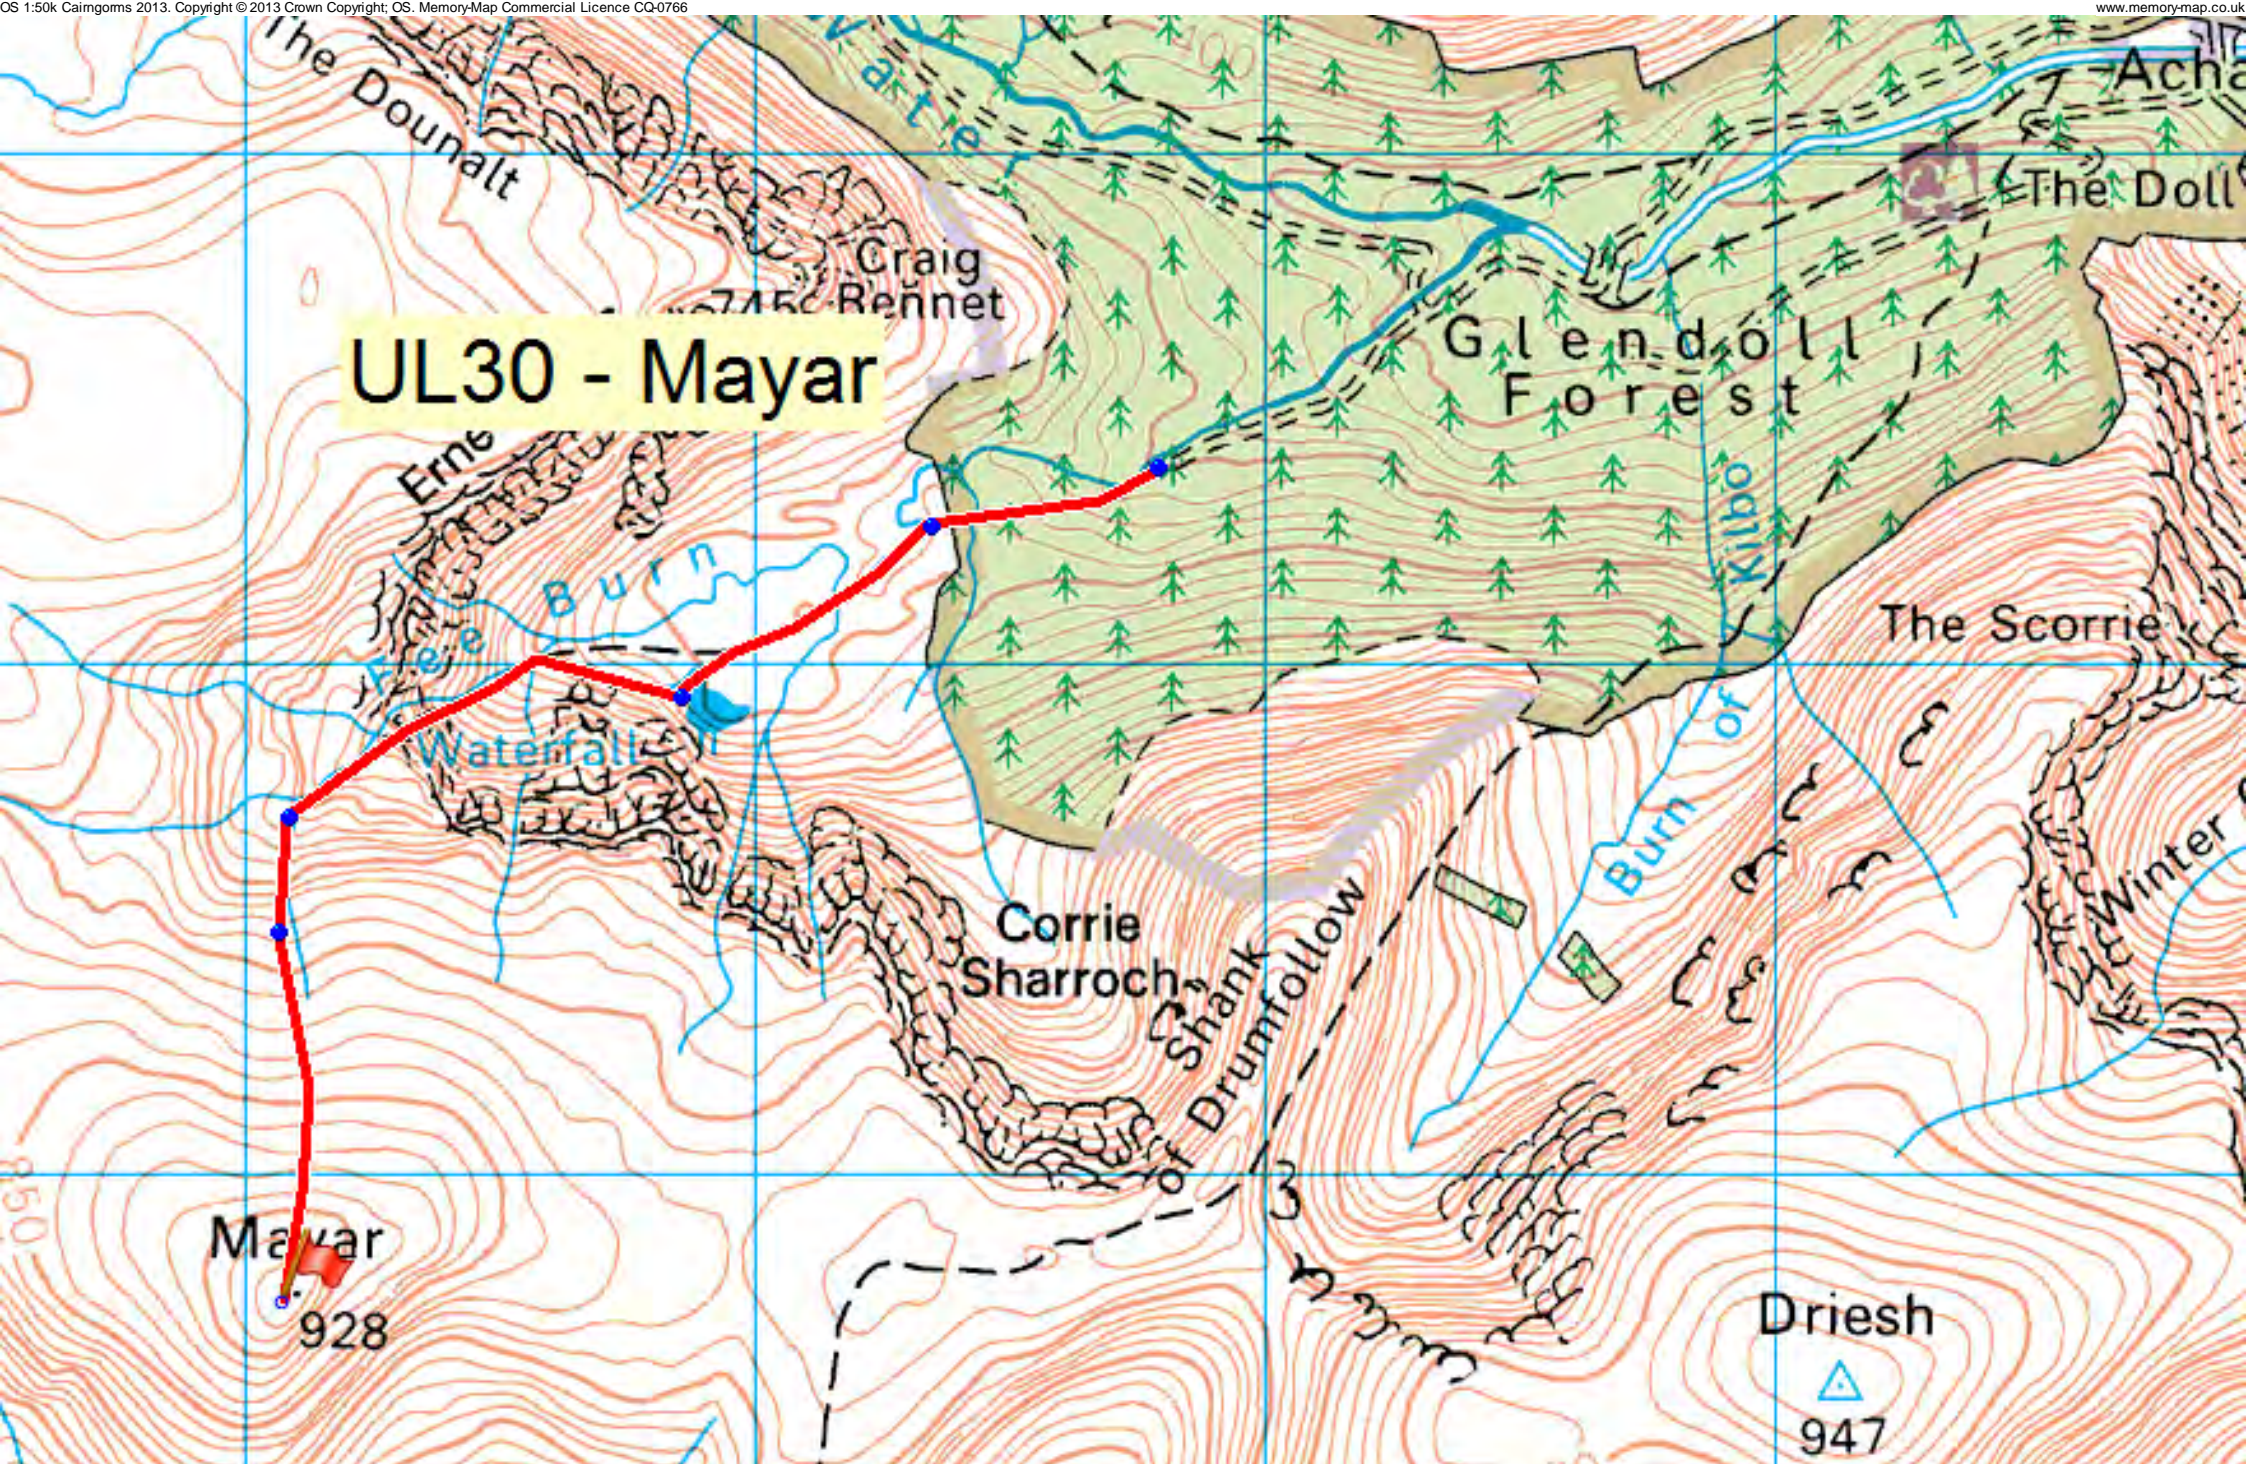
Popular through route for mountain bikes. Forestry section is contained. Machine build will be best solution

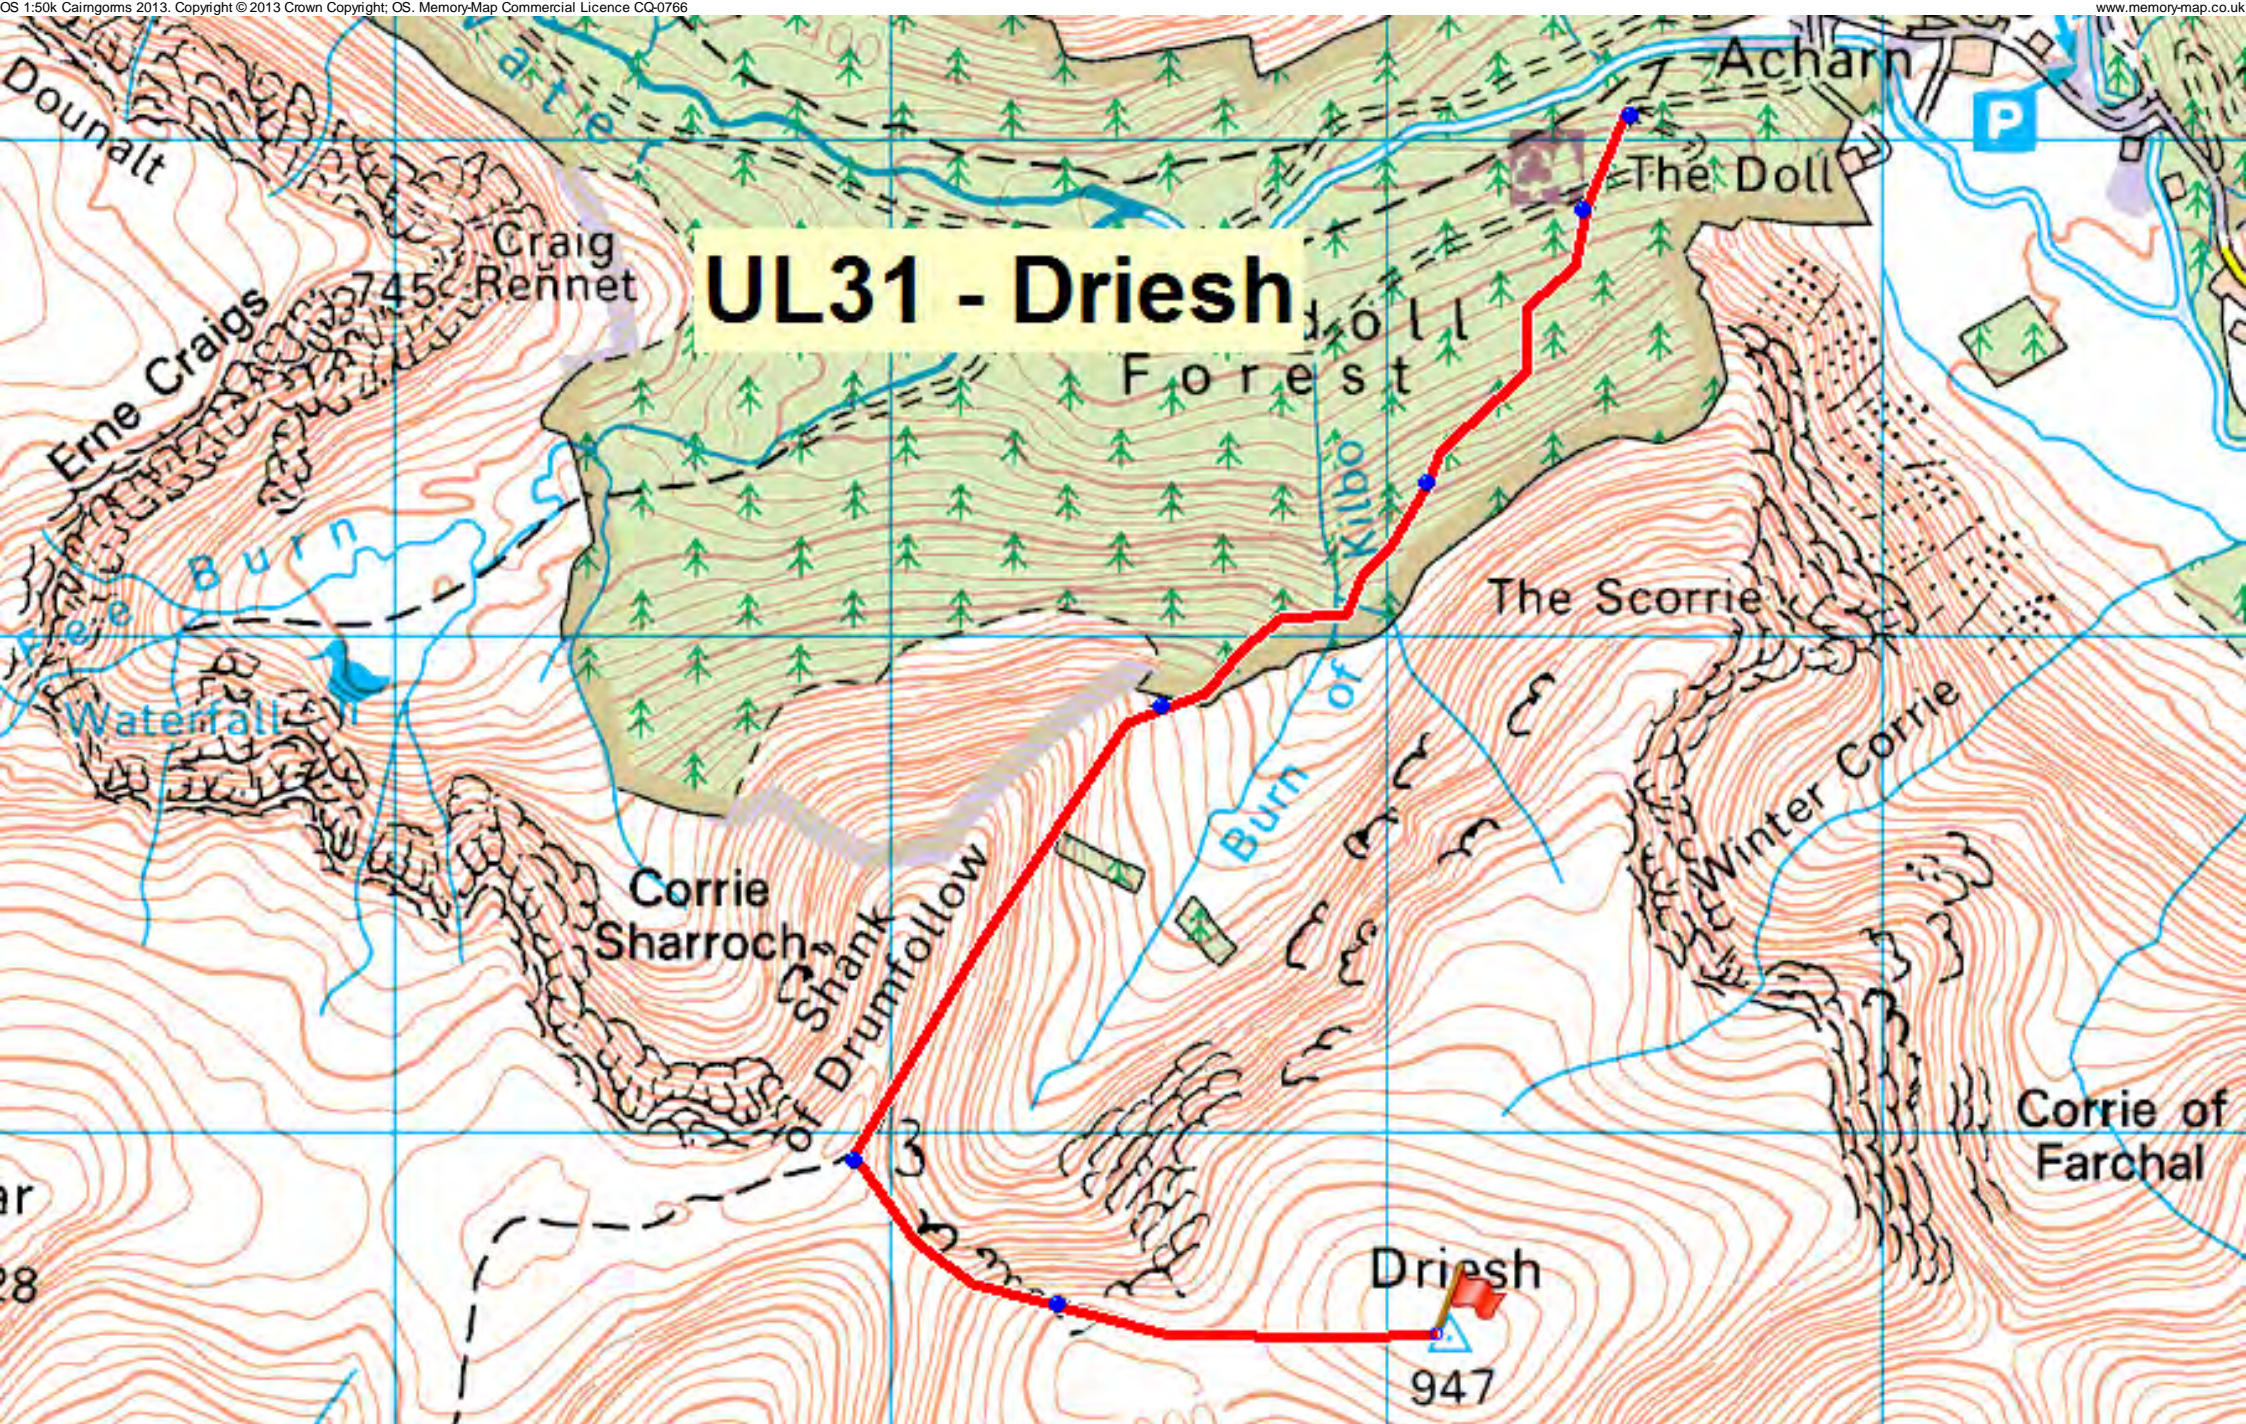
Sections 1-3 cover a well constructed path in good condition. Section 4 is badly eroded and needs a full build path

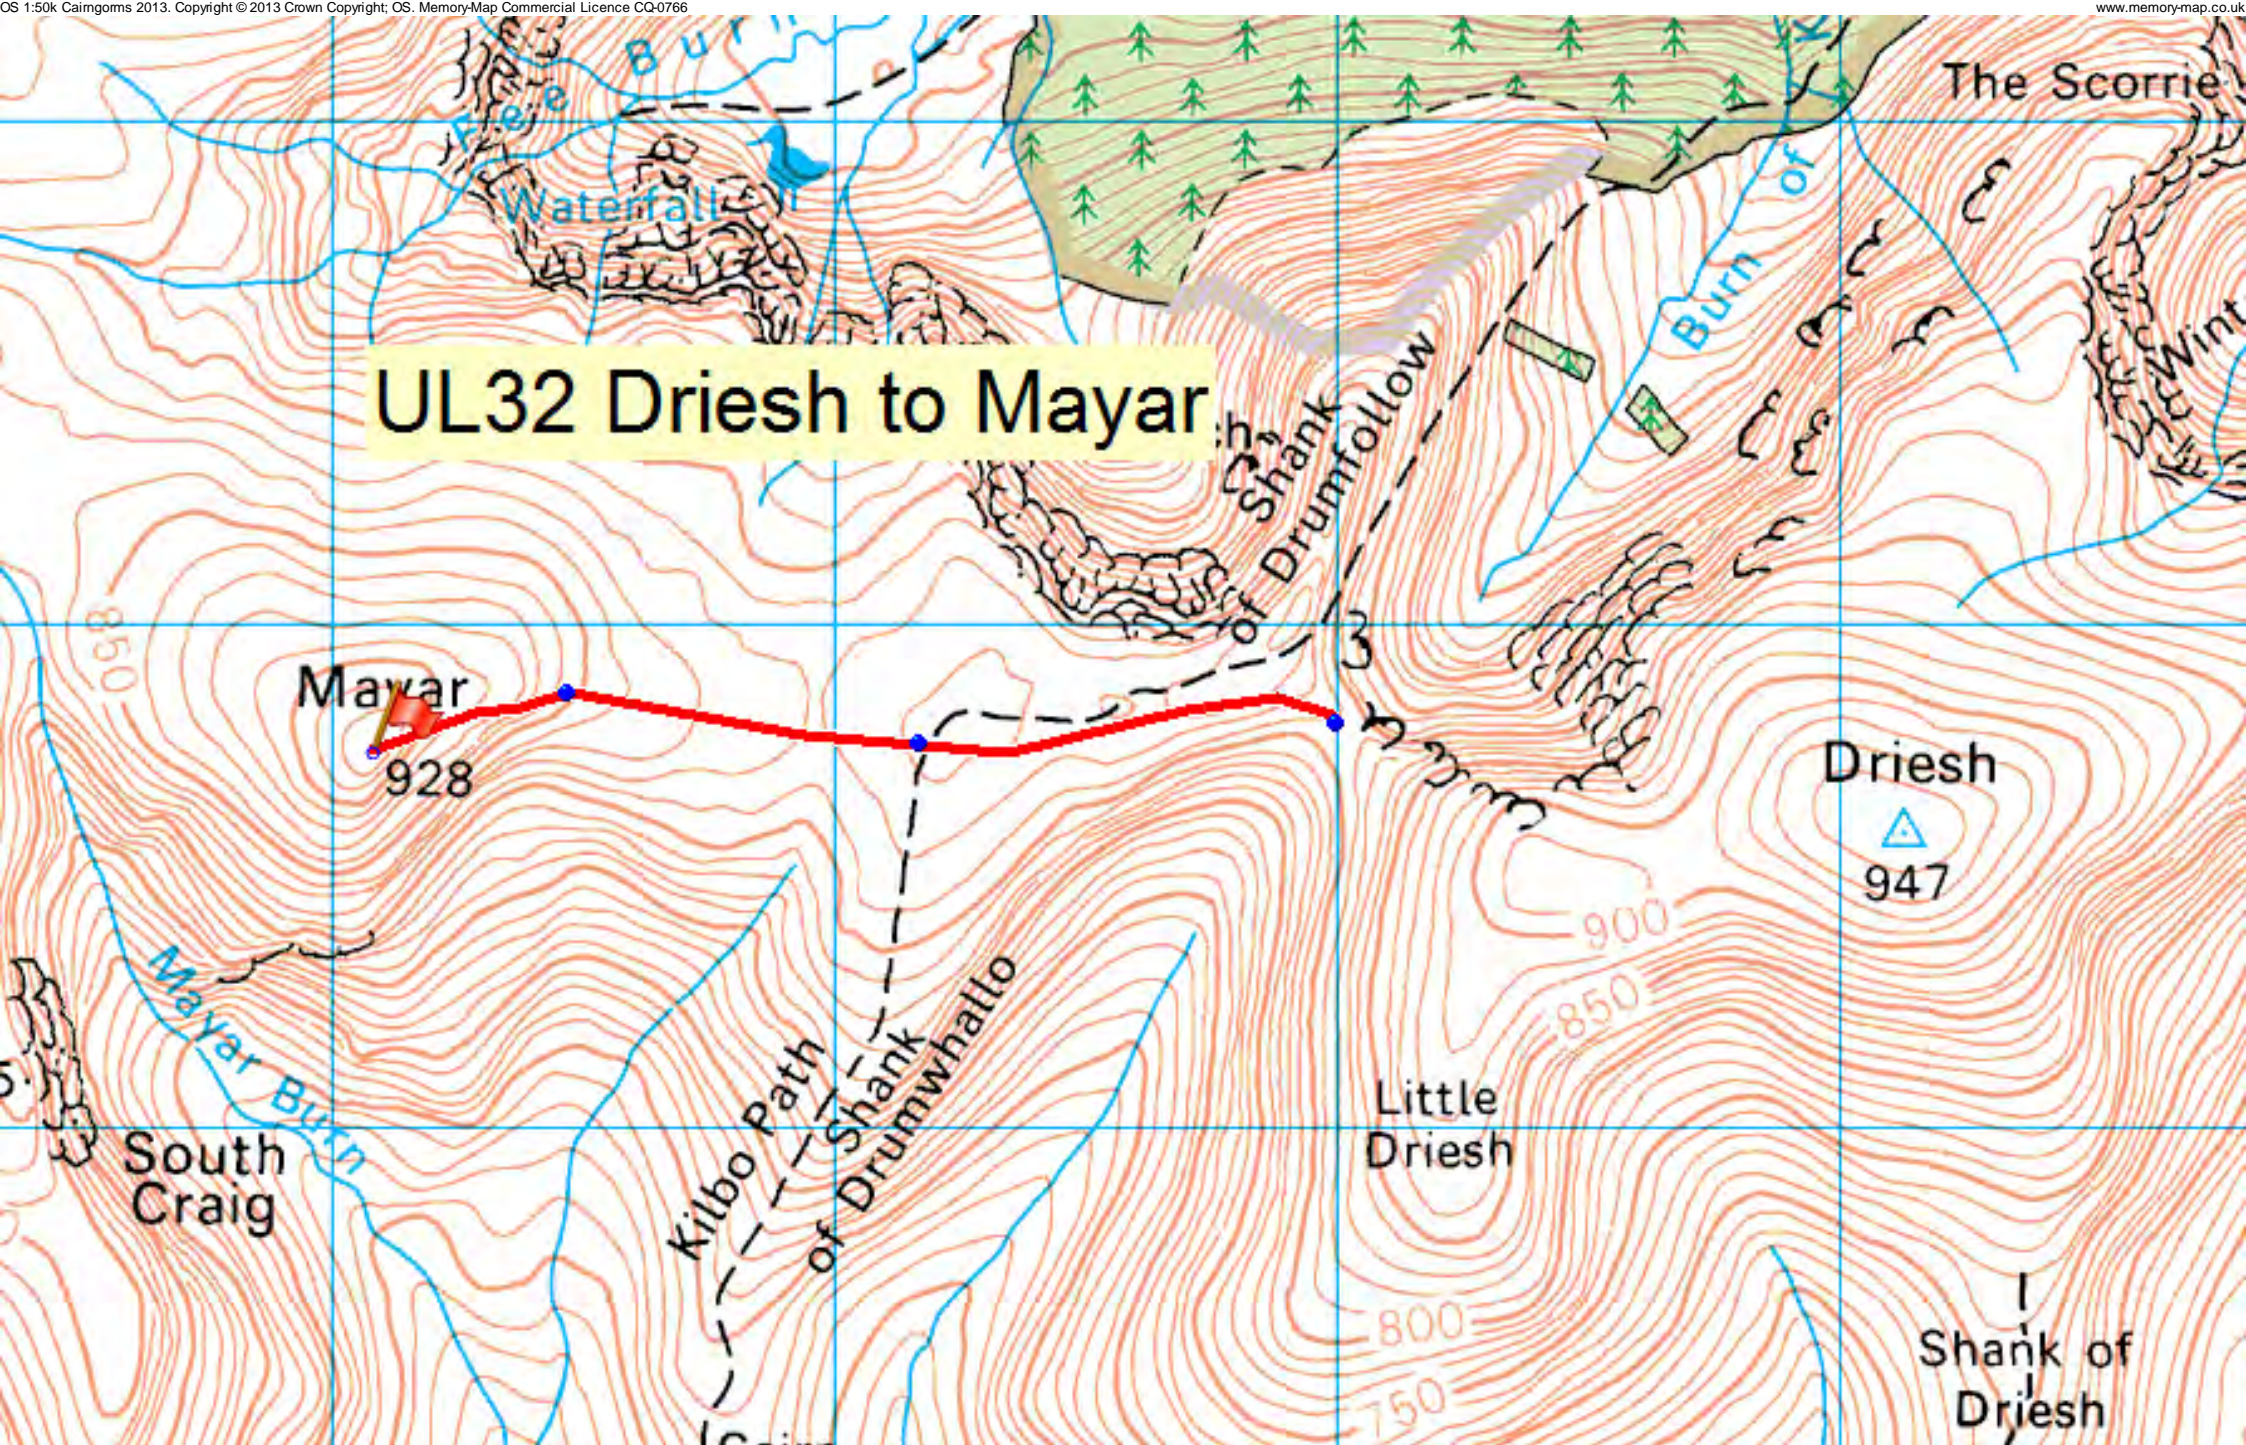
Sections 1-3 need rebuilt. Full build required on section 4. Upper section would benefit from light touch works.
