Scotland's National Parks - Upland Path Project

South and East Cairngorms

Upland Path Audit 2013

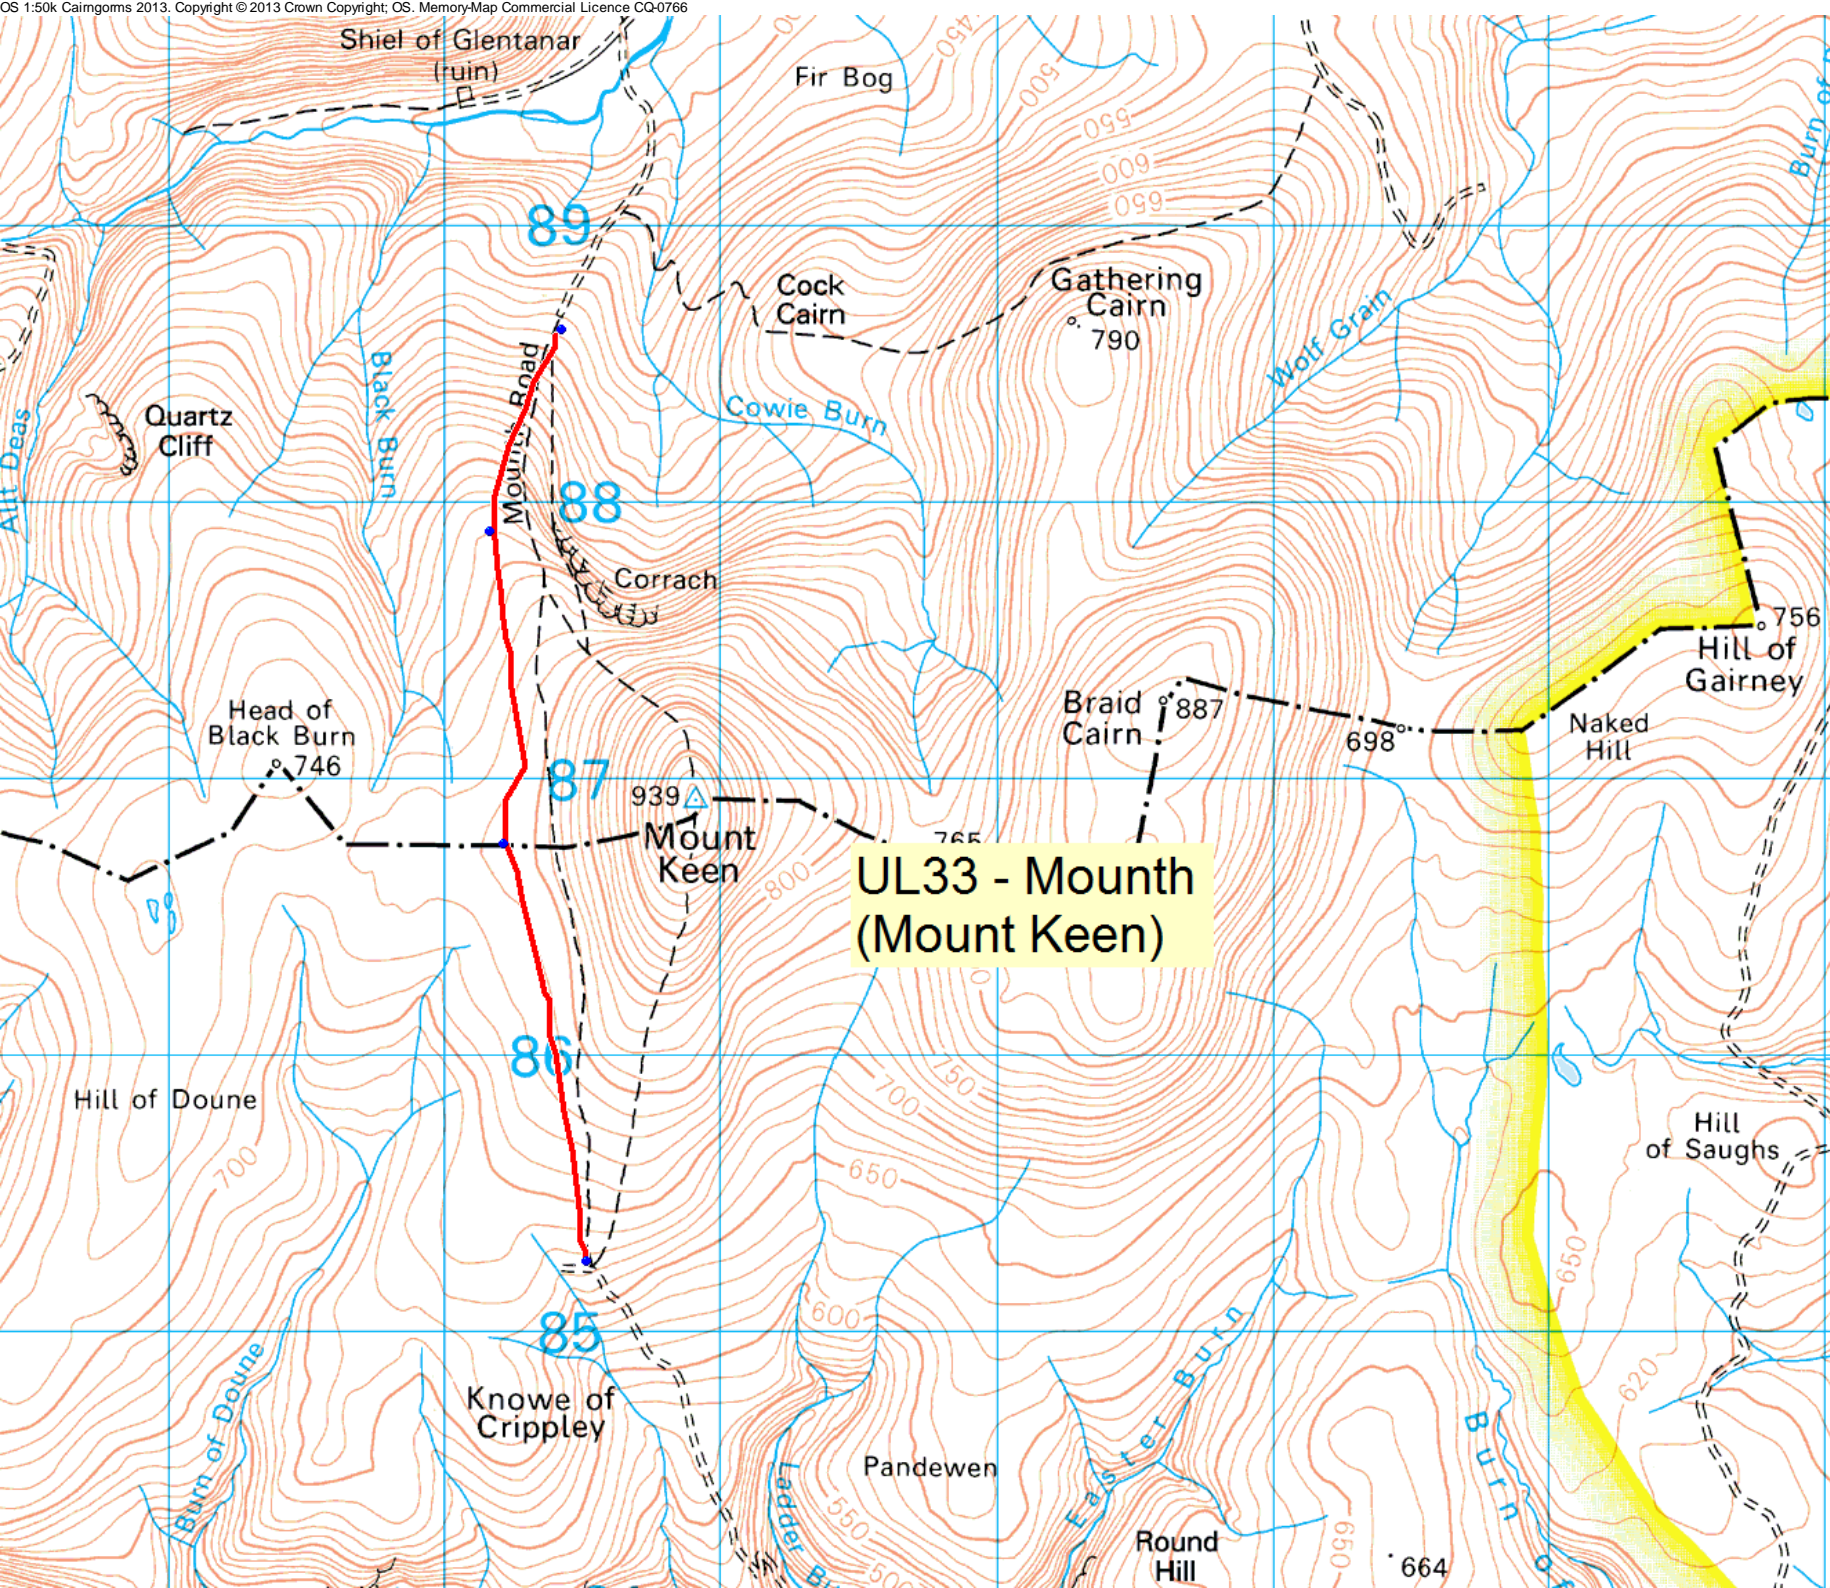
Sections 2 and 3 would benefit from work to brevent further erosion especially on steper
 areas.

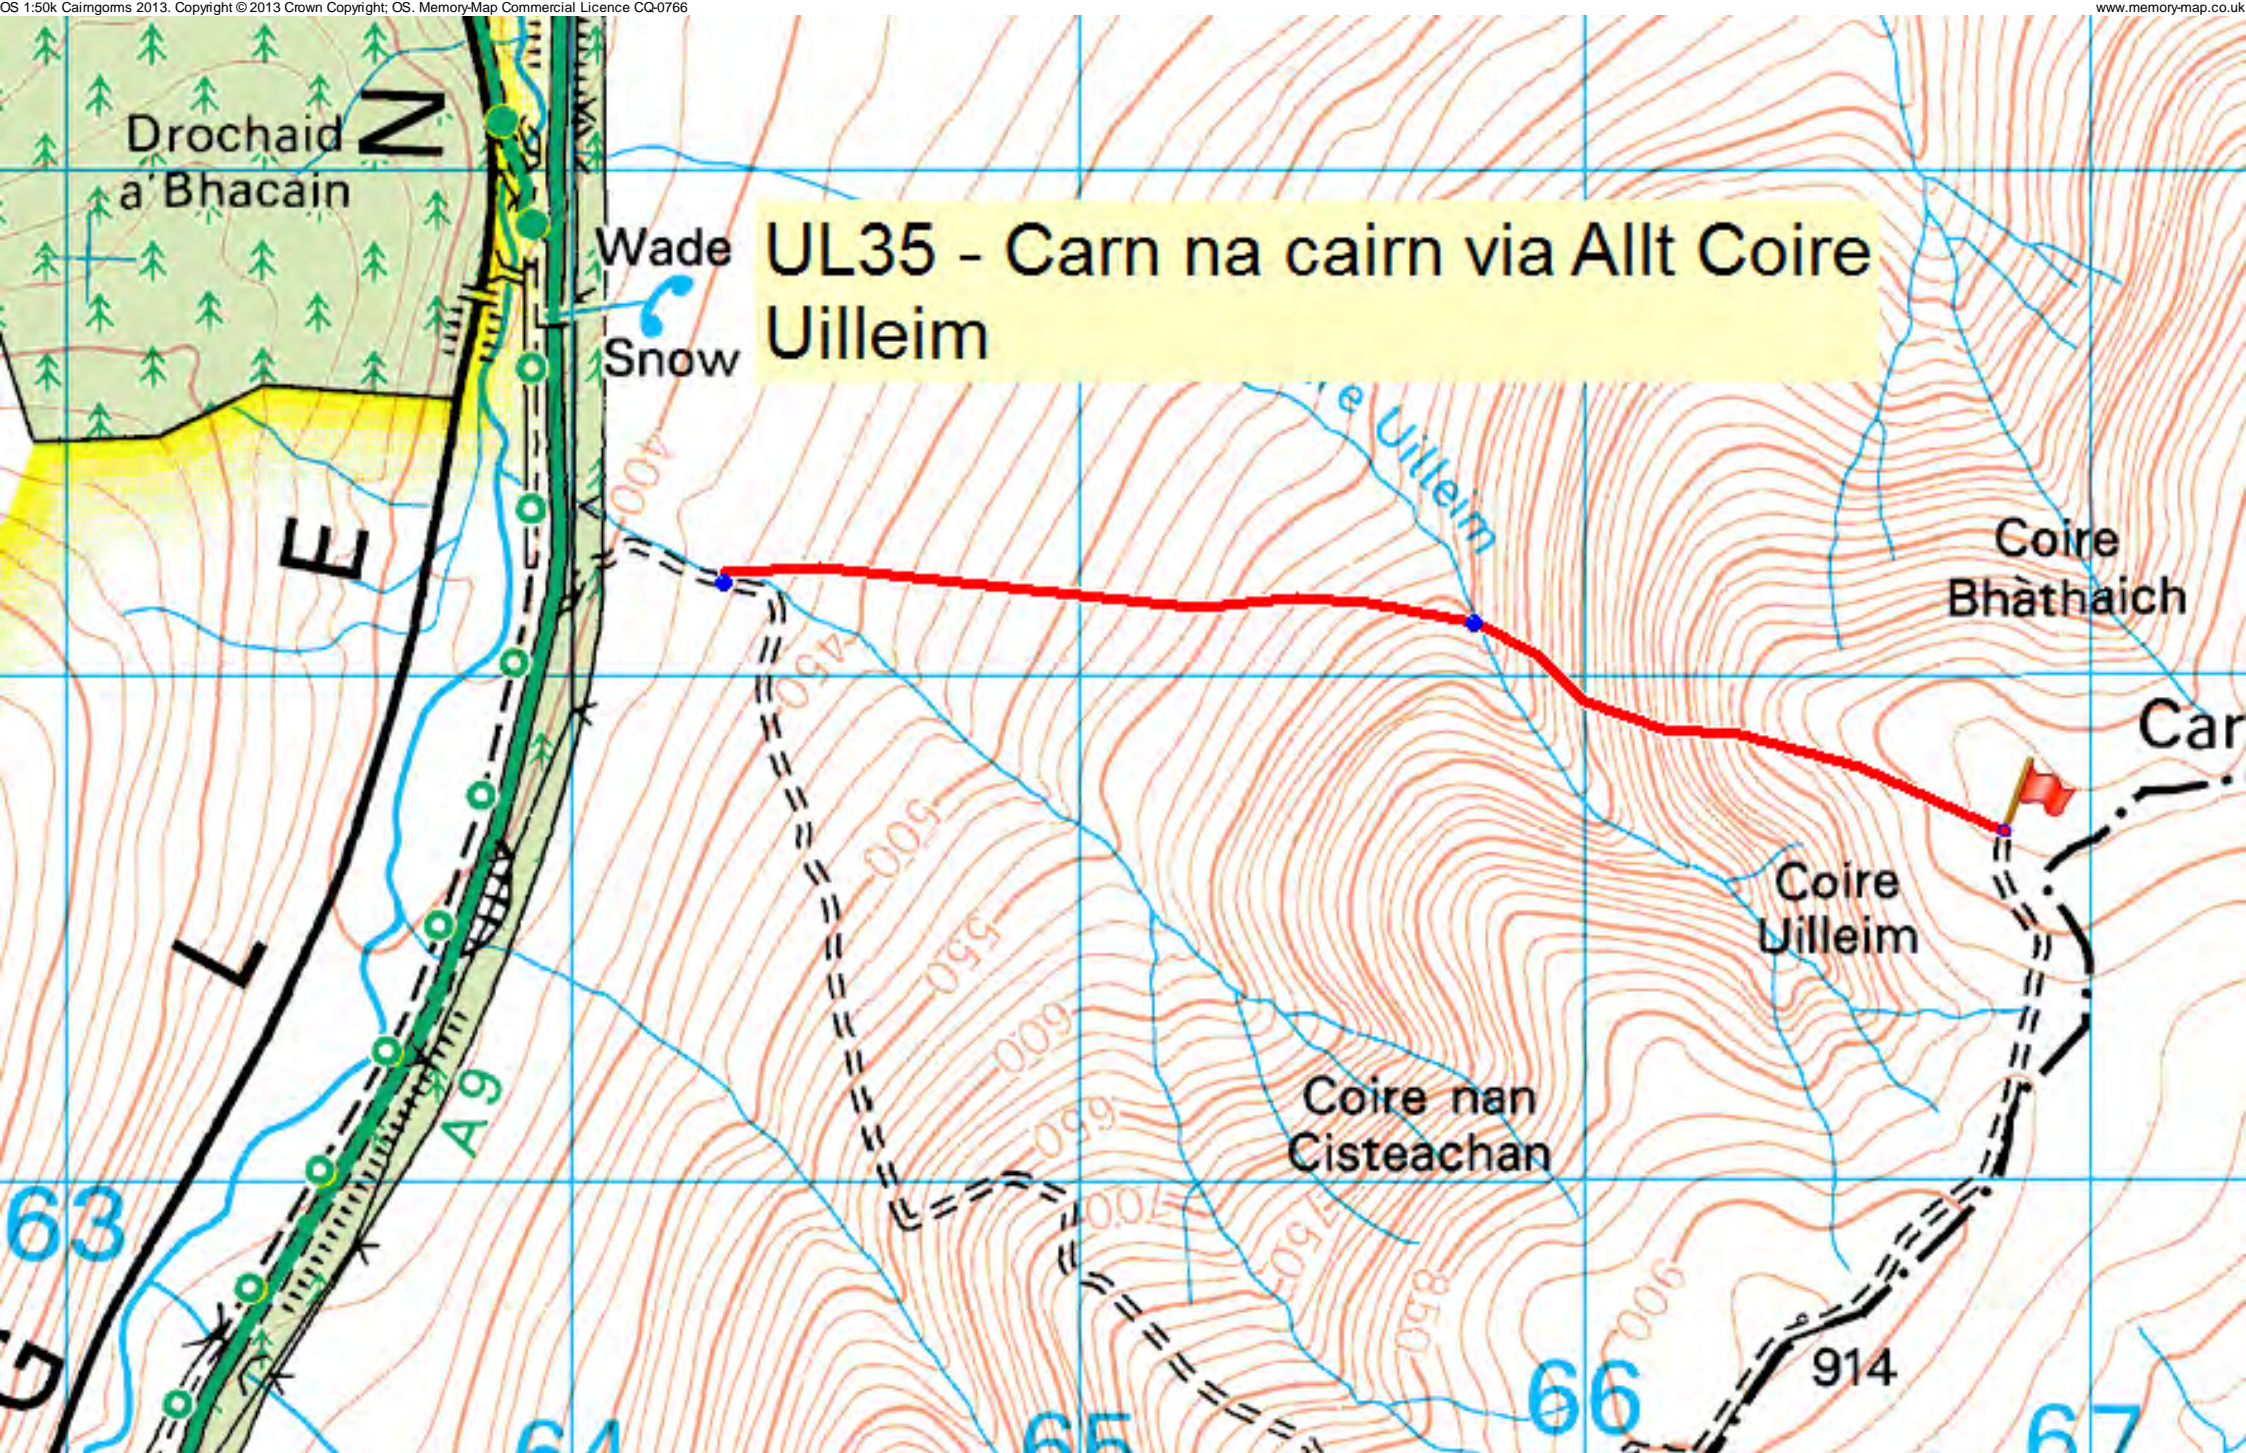
Very badly gullied section parallel to Mount Keen start, could rationalise? Machine Build all the way

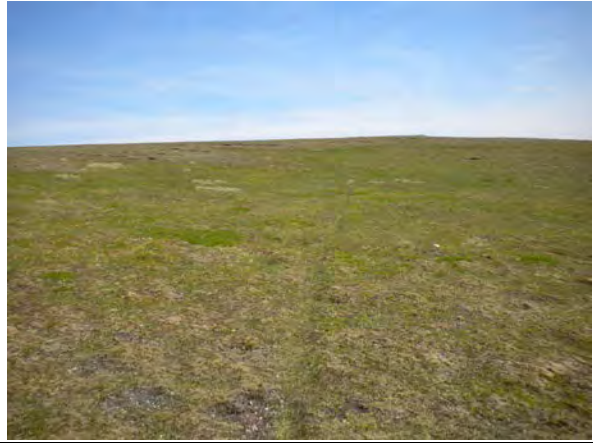
Section 2

from burn crossing to plateau. Intermittent line and deer tracks.
No work required.

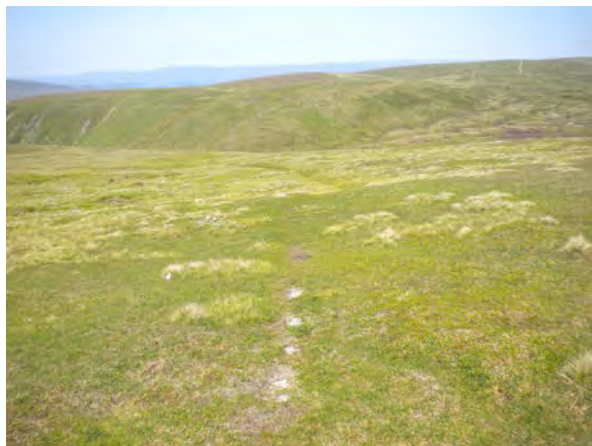
Section 1.

evolved line from cairn to burn crossing. Some pigeon holing evident.
 Lack of building stone. Full machine build recommended if anything.

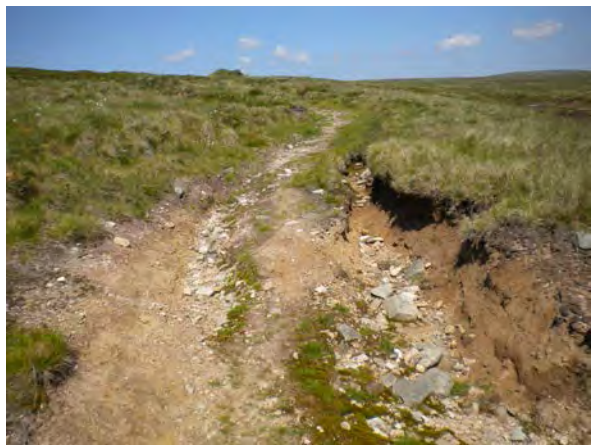
section 2

From burn crossing to cairn at A' Buidheanach
 Vehicle track with onew badly eroded corner.

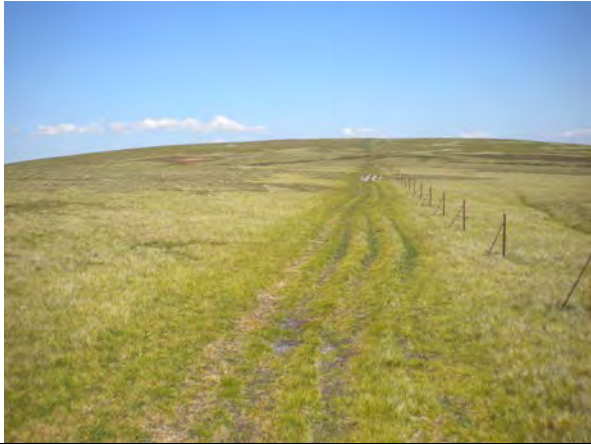
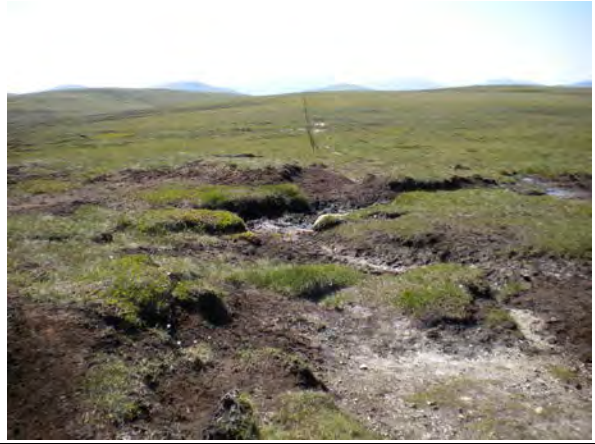
Section 5

This route follows an established vehicle track for most of the way. Any work carried out should be on sections 1 and sections 5 - not critical

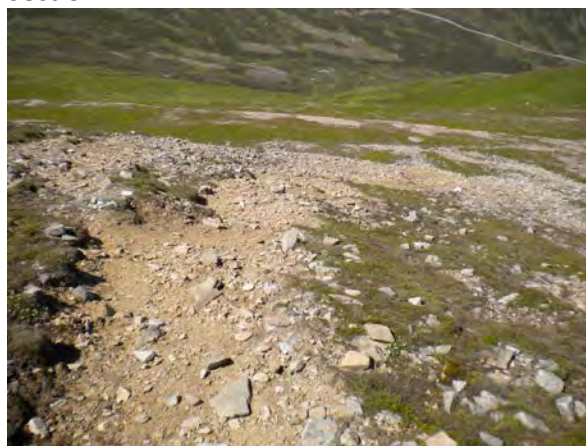
Section 4

From increace in angle to the summit cairn. Loose path material will lead to gullyng
Light touch works required. Anchorbars and waterbars.

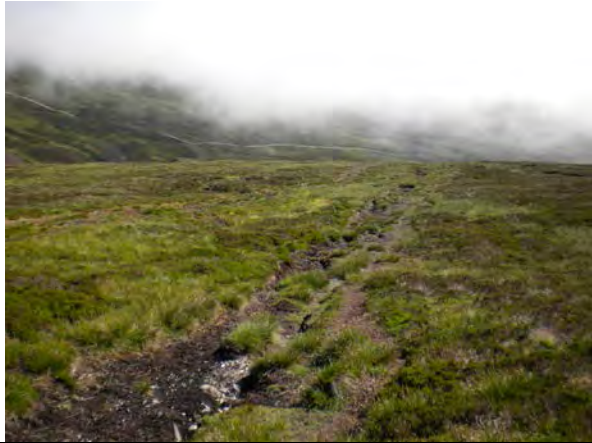
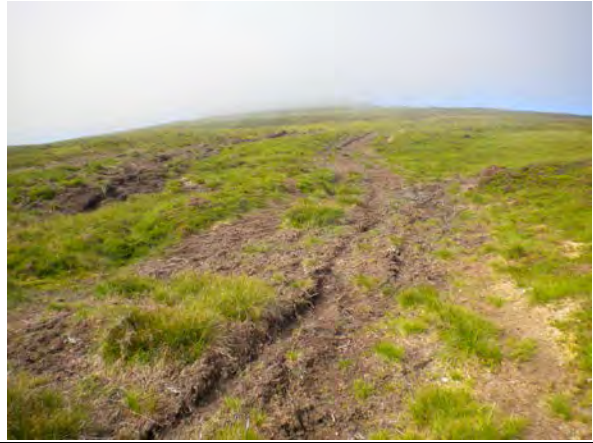
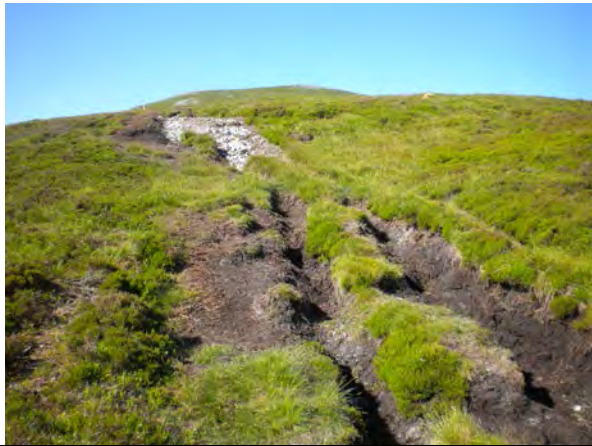
This route follows a well built estate ATV track. Section 3 is in poor condition due to peaty ground. ATV use will need to be taken into consideration when planning any future work.

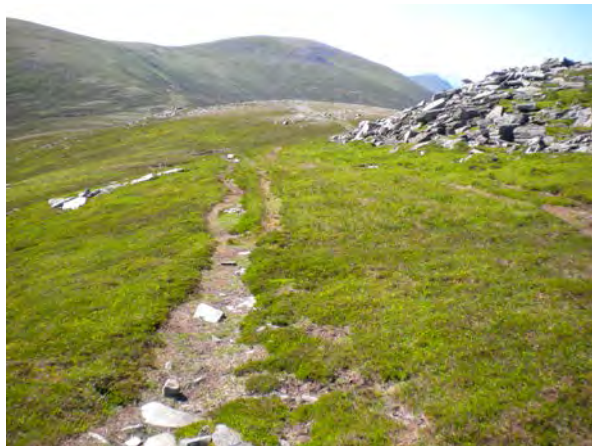
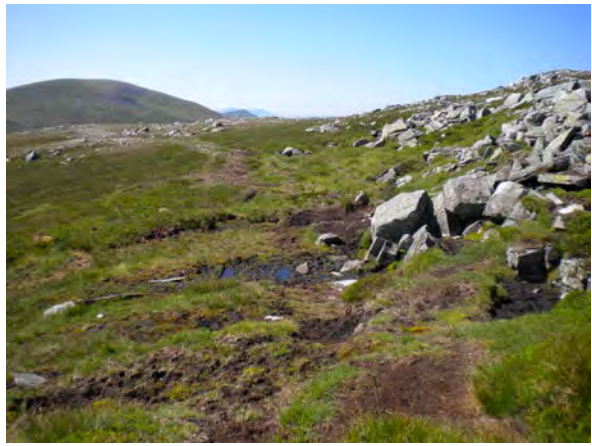
Maintenance: Once repaired the path will require on-going annual maintenance			
Section 1.

Route between the two Munro summits. Section 1 would benefit from robust light touch techniques. Section 3 is more of priority requiring full handbuilt path

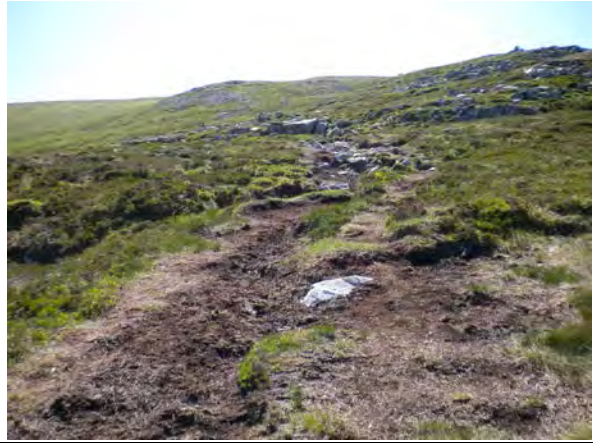
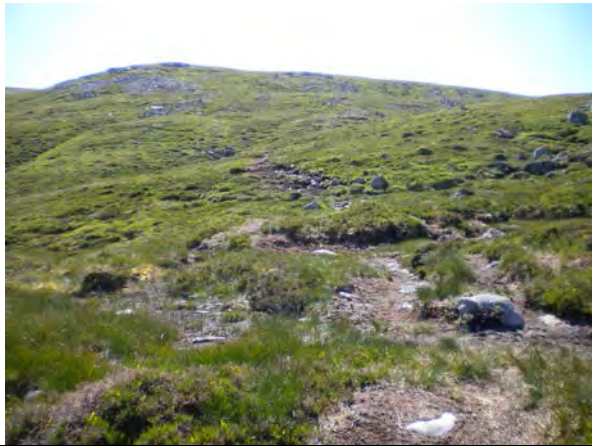
Section 3

From access track to Plateau. Poor condition with evidence of path spread
Hand - build stalker style path required.

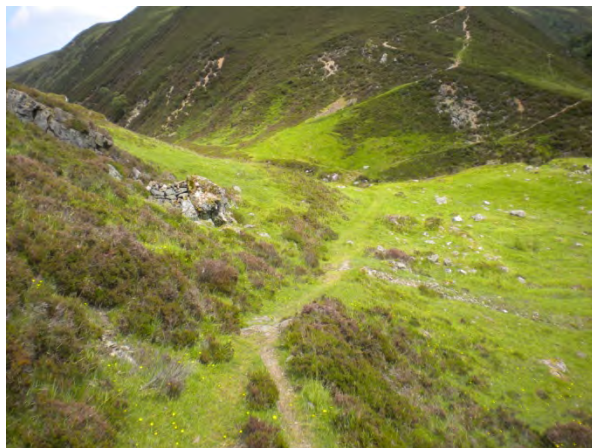
Maintenance: Once repaired the path will require annual maintenance, with drains to be cleared and path surface occasionally topped up.			
Section 1

From start of path to burn crossing. Large stepping stones would be needed for the burn when in spate.

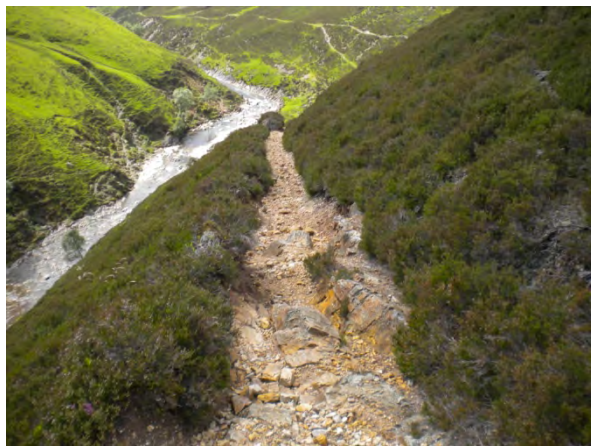
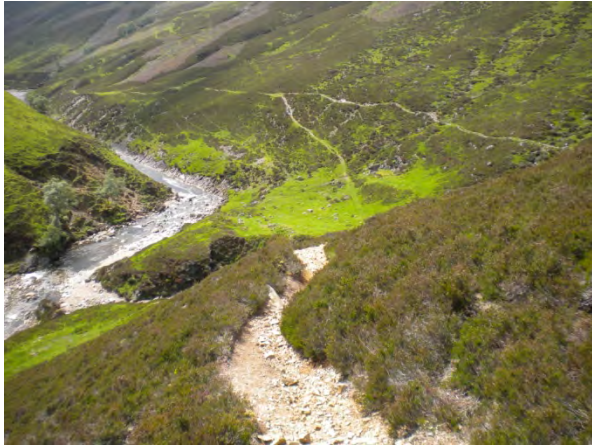
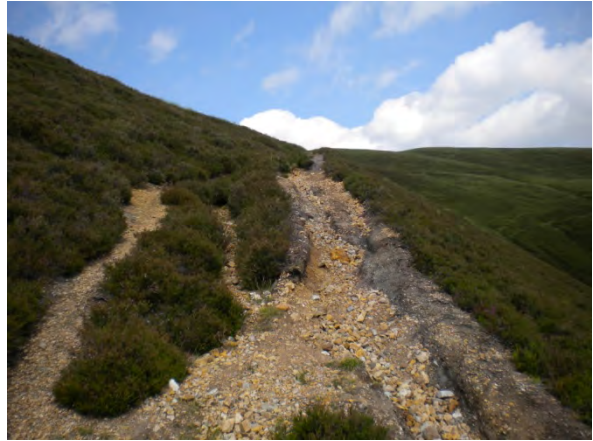
steep climb up from burn onto ridge. Loose material is being washed out of pathline Full build required with 30m of pitching. Lack of stone close to path will be a problem.

Section 2 is the most dynamic and in danger of further erosion. This would require intensive hand build.
