Scotland's National Parks - Upland Path Project

The Mountains and The People

Loch Lomond and the Trossachs

Upland Path Audit 2013

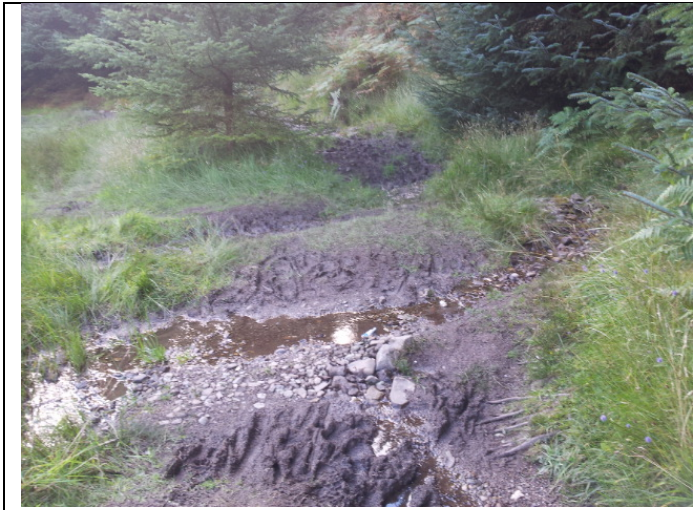
Path line widening through section 2
