# Cairngorms Mountain Heritage Project

## Upland Path Audit

Surveyors – Dougie Baird, Chris Goodman

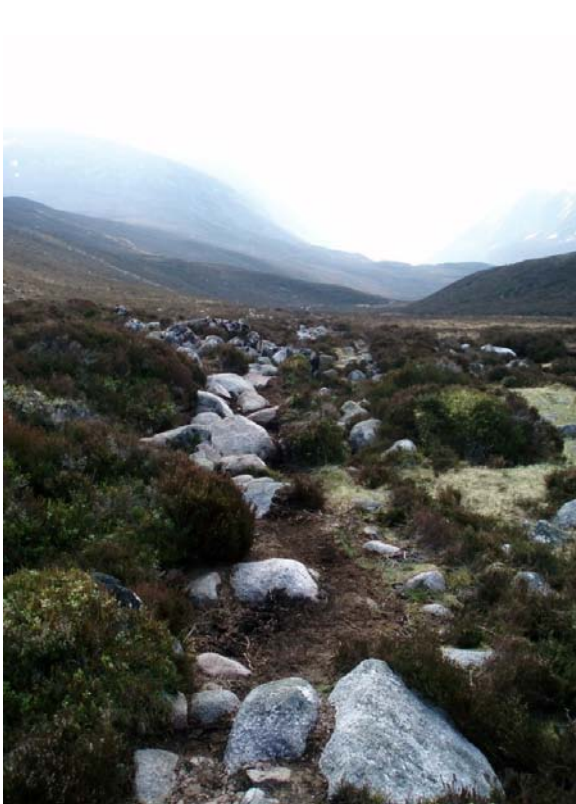
**Section 4 rough but stable.**

Some old UFMP work c. 1988/9, robust xds and wbs. A bit beat up and in need of some maintenance but no construction work recommended.

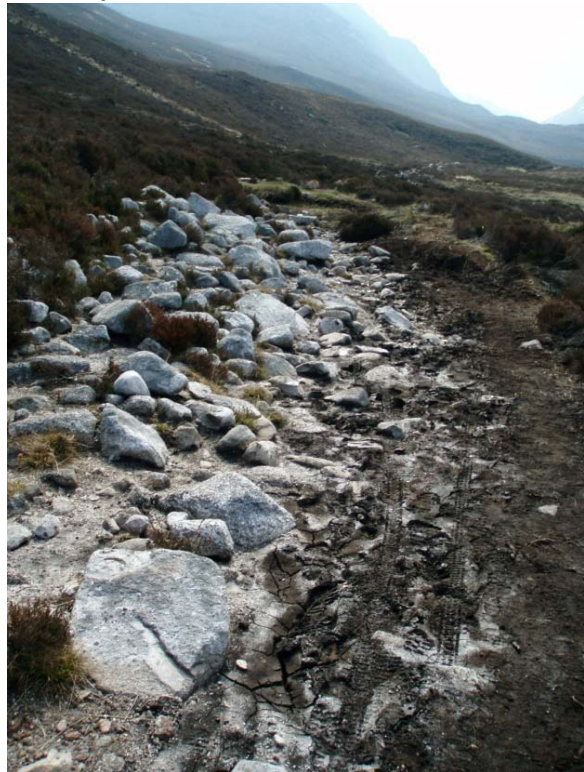
**Light Touch works required further in to contain path.**

light touch work required on this section, which ascends the left and then right side of the burn on a fairly well contained slope.

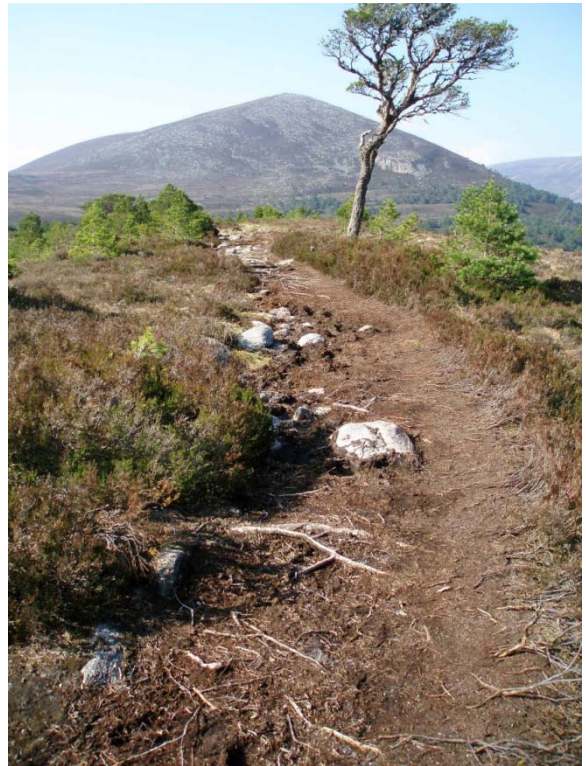
**Peaty soil with tree roots to be worked around.**

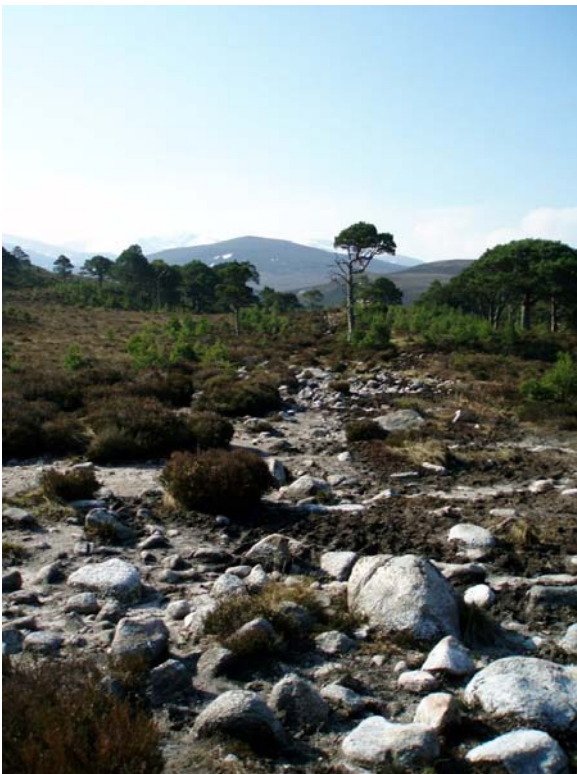
**Section 3 very badly eroded.**

Badly damaged path, used by cyclists and walkers. Machine built hi and dri path required with low maintenance, high load bearing and gets the path above the tree roots without compromising them.

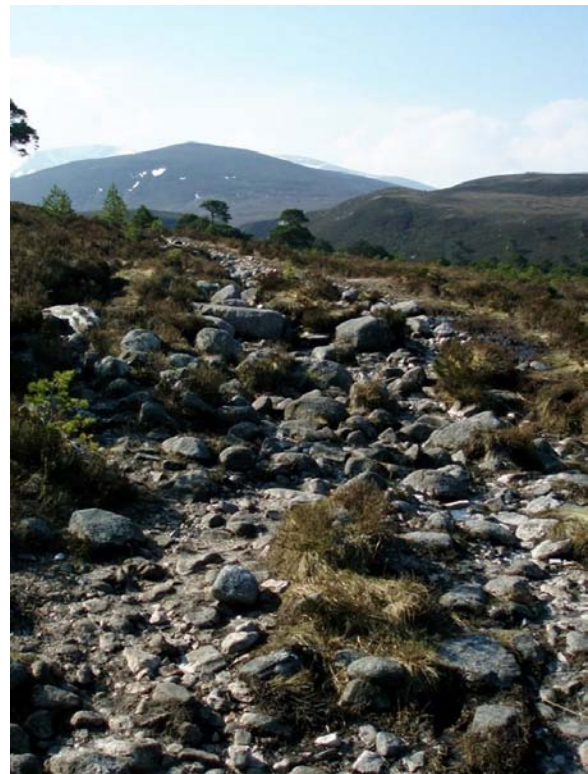
**Further erosion, section 3.**

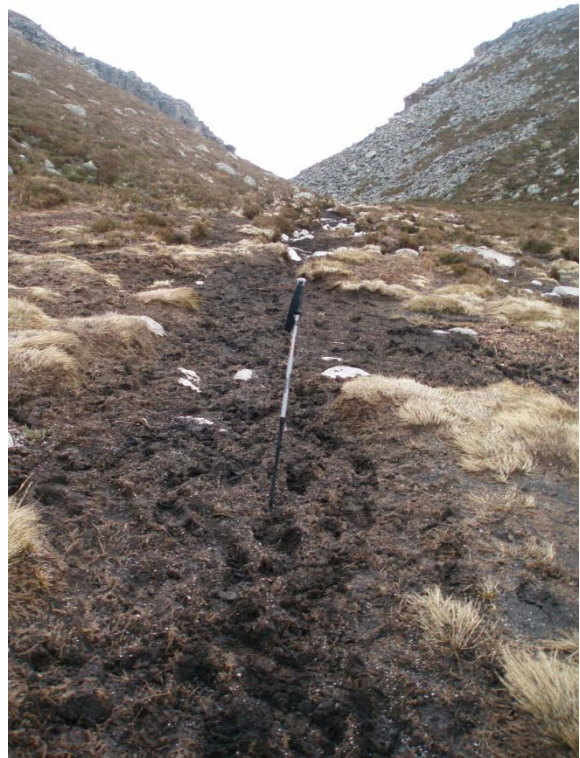
**Erosion problems on section 8**

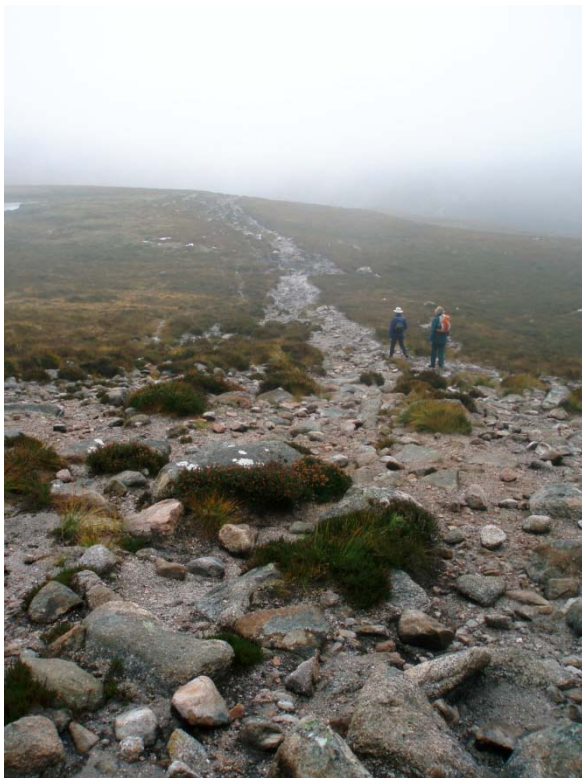
**Further erosion problems on section 8.**

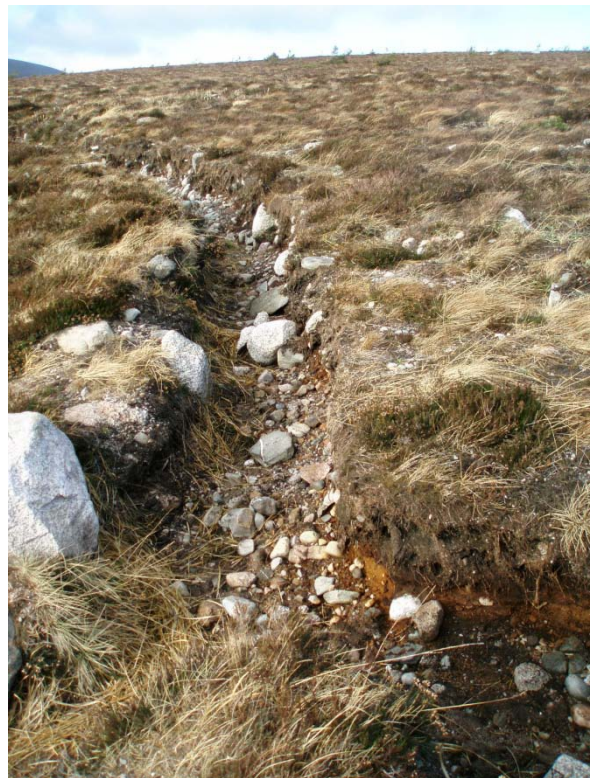
**Some gullying on section 9.**

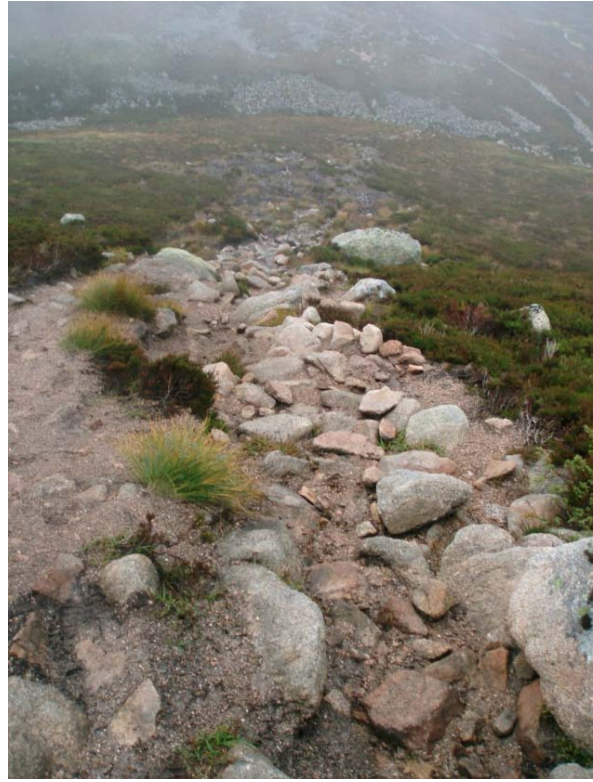
**Gullying around previous work.**

Built in recent years but failing very badly - hardcore is exposed and not fit for purpose. Path needs rebuilt/ hardcore broken up properly and bound surface laid

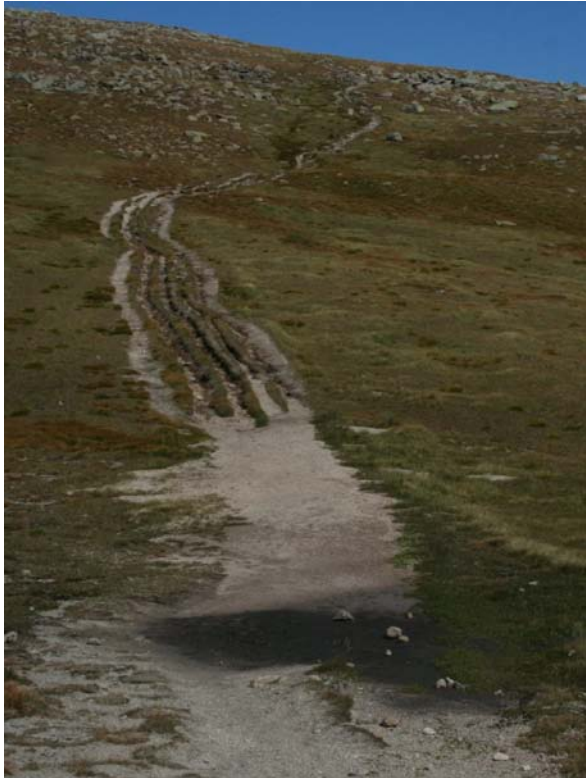
**Bad braiding needs contained with water bars to protect path surface.**

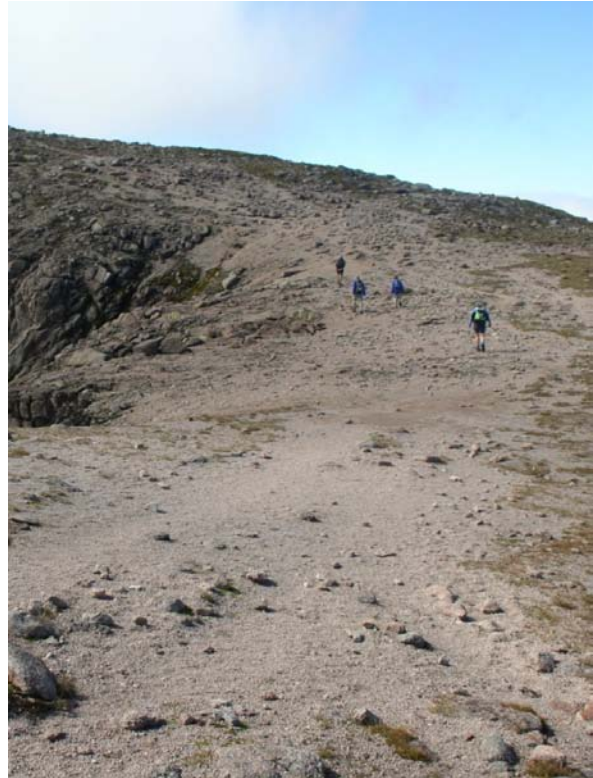
**Extreme erosion on summit approach.**

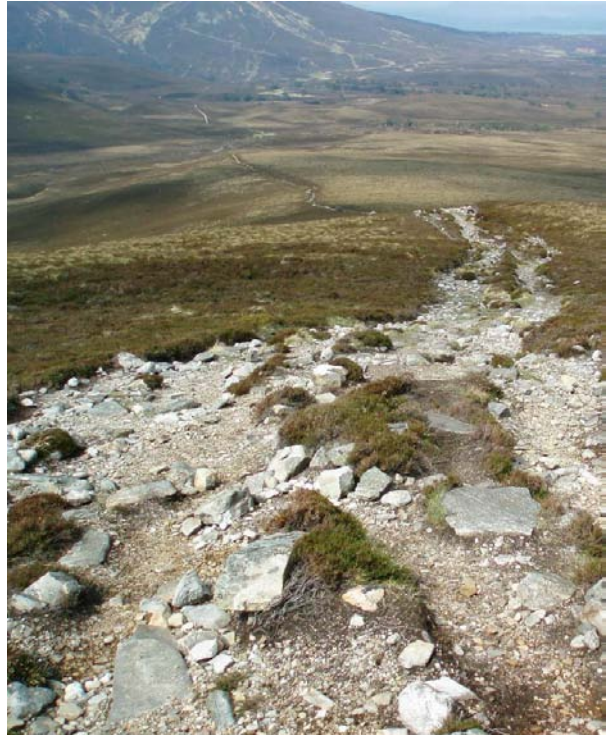
**High Build required on the first few kms**

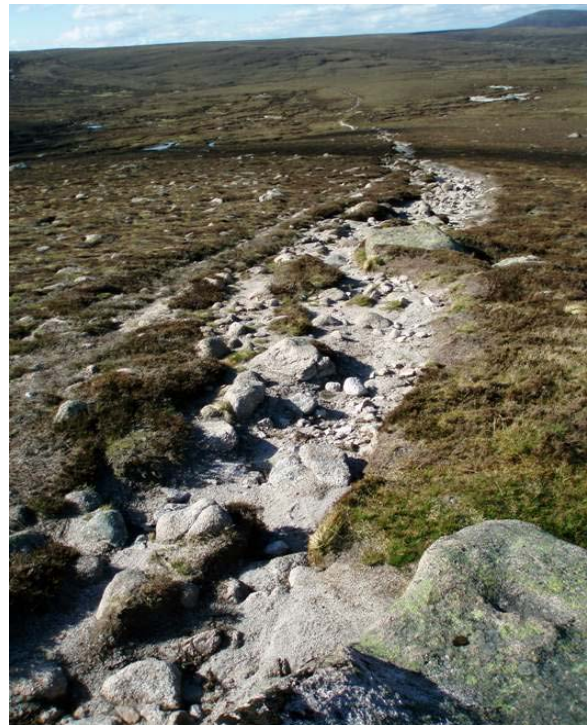
**Light Touch works required further in.**

Fords up to neck at Dubh Lochan - robust path with little damage light touch and pre-emptive work only

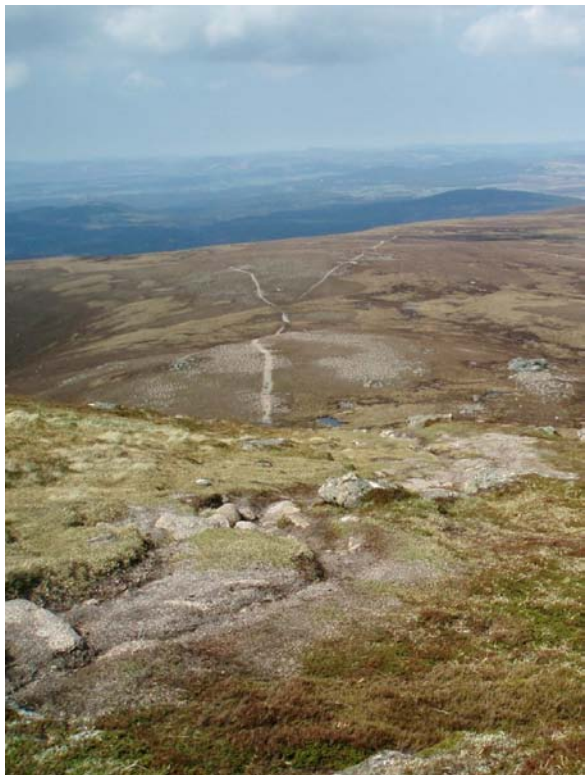
**Path line very visible from high ground.**

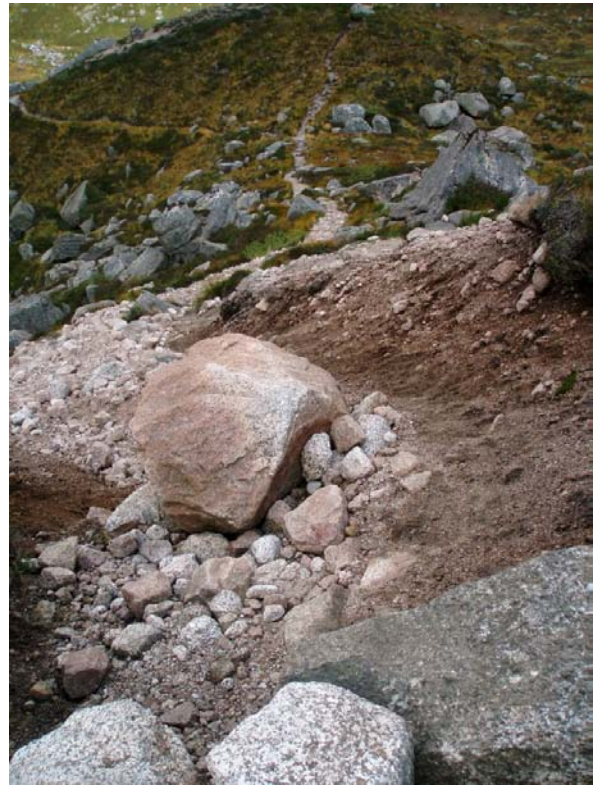
**Short section badly eroded**

shelter stone up slope towards loch etchachan. Start sections very badly damaged in places, further up needs lighter touch. Partial build required.

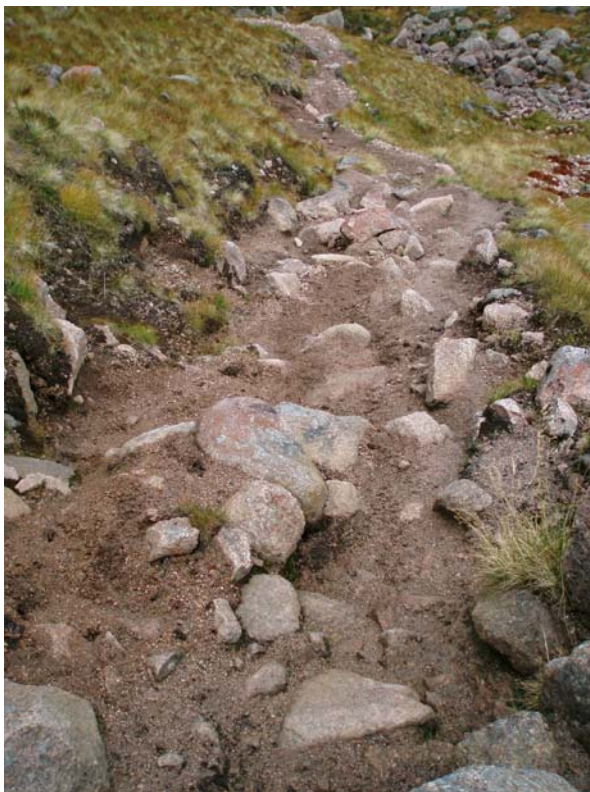
**Rough section leading up to Loch Etchachan.**

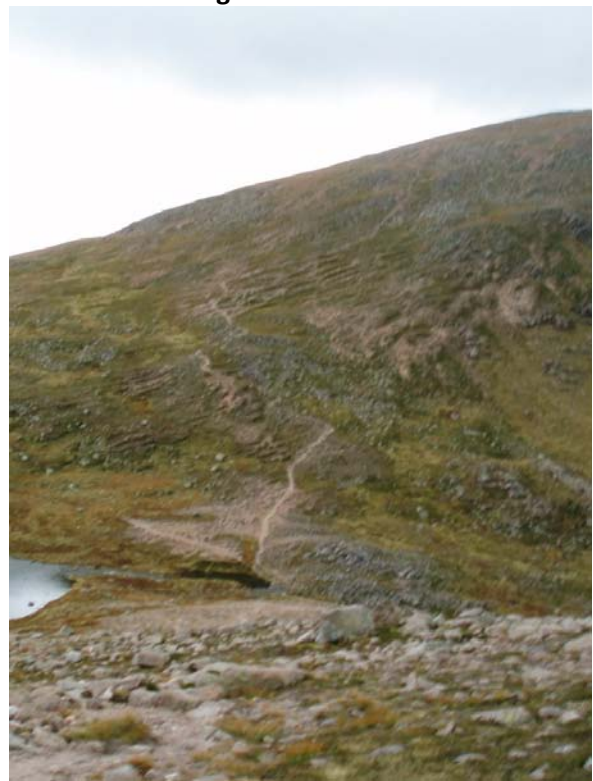
**Route up Beinn Mheadhoin needs light touch definition and alignment.**

Path from ethcachan up to first top - steep worn route, had light touch work by UALtd c.2002/3. Needs more of this, mostly definition and alignment.

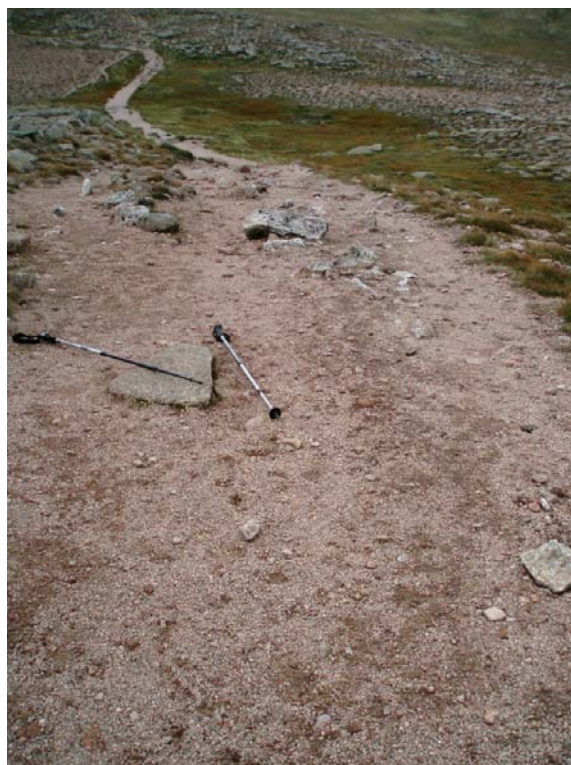
**3-4m wide erosion scar.**

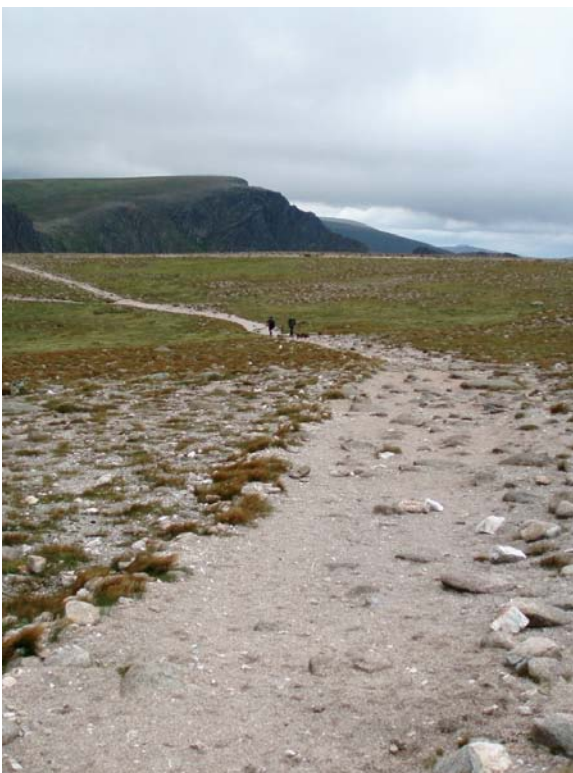
**Top of Coire an t-Sneachda.**

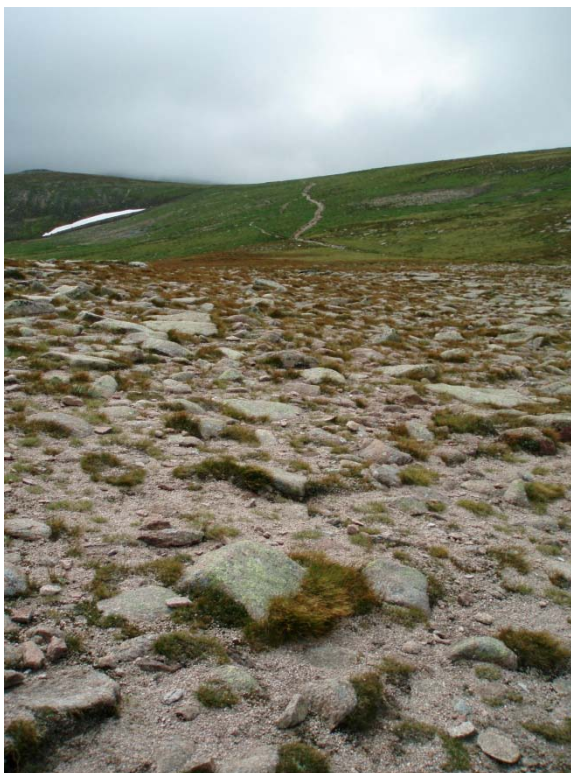
**Path from Coire rim across plateau.**

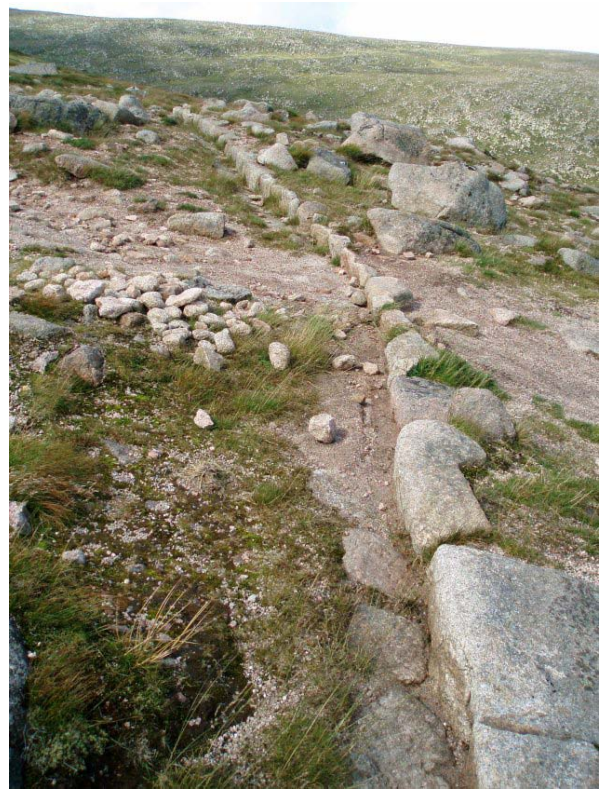
**12m water bar.**

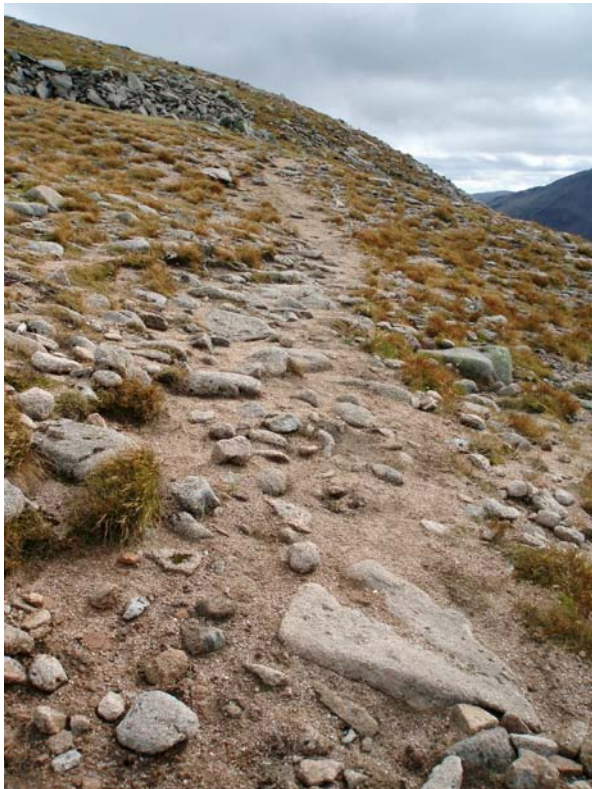
**Shoulder of Cairn Lochan.**

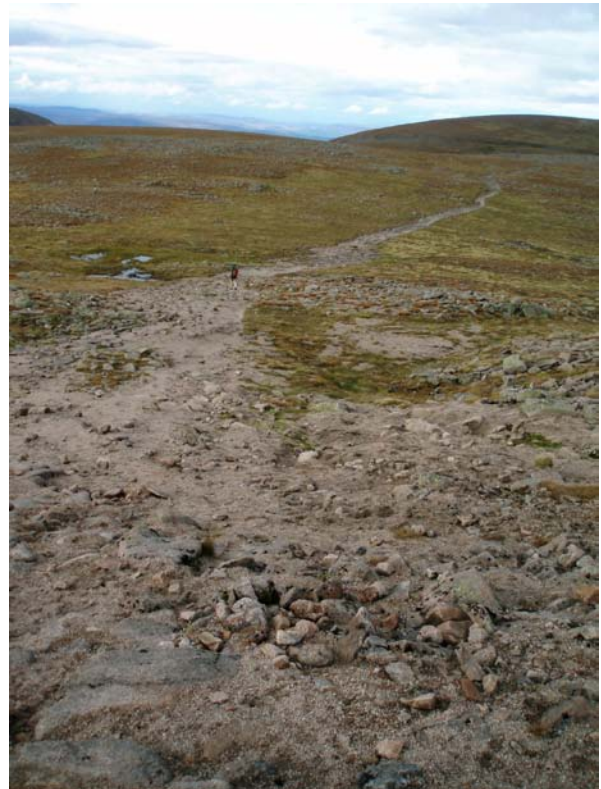
**Erosion on plateau needs containing.**

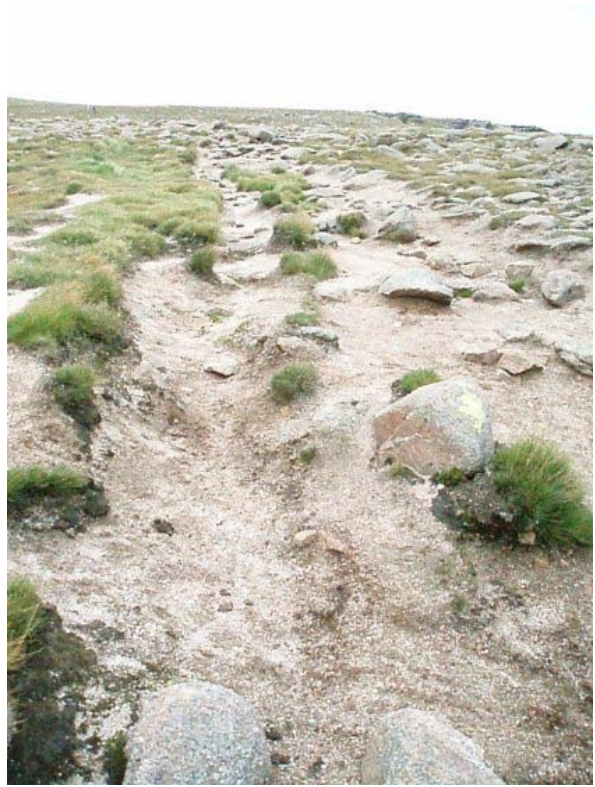
**Gullying of plateau soil**

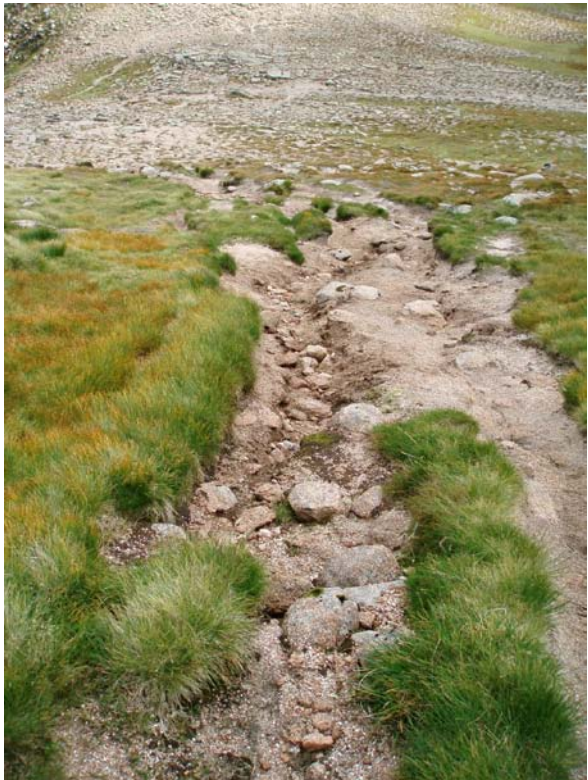
**Further gullying.**

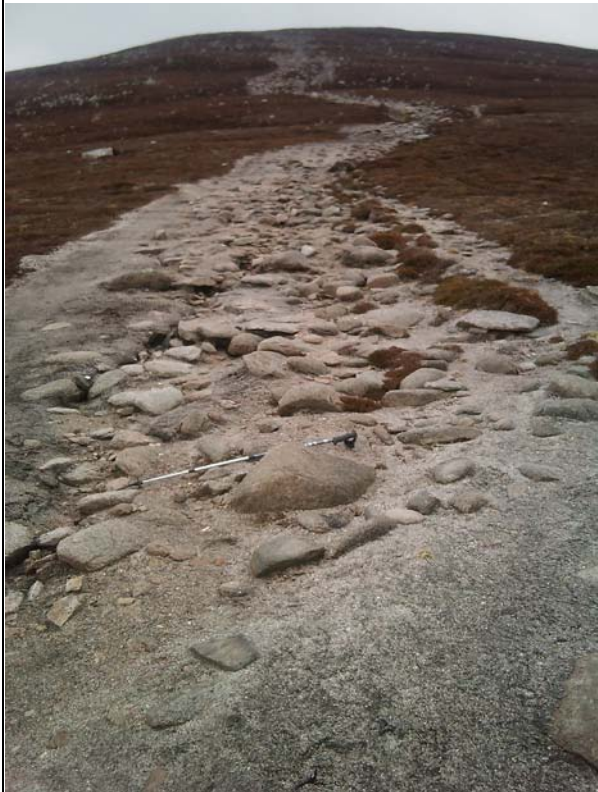
<b>Broad erosion scar on section 4/5</b>

Section taverses to shoulder to short plateau, heavy damage at top. Full build required with heavy landscaping at top.

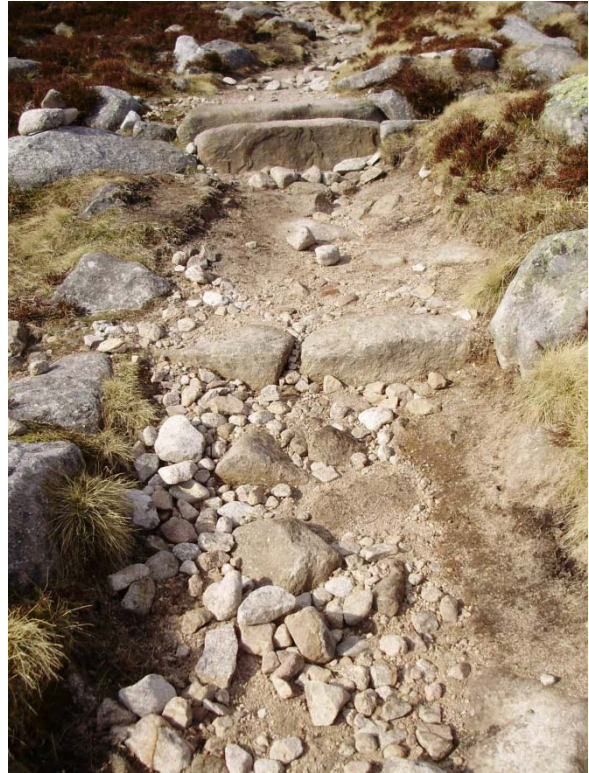
**Resurfacing needed, section 1.**

Lower built surface is typical of its time - shallow hardcore base is now exposed and surface is avoided. Needs hardcore and surface relaid for c.700m. Some further stone pitched sections may help durability of path surface in places.

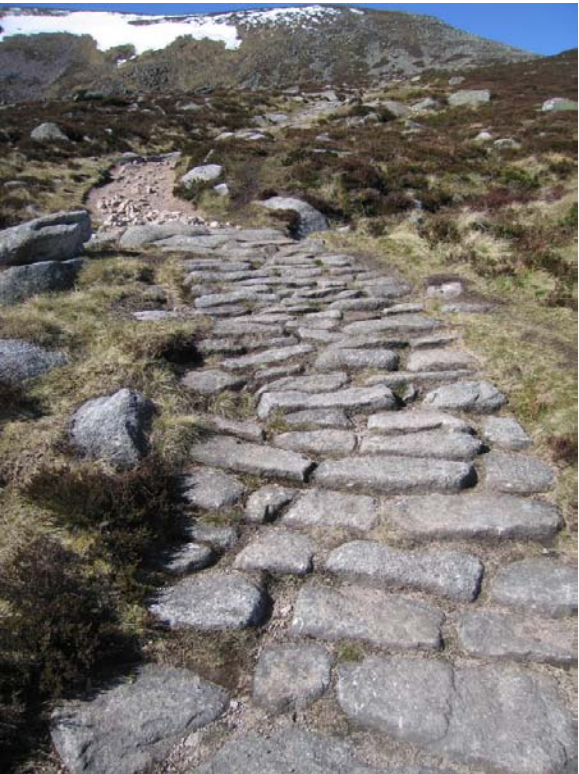
**Pitching, section 2.**

Continous pitching section from saddle to corrie rim. Excellent condition.

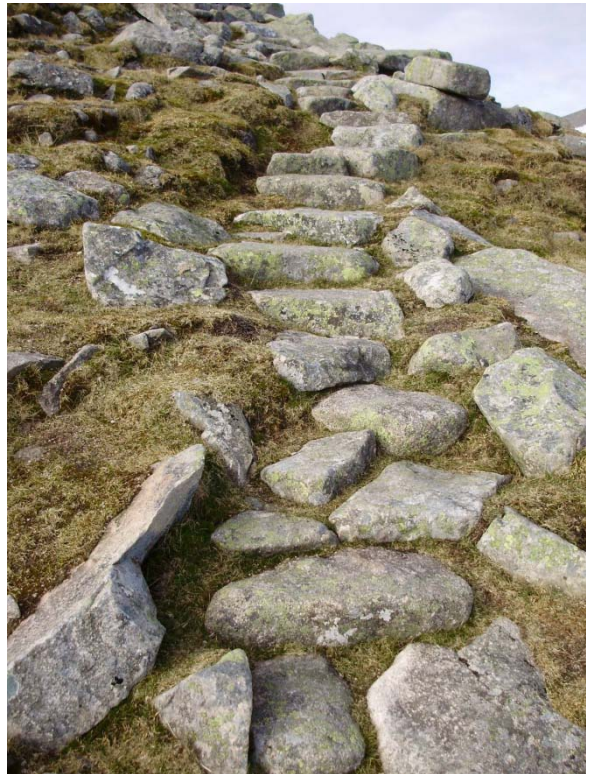
**Pitching, section 2.**

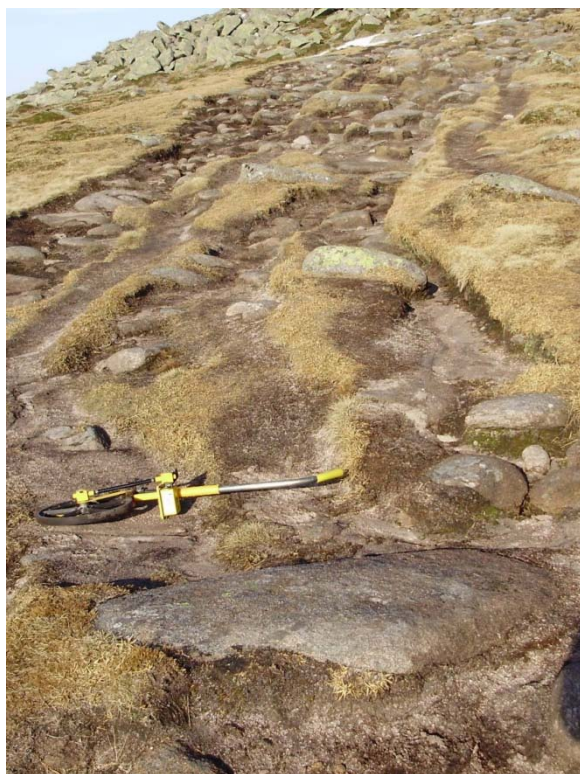
**Could re-route section onto Glas Allt path.**

Steeper eroded section in bad condition. Only 20m from built Glas Allt path and could be rerouted onto this. Otherwise would need full build path.

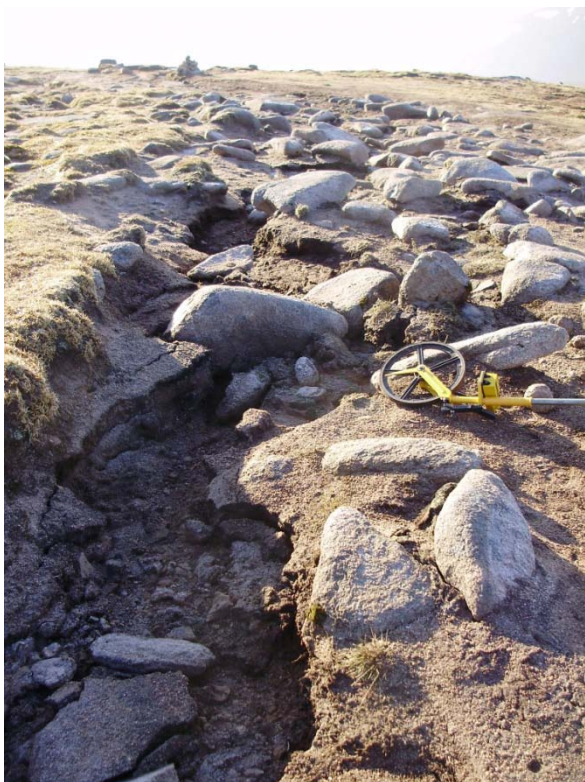
**Some gullying of fines where unprotected.**

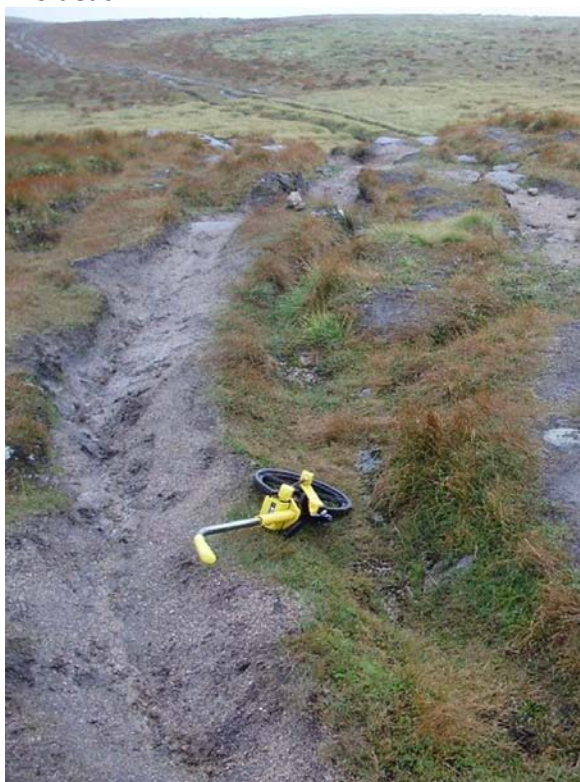
**Less erosion on path to Carn a' Choire Bhoideach.**

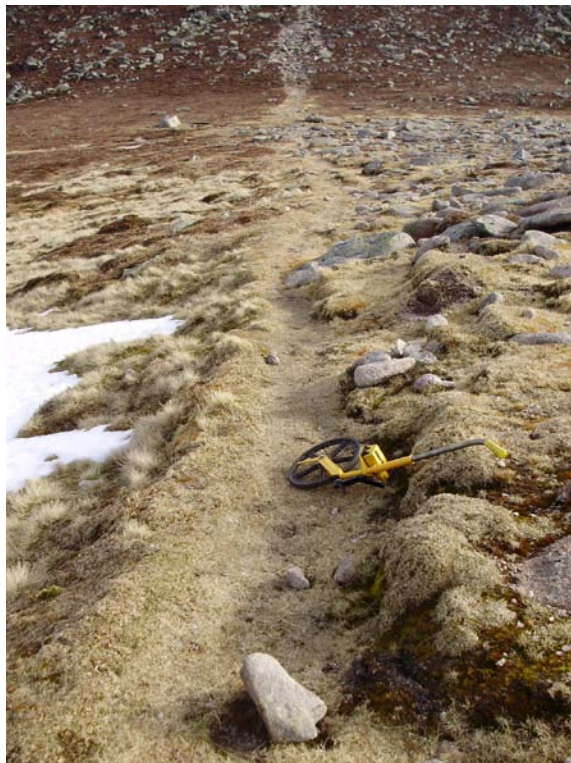
**Section across saddle.**

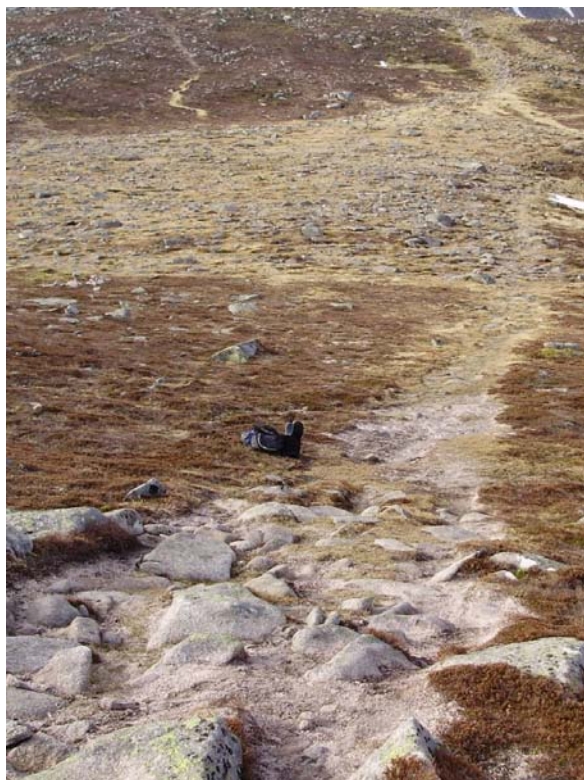
**Some loss of vegetation, section 2.**

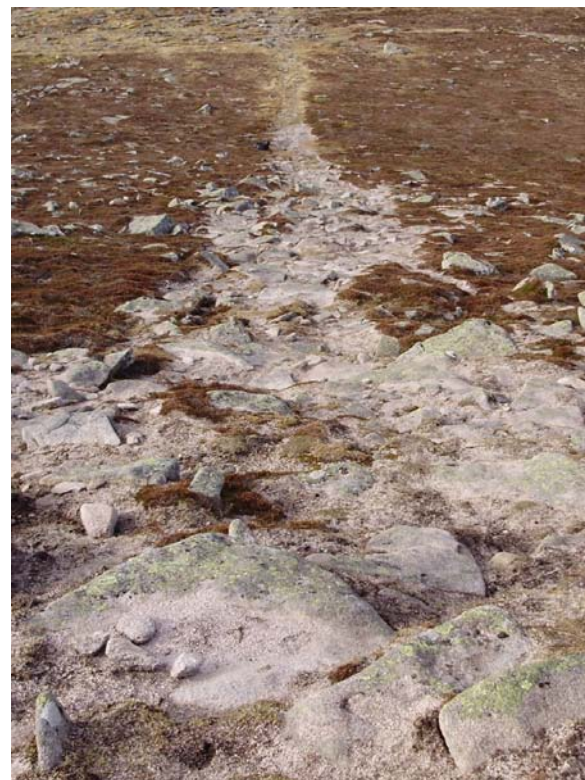
**Worsening erosion, section 2.**

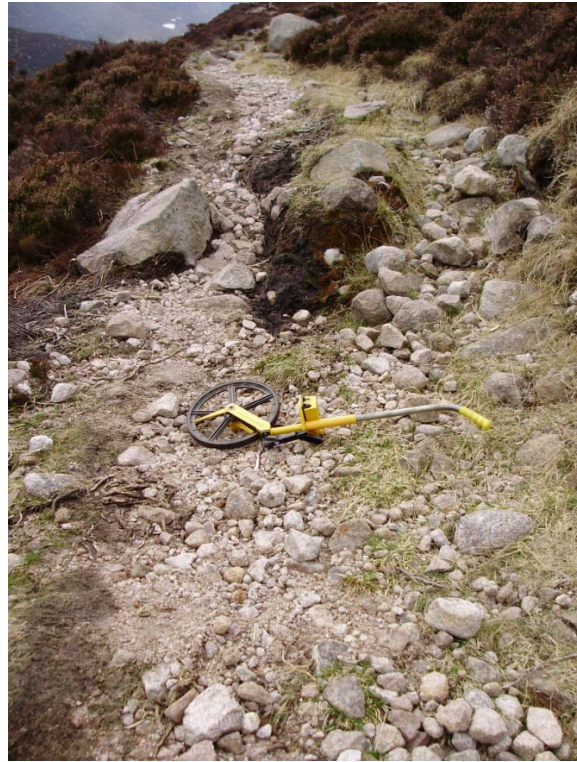
**Section 4 needs full build.**

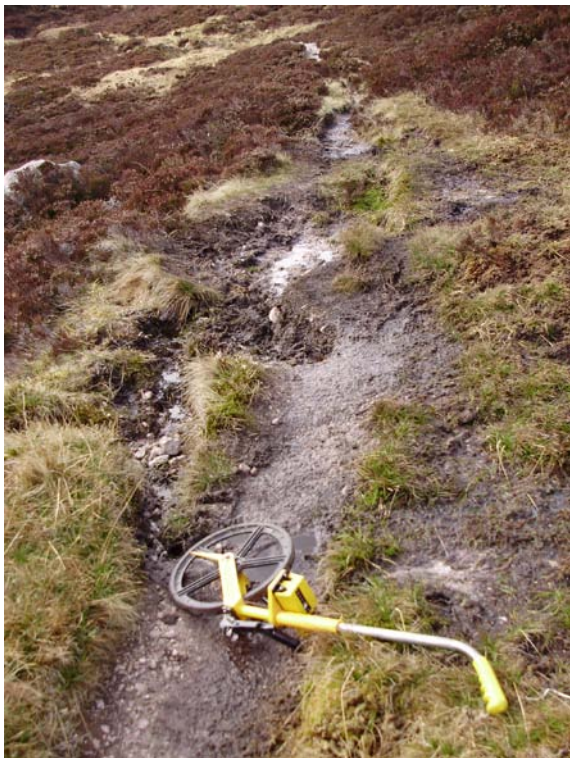
**Some work needed on section 5.**

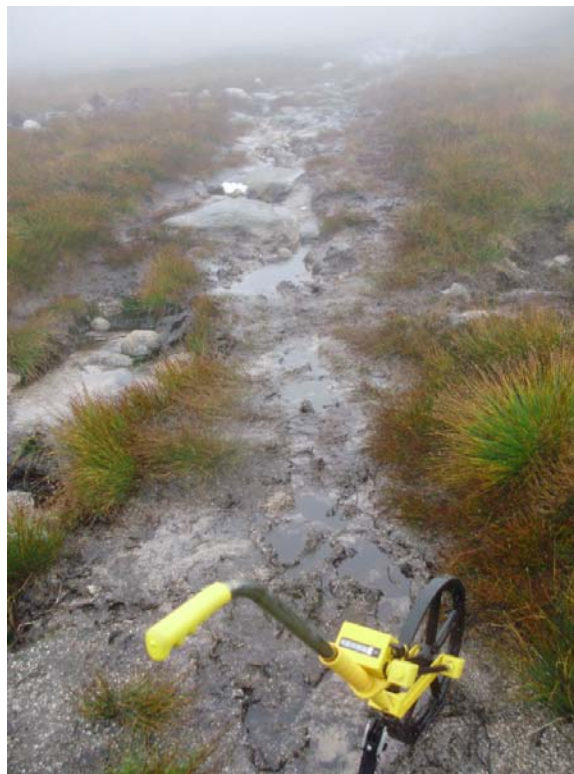
**More substantial work needed after vehicle track ends.**

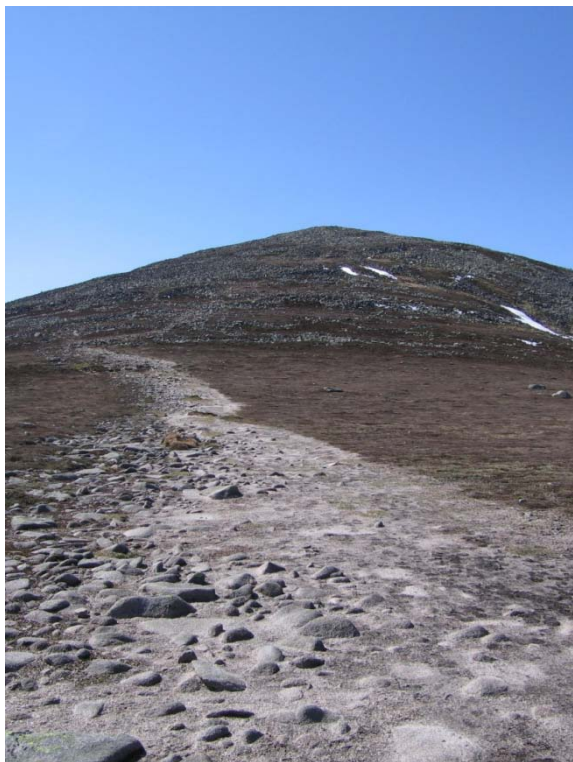
**Plateau path to Broad Cairn.**

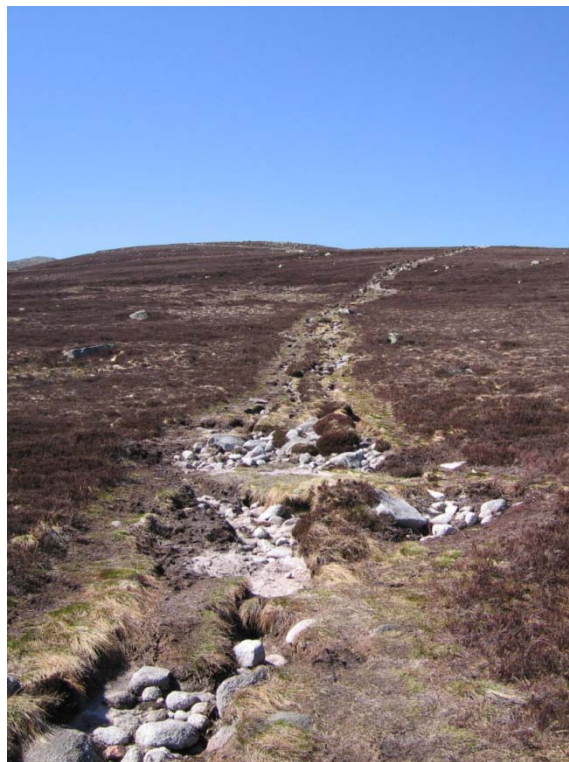
**Gullying on higher sections.**

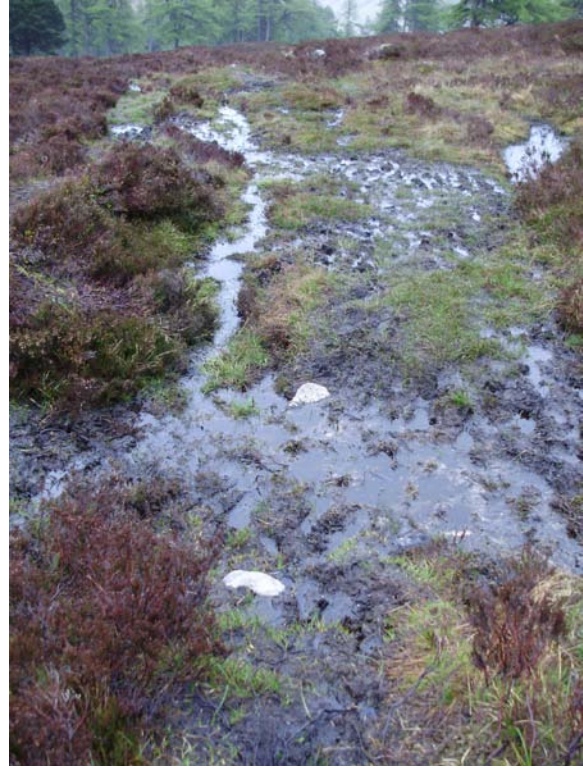
**Wet ground on section 2.**

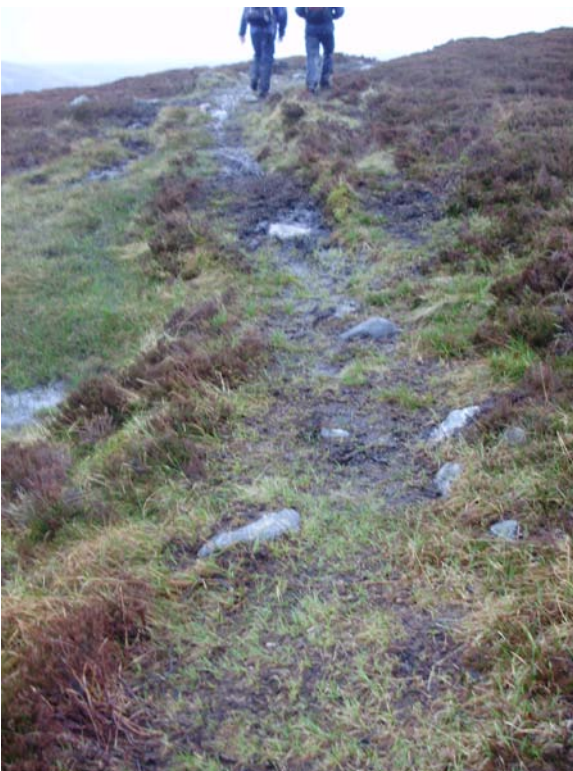
**Light touch work required section 3.**

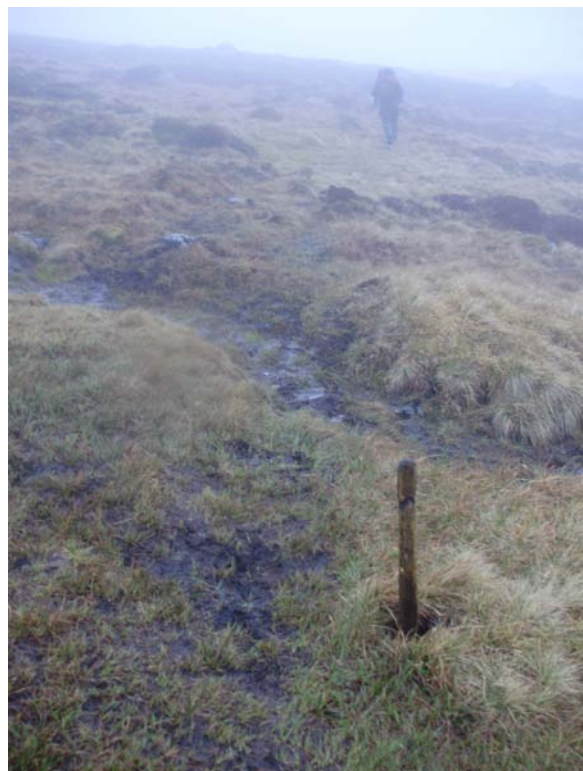
**Path less well defined on section 4.**

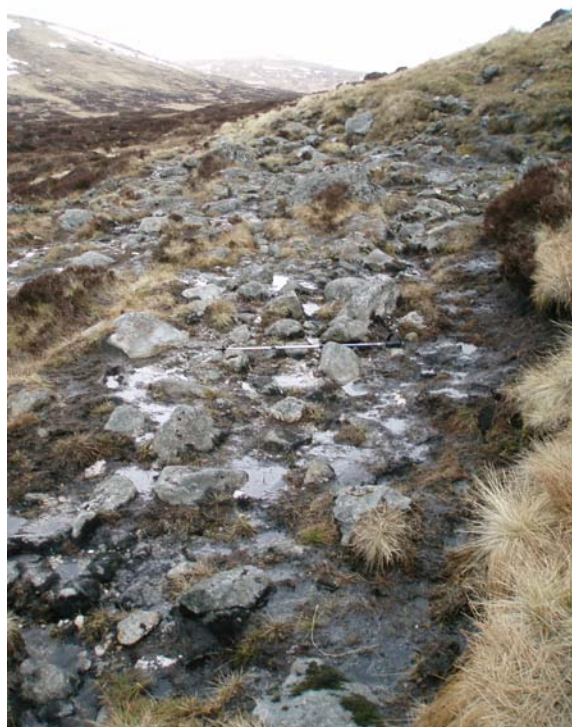
**Full build required on section 4.**

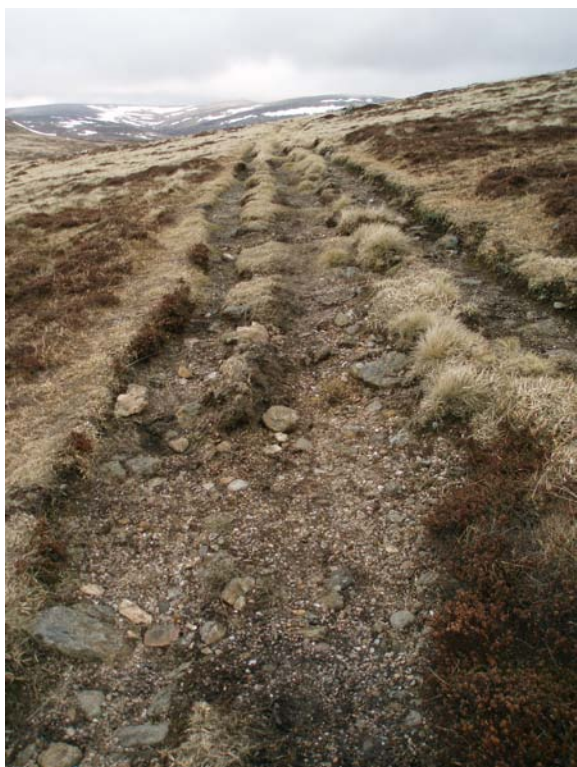
**Light Touch works required further in.**

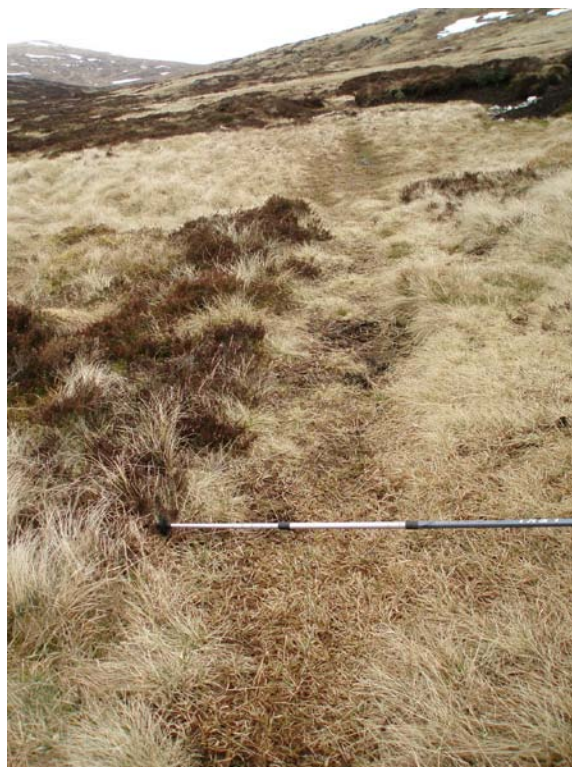
**Route less well defined on higher ground.**

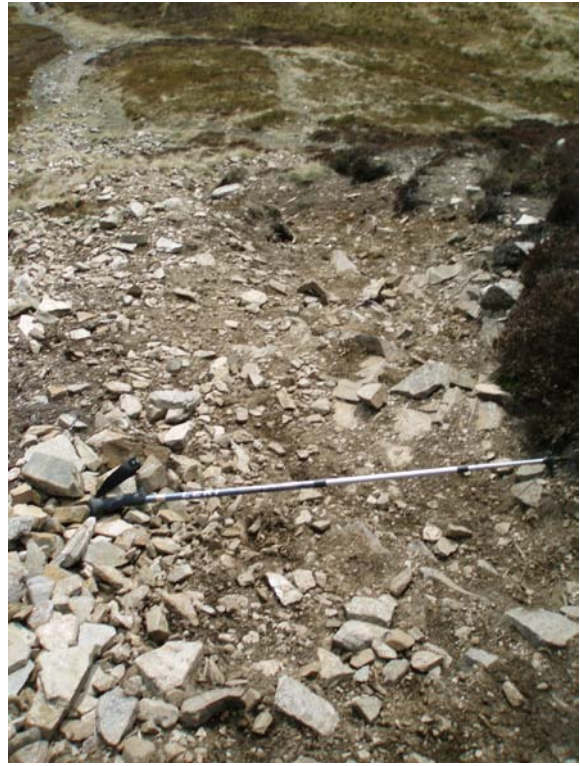
**Full build required up Snub.**

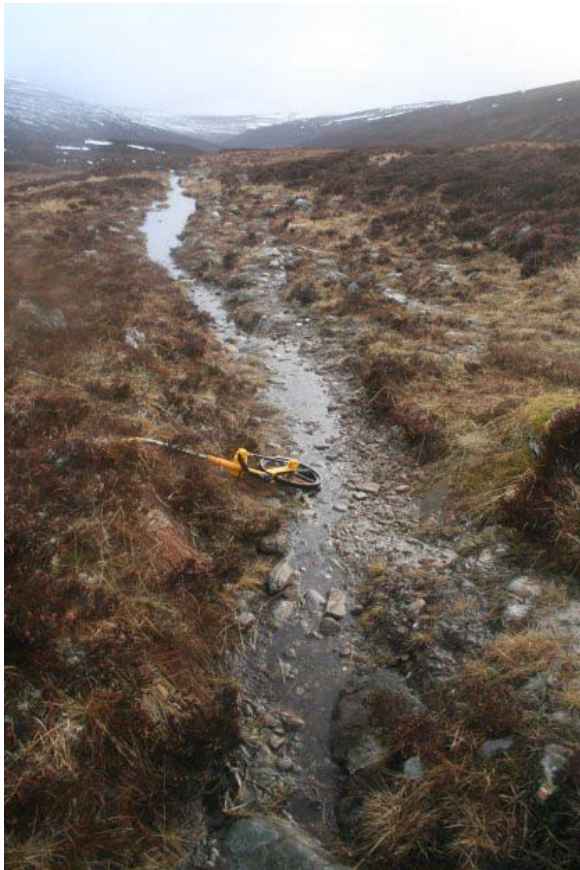
**'Light touch' works would be beneficial on section 7.**

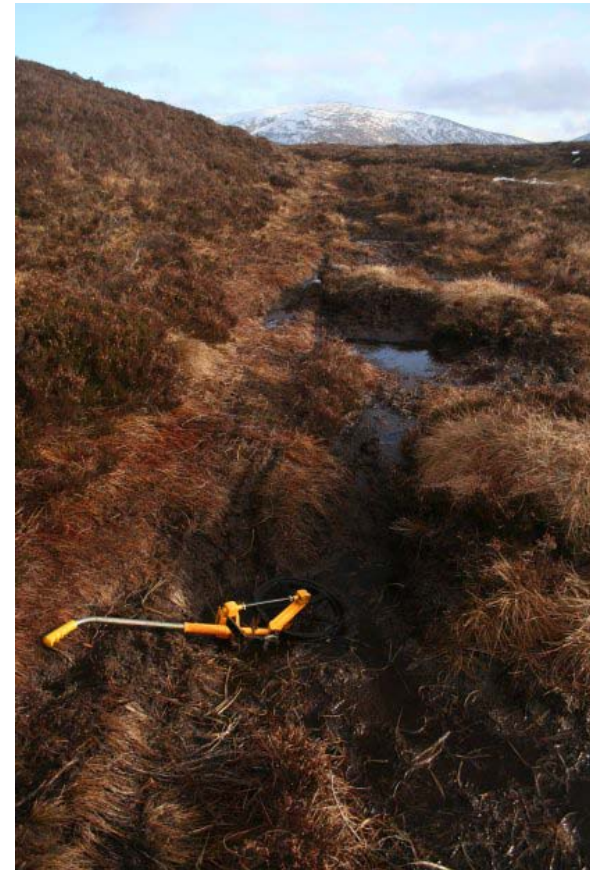
**Section 8 – full build or leave alone.**
