# Cairngorms Mountain Heritage Project

## Upland Path Audit

Surveyors – Dougie Baird, Chris Goodman

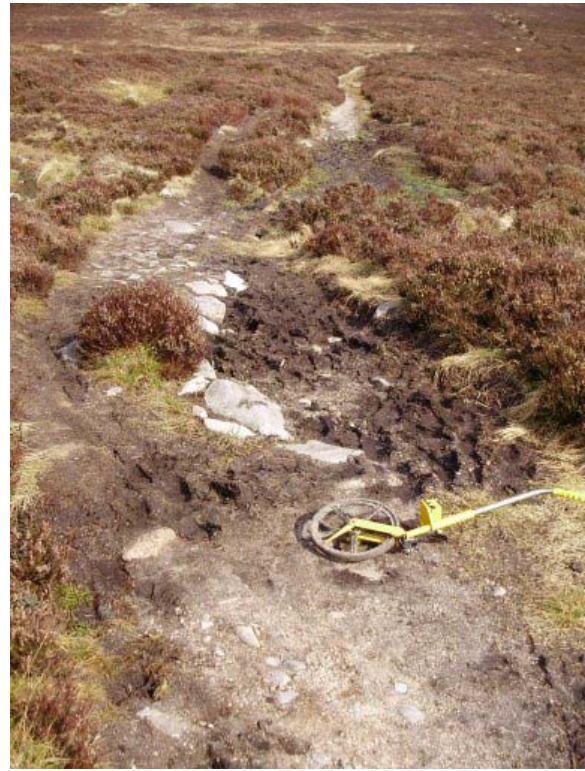
**Short muddy stretch, section 2.**

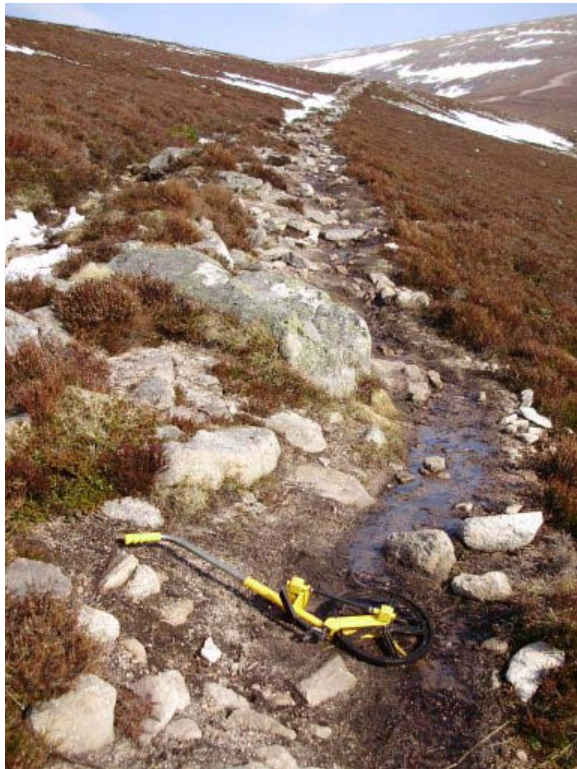
**Section 3 – path line gradually migrating down hill.**

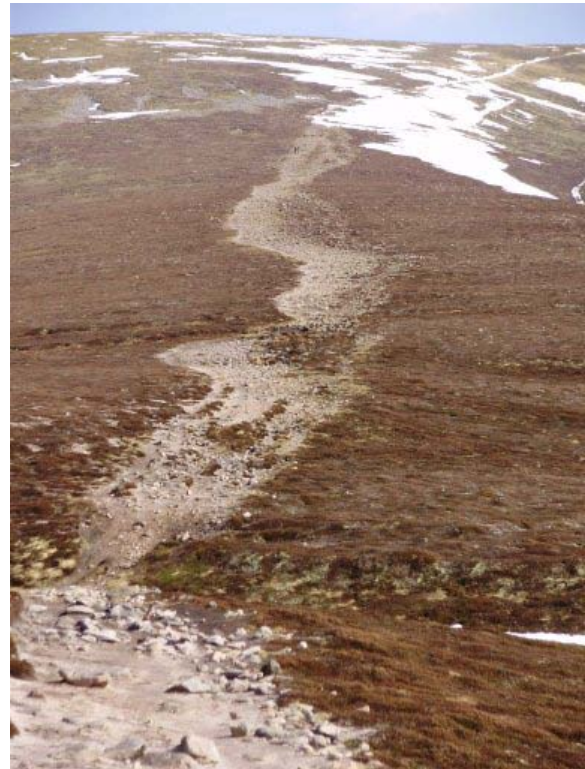
**Section 4 – highly visible path line with significant spread.**

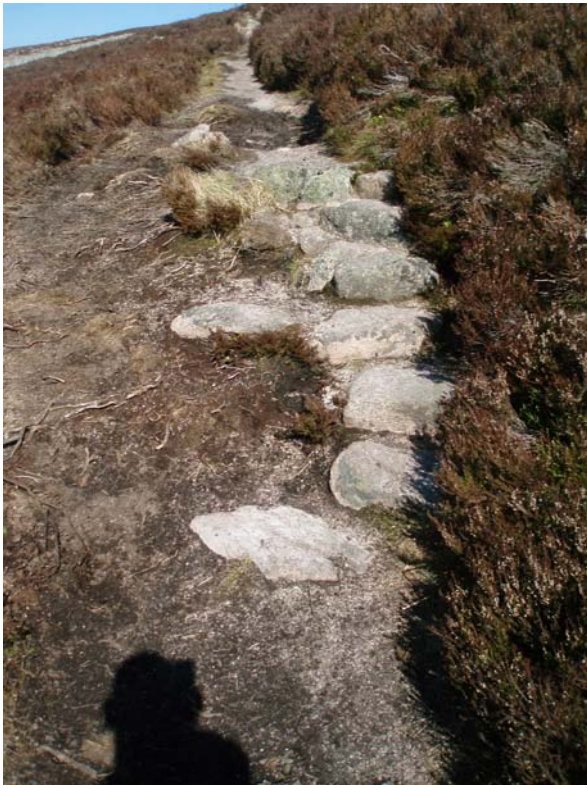
**Pitching being avoided.**

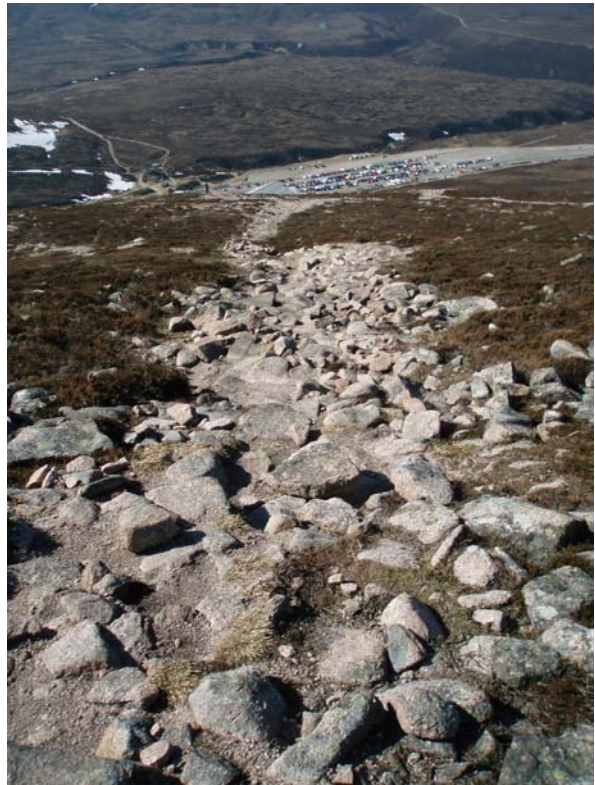
**Rougher path higher up.**

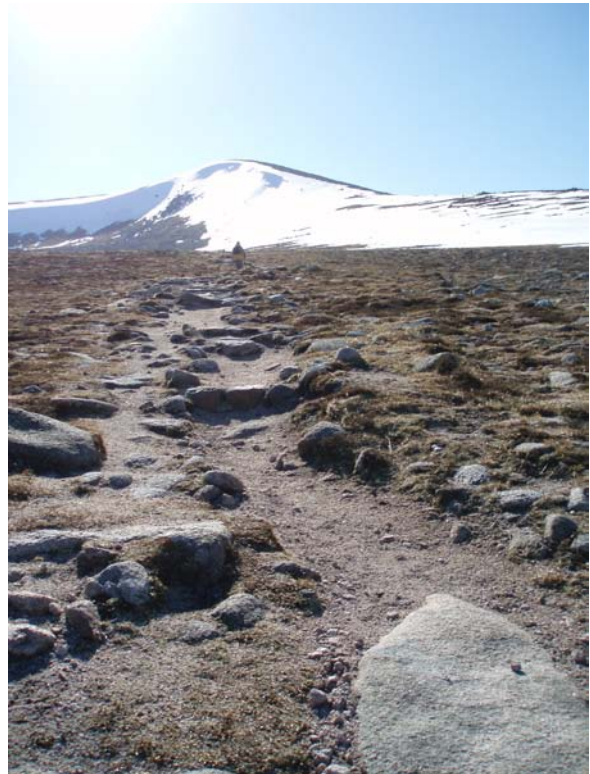
**Some brading.**

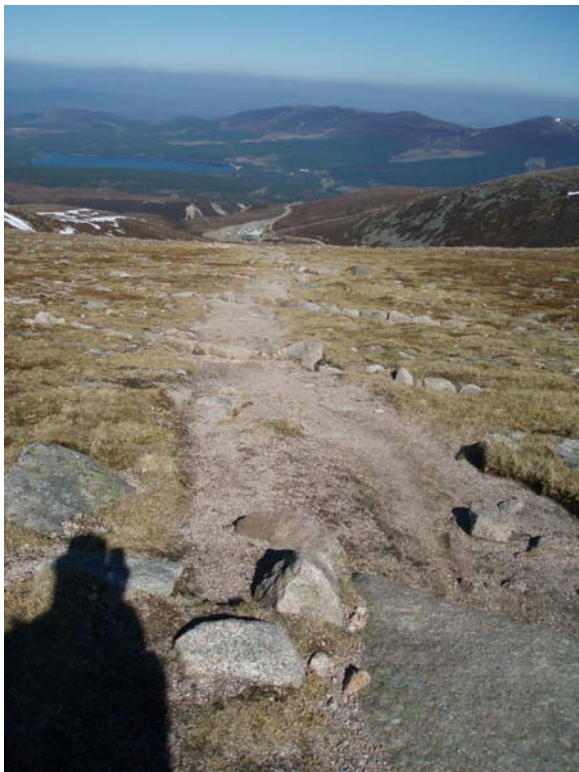
**Higher section.**

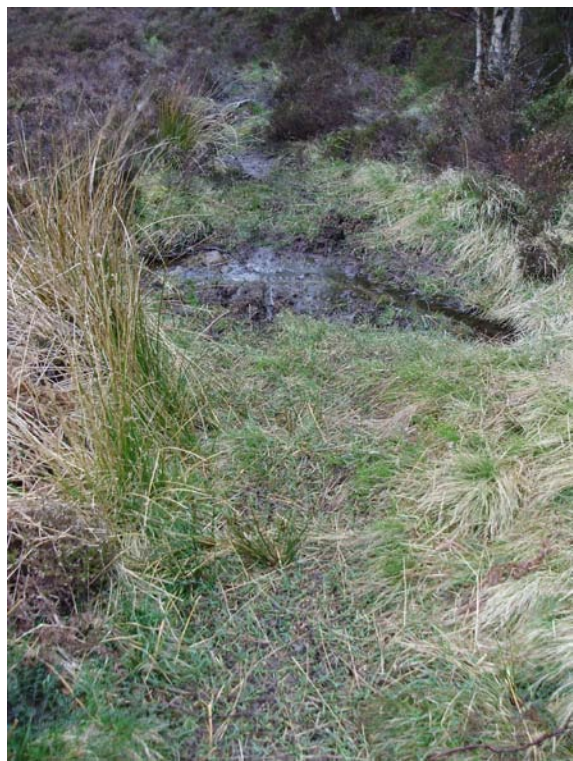
<b>Maintenance:</b> <ul style="list-style-type: none"><li>Built sections will need some ongoing maintenance and top up of surfacing.</li></ul>			
<b>Wet ground, section 3</b>

Re-route section 3 onto high ground machine built, full-build path.

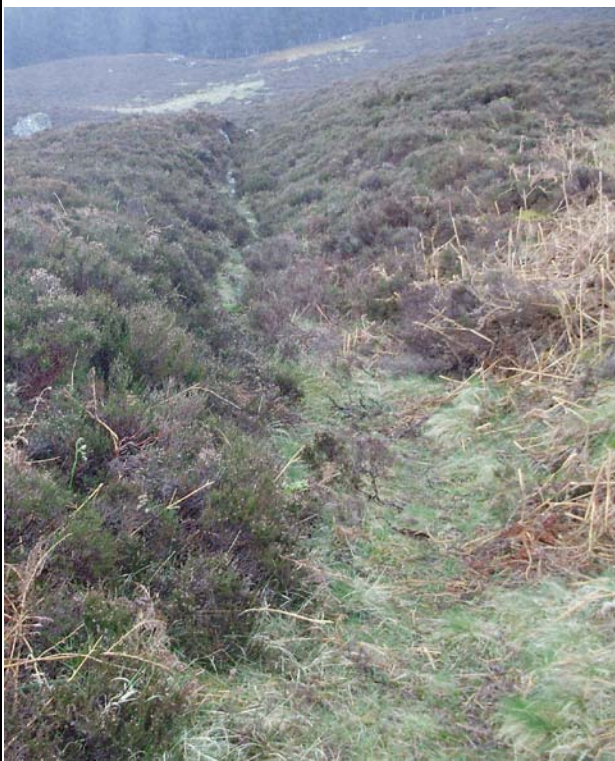
<b>Path in gully, section 3</b>

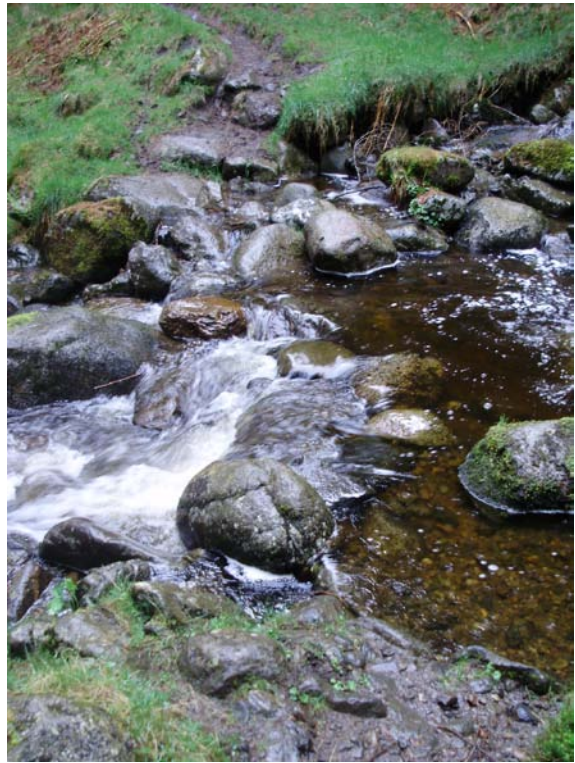
**Burn crossing.**

Path through trees. Generally hard surface but wet in places for first 300m with 10° LG, could use some hc & s and ditching. Upper 250m steeper with some wear, could use wbs & abs to protect. Burn crossing not easy when in spate - would need pitched ford or v. large stepping stones.

Needs some hc & s and ditching on wet sections and some abs & wbs higher up. Burn crossing needs large stepping stones/pitched ford.

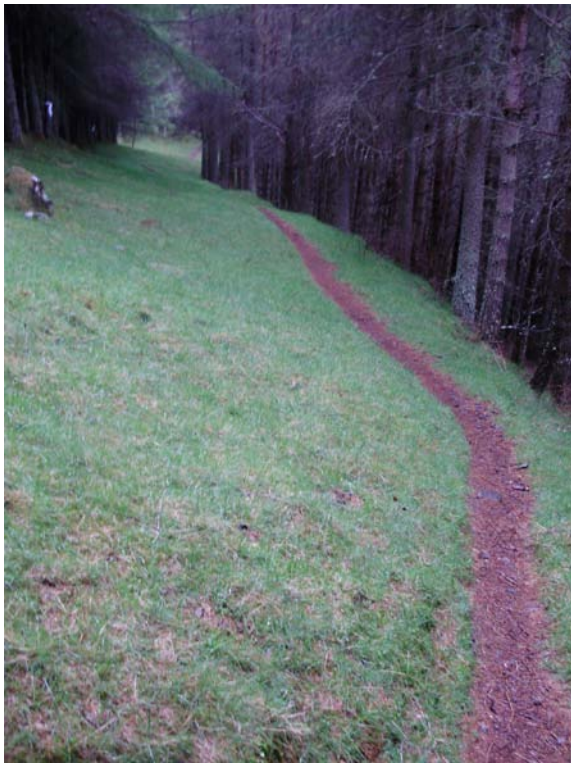
**Route through forest.**

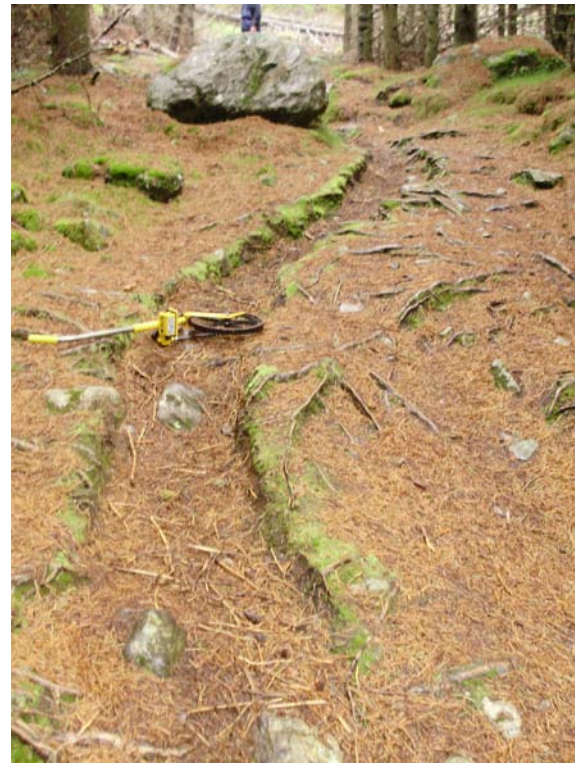
**Some gullying on steeper sections.**

<b>Recommendations:</b> <ul style="list-style-type: none"><li>• Could use partial build for first 300m with aggregate path, ditching and cross-drains.</li><li>• Upper 300m could use some water bars and anchor bars to protect longer-term.</li><li>• Re-positioning of large boulders in burn would help crossing.</li><li>•</li></ul>			
<b>Maintenance:</b> <ul style="list-style-type: none"><li>• Built sections will need some ongoing maintenance and top up of surfacing.</li></ul>
