Scotland's National Parks - Upland Path Project

The Mountains and The People

Loch Lomond and the Trossachs

Upland Path Audit 2013

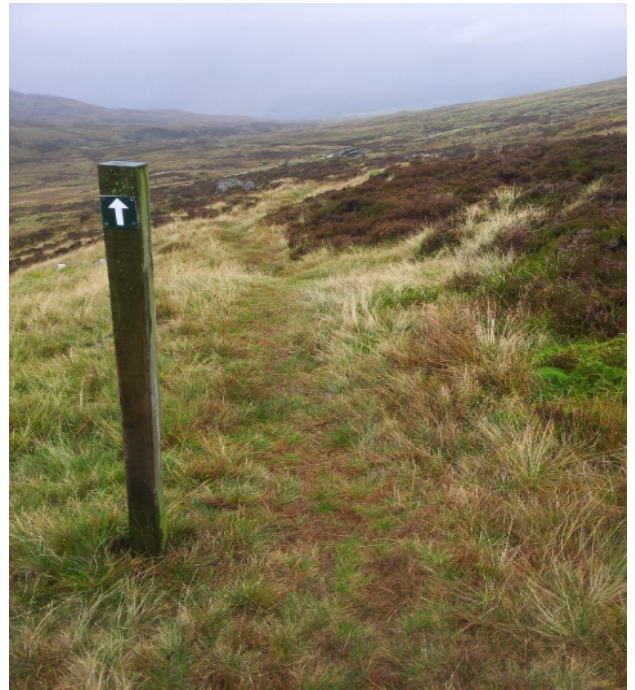
Typical trod line

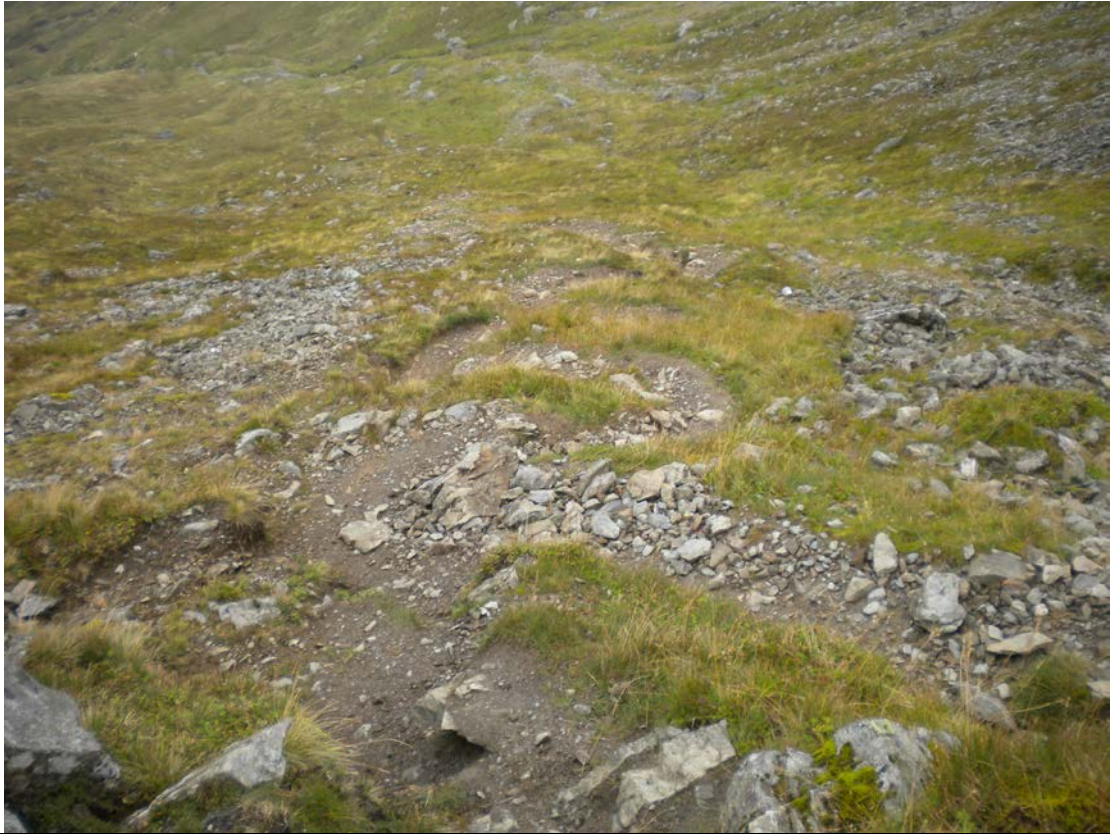
Section 2

Popular route bypassing the steep buttress on stuc a Chroin. Also used as a reurn route. Generally in good condition but some 'light touch' work on section 2 would help to prevent further erosion.

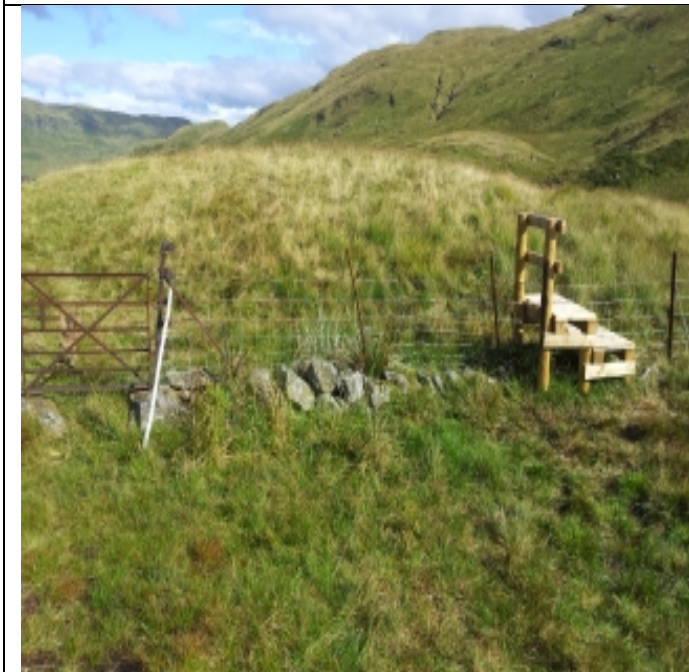
New Stile Sections 9/10

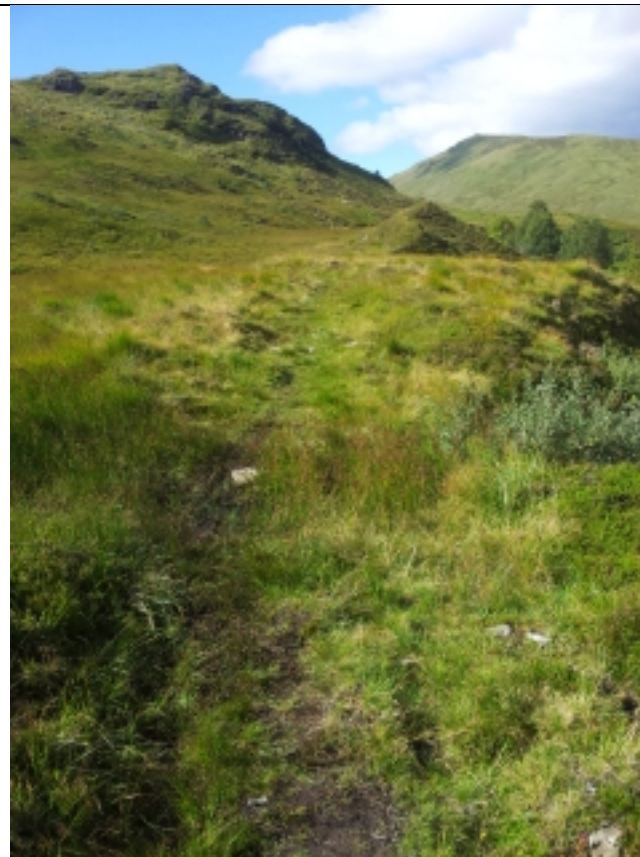
Typical trod line

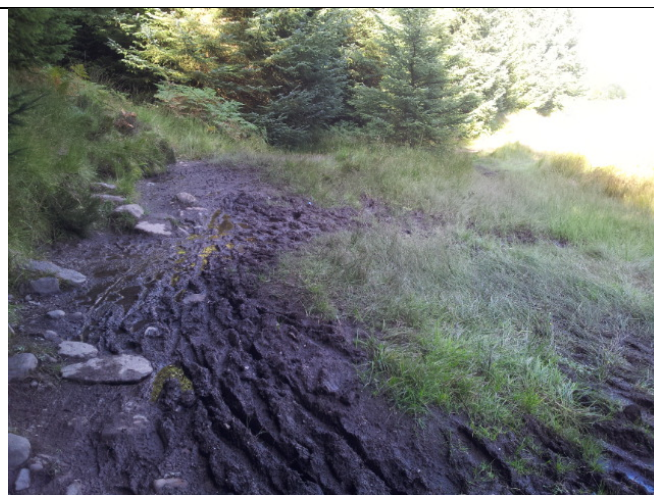
Section 6 through plantation

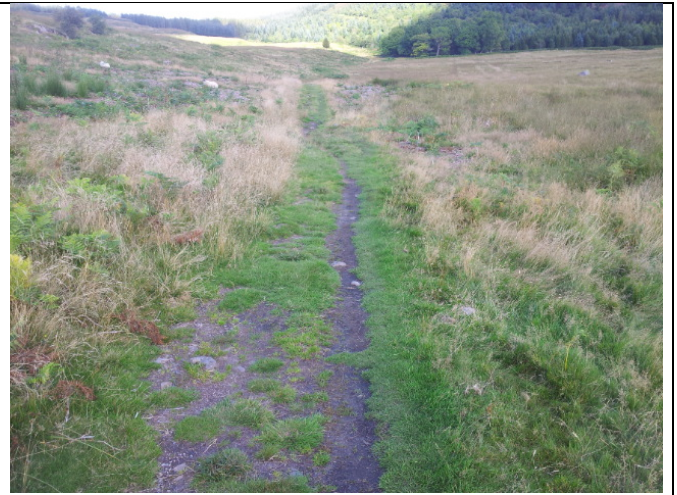
Mid section 4/5 light braiding

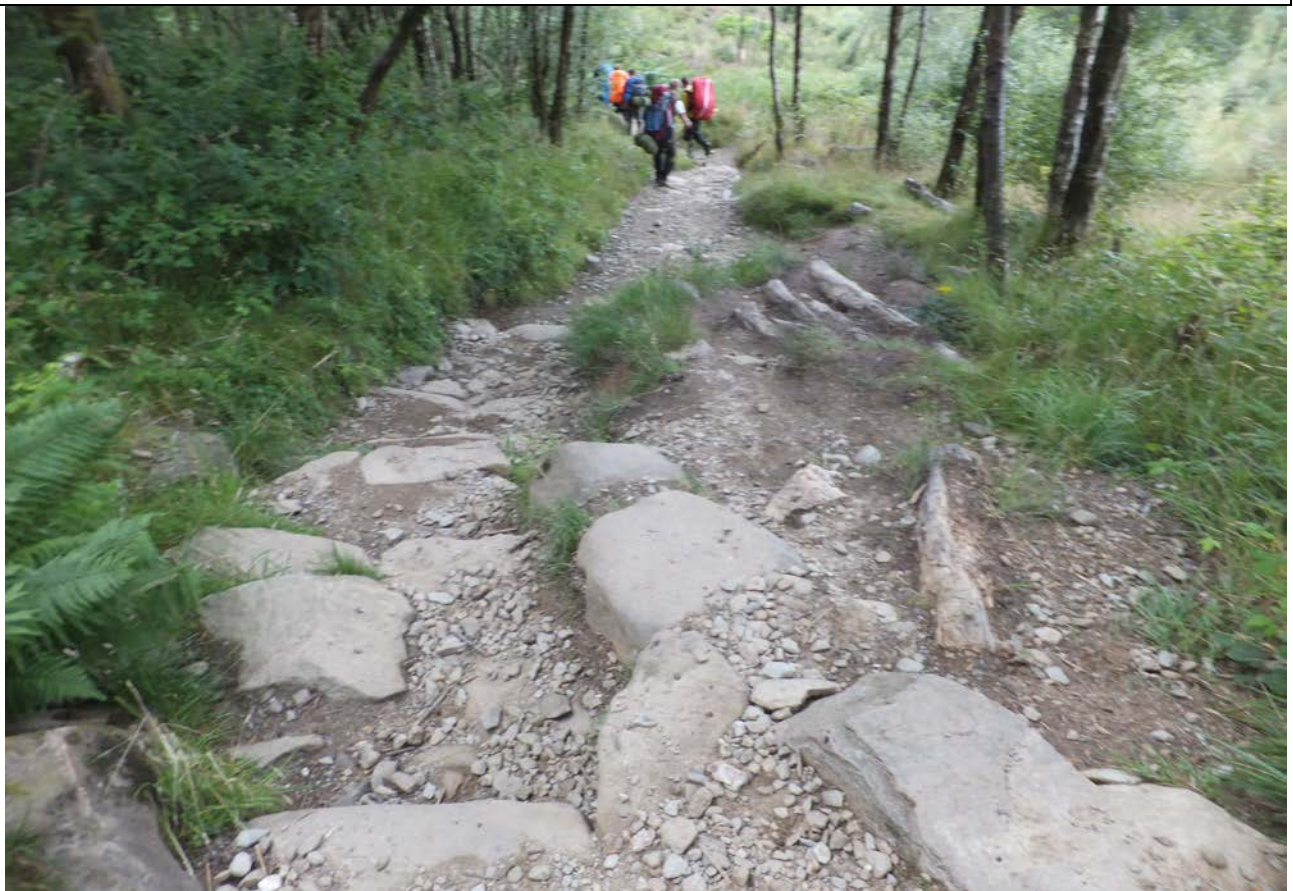
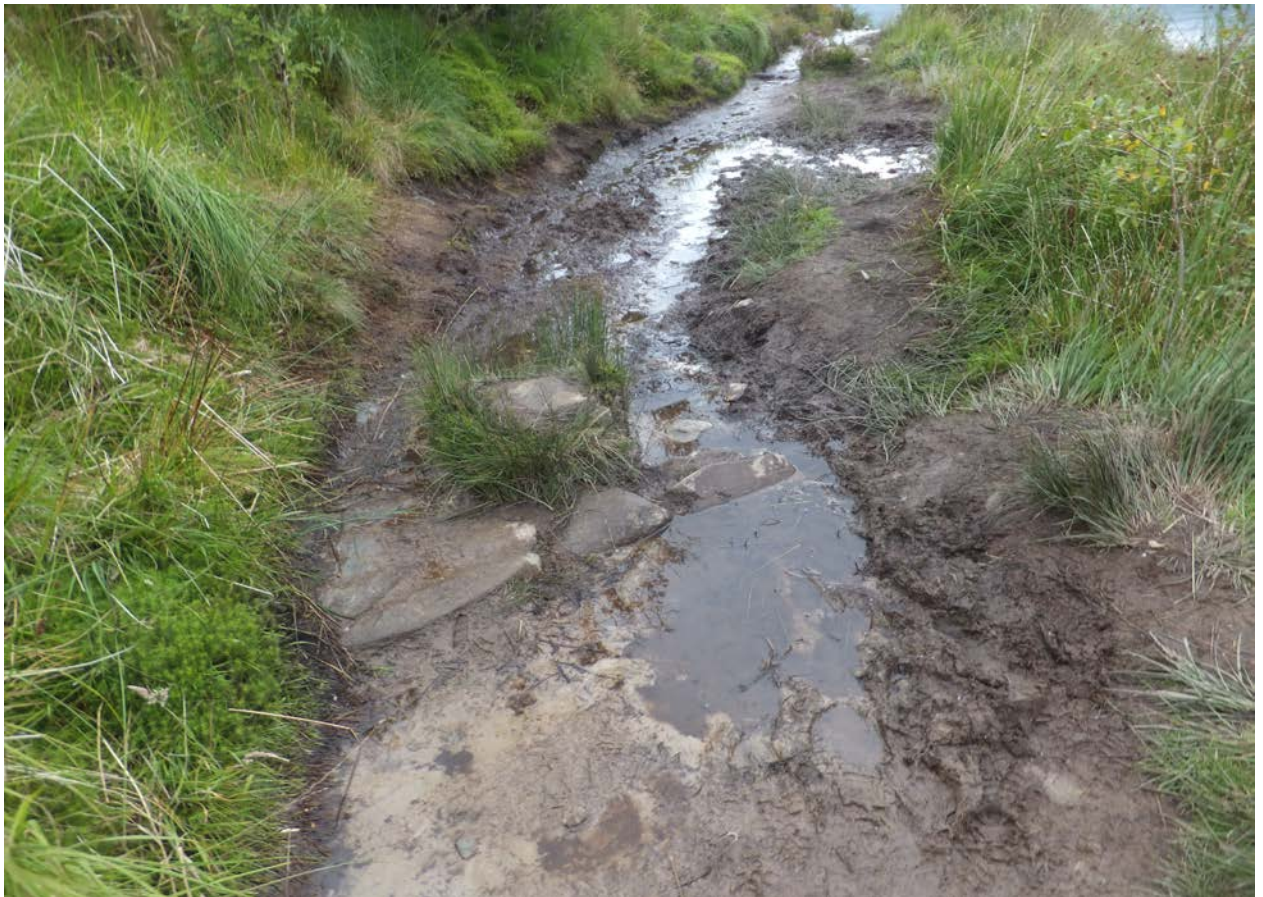
Path Management Constraints: <ul style="list-style-type: none"> • The terrain would make machine access difficult in many locations, which is a pity 			
Path Condition: <ul style="list-style-type: none"> • The path is very badly damaged along its length, and curiously has never had effective lateral drainage installed. 			
Recommendations: <ul style="list-style-type: none"> • A full rebuild required, by machine where possible. • Raised path and side drains everywhere except for the bedrock 			
Maintenance: Regular maintenance and pre-emptive works will be required once work has been completed.

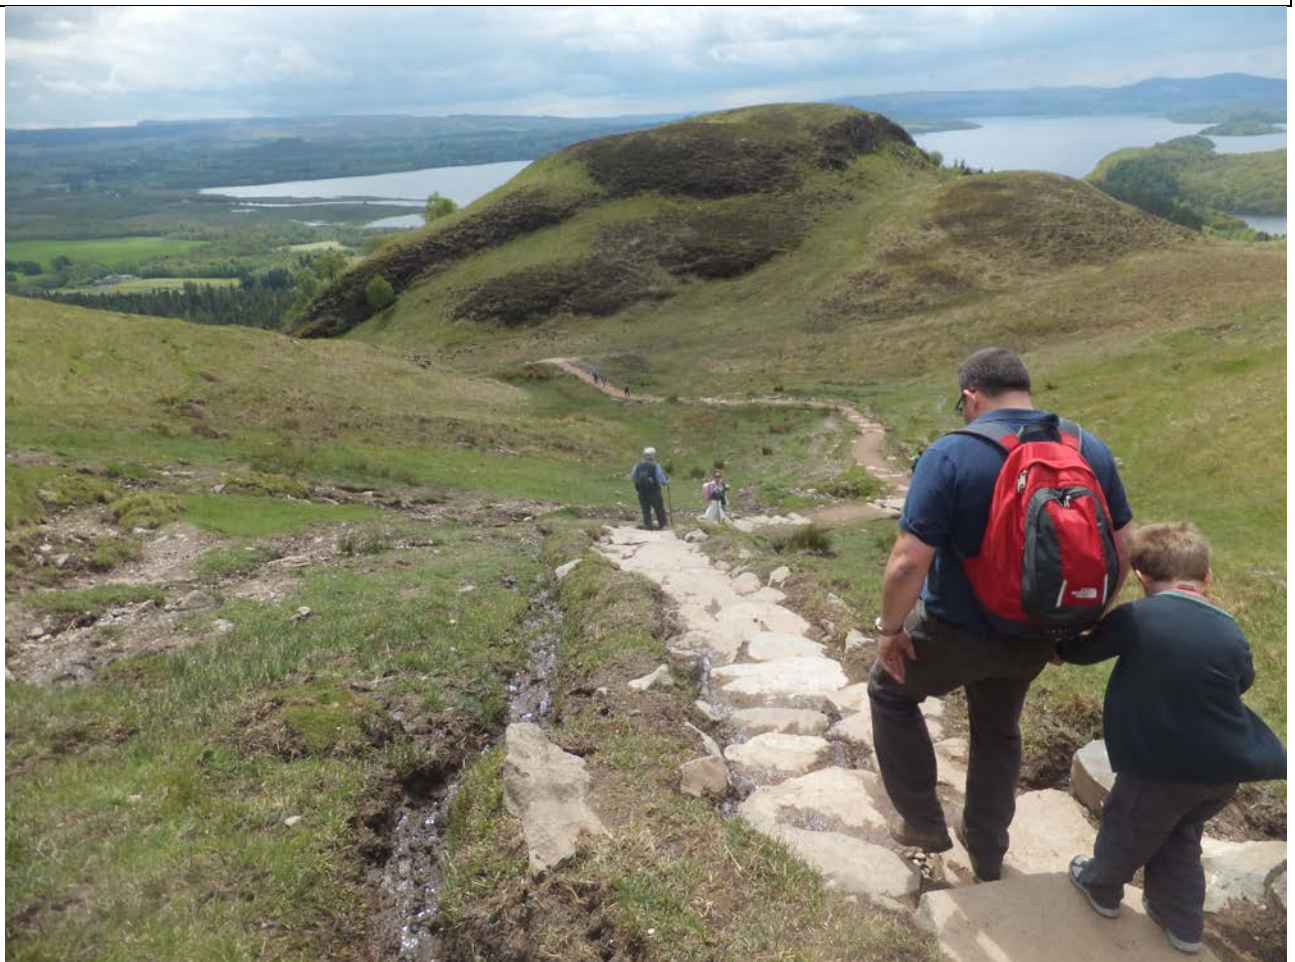
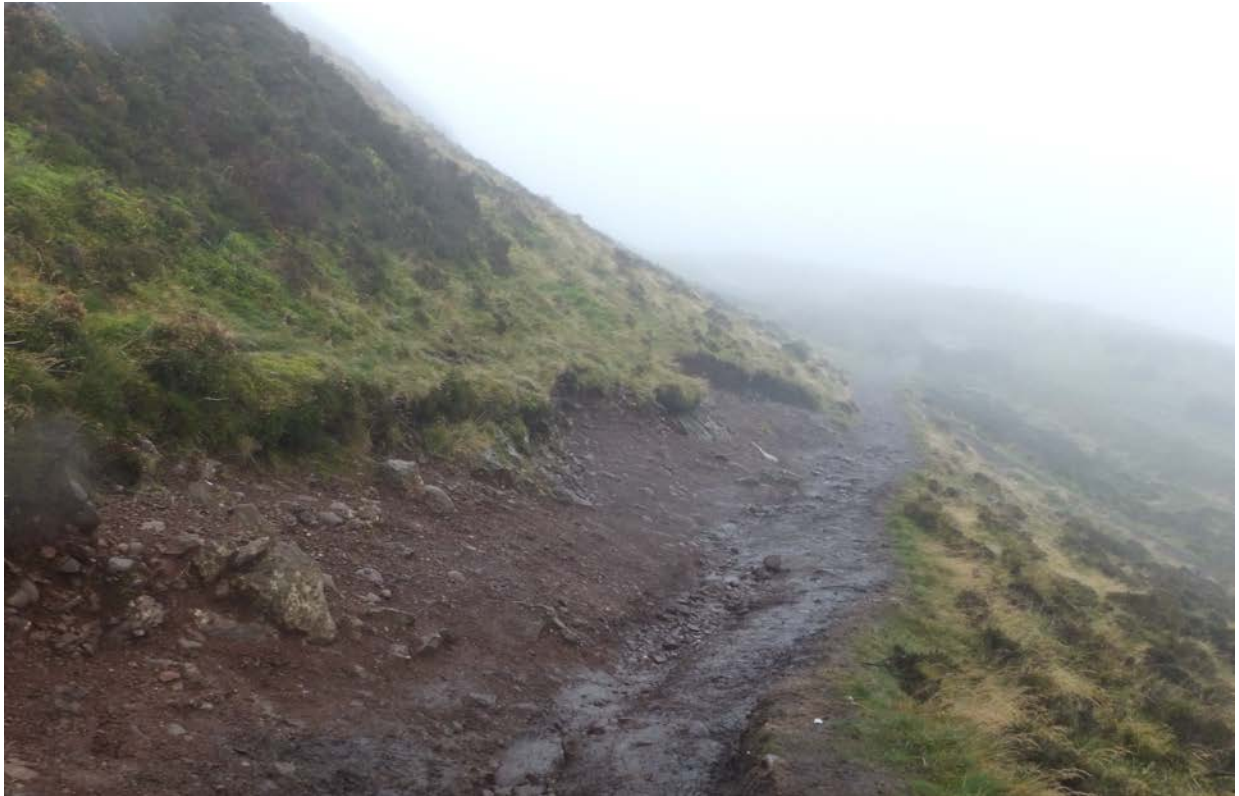
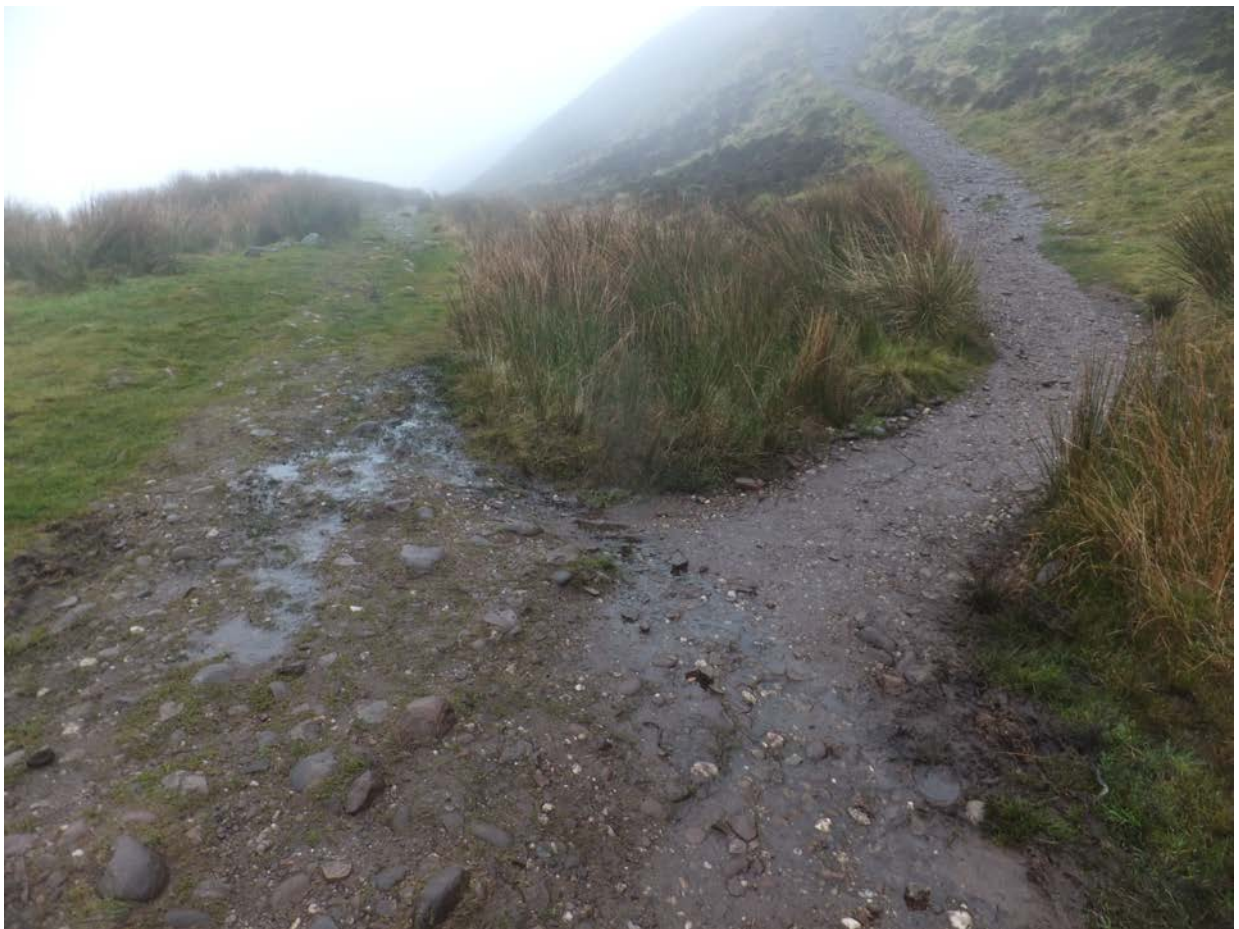
Path Number: LL34	Path Name: Conic Hill	Distance: 1,930m	Location: Start: NS 42341 91129 End: NS 43217 92334
Landowner: FCS	Designations: SSSI, NSA	Land Management Priorities: Recreation	
Use: Hugely popular route that is part of the West Highland Way. The spur leading off the Way to the summit of Conic Hill gives an excellent viewpoint over Loch Lomond, the Highland Boundary Fault and south over Strathclyde and Forth Valley.			
Previous Path Management: <ul style="list-style-type: none"> - The route up to the spur has been extensively constructed recently - There has seen no previous work carried on the spur to Conic Hill Summit 			
Path Management Constraints: <ul style="list-style-type: none"> • No machine access available • No construction stone available on site 			
Path Condition: <ul style="list-style-type: none"> • The path is badly gullied and likely to get a lot worse soon. 			
Recommendations: <ul style="list-style-type: none"> • A full rebuild required primarily using stone pitching.

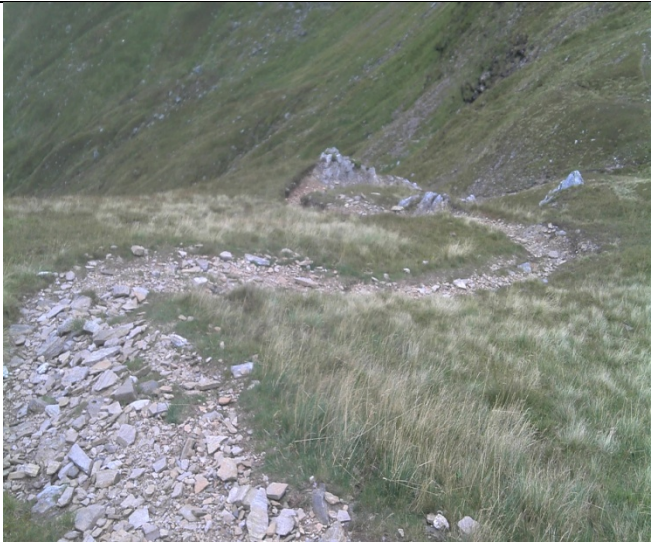
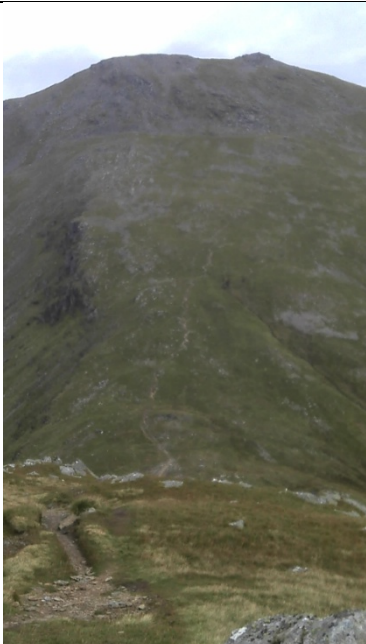
Path Number: LL 35	Path Name: Ben Lui and Beinn A Chleibh (A85)	Distance: 9.231Km	Location: NN2394227823 to NN2394227823 (loop)
Landowner: FCS/???	Designations: SSSI, NSA, SAC, NAC, NNR	Land Management Priorities:	
Use: Growing in popularity, a well used route from Glen Lochy to Ben Lui, enabling easy inclusion of neighbouring Beinn a'Chleibh.			
Previous Path Management: As dug path to river otherwise none. <i>See note below*</i>			
Path Management Constraints: <ul style="list-style-type: none"> • A high specification path would greatly improve the route through the plantation areas and reduce path spread and erosion. • Specific railway crossing at start is priority • *Evidence of possible monitoring by another interested party – number of spray paint markers noted on section 7 			
Path Condition: <ul style="list-style-type: none"> • Lower sections through plantation rough and muddy • Route on hill proper generally robust with cobble cover • End sections 11,12 little evidence of use

Recommendations: <ul style="list-style-type: none"> • Sections through plantation would benefit from intensive repair/build. Recommend machine use. • Light touch, consolidation and drainage works along route would be beneficial in maintaining path and surrounding habitat integrity. 			
Maintenance: Once repaired the path will require quite intensive maintenance, with drains to be cleared, path surface occasionally topped up, and a continuity of light touch and pre-emptive work further in.
